URBAN RENEWAL STUDY

Columbia Tusculum Redevelopment Area

Documentation of a Blight or Deterioration

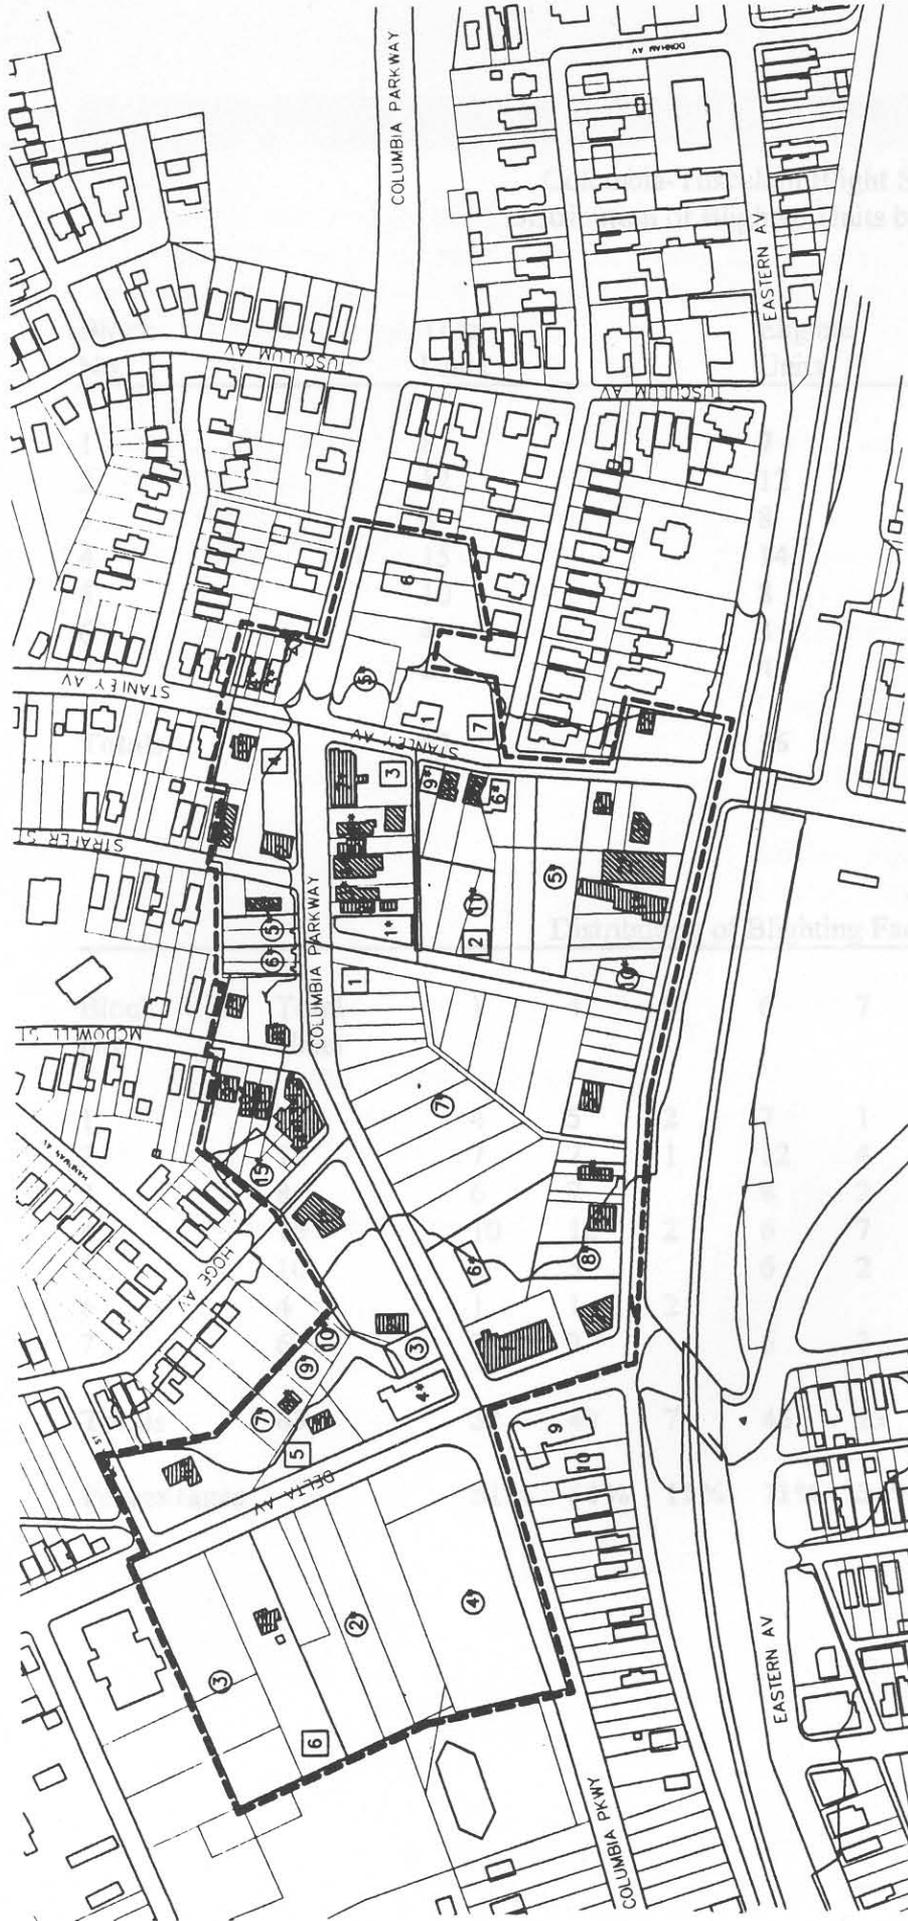
Blight Study

COLUMBIA-TUSCULUM BLIGHT STUDY
