HISTORIC CONSERVATION BOARD AGENDA

II CENTENNIAL PLAZA – 5TH FLOOR,
PUBLIC CONFERENCE ROOM, 805 CENTRAL AVE
Monday, March 21, 2016 – 3:00 pm

**APPLICATION FOR
CERTIFICATE OF APPROPRIATENESS
AND ZONING VARIANCE
HISTORIC CONSERVATION BOARD PUBLIC HEARING
STAFF REPORT**

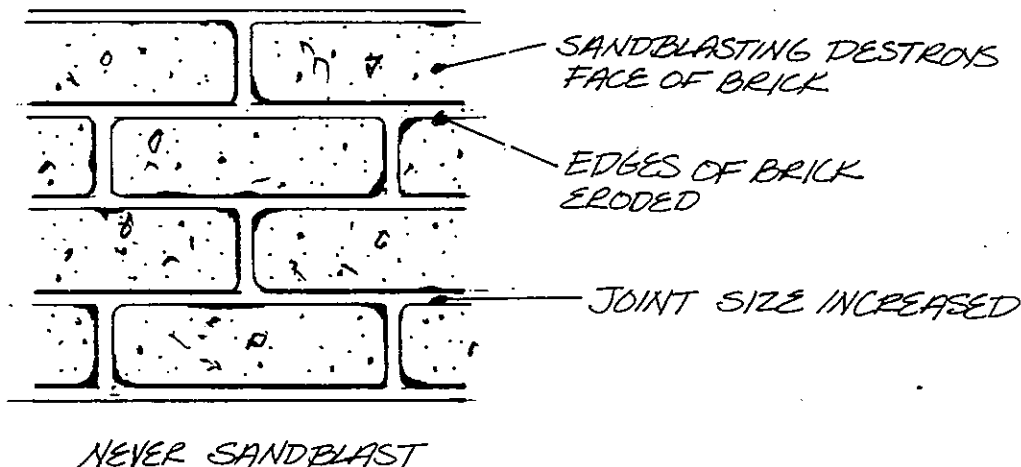
A. Cleaning: Cleaning dirt or old paint off of a building should be done by the gentlest means possible. Low pressure water, detergent, and natural bristle brushes are often adequate. Never sandblast. Sandblasting permanently damages the surface of brick.

Guideline Never sandblast.

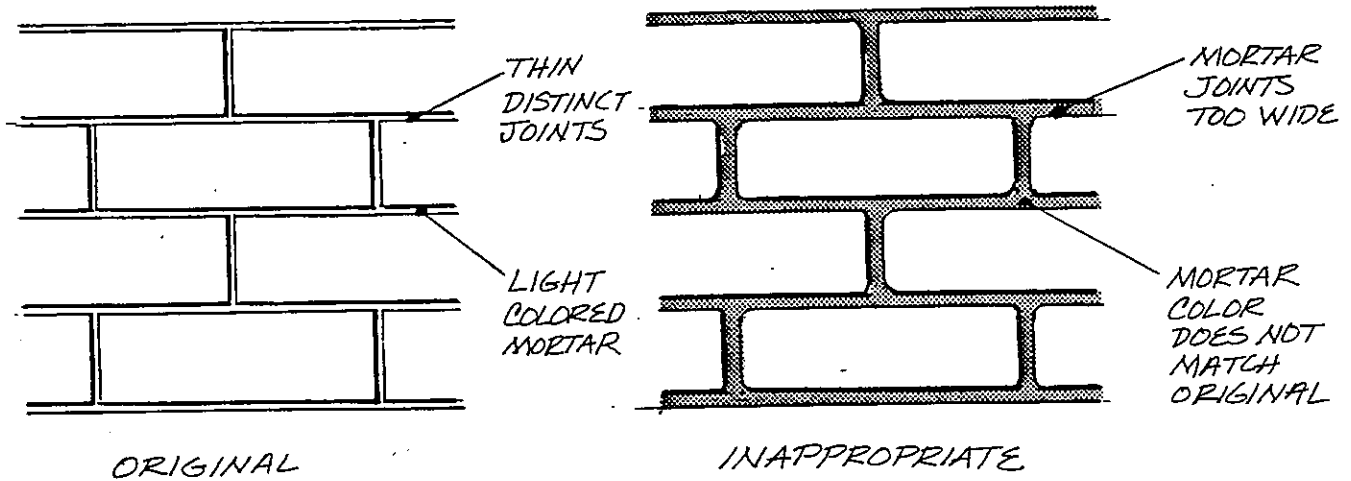
B. Pointing: Repointing masonry walls built before the turn of the century should be done with a soft lime-based mortar mix rather than a harder Portland cement based mortar which would be stronger than the old brick and could crack the brick itself. The mortar color, texture, and type and size of joint should match the original or the wall will look like a patchwork.

Guideline Repoint old masonry with care.

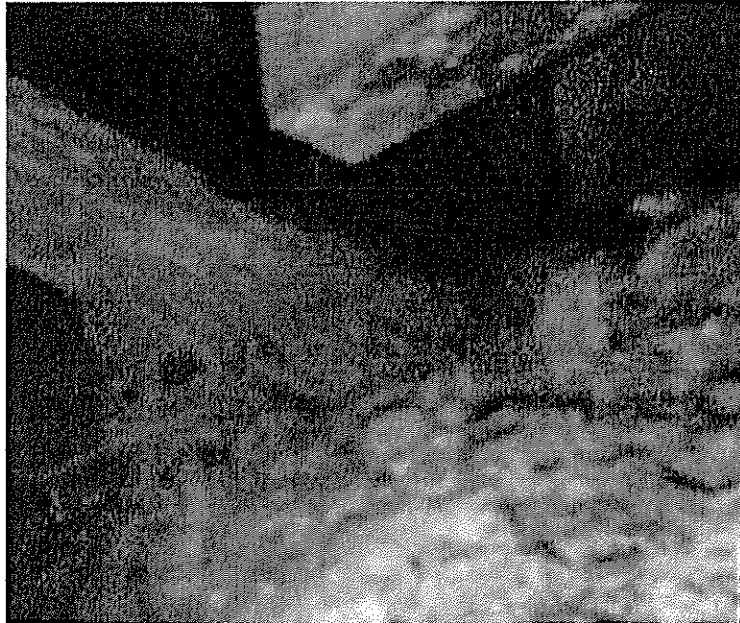
The building has experienced settling and has significant structural challenges. There has been temporary shoring installed in the basement to address sagging areas in the structure. The western terminus of the main structural beam that runs through the basement of the building has rotted and has begun to crush.

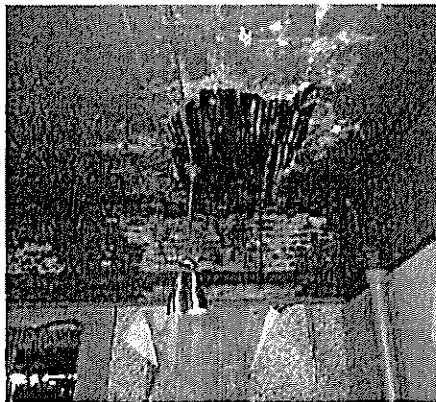
ii. Roof & Water Damage

In addition to primary structural challenges, the roof has been permitted to leak water into the building in at least two places for a significant amount of time. This has caused structural failures in these areas in at least three of the top stories. The images show where the water has come through the ceiling from the floor above

The cost to repair the roof was estimated at \$165,000, which did not include the repairs to the structural damage in the floors below.

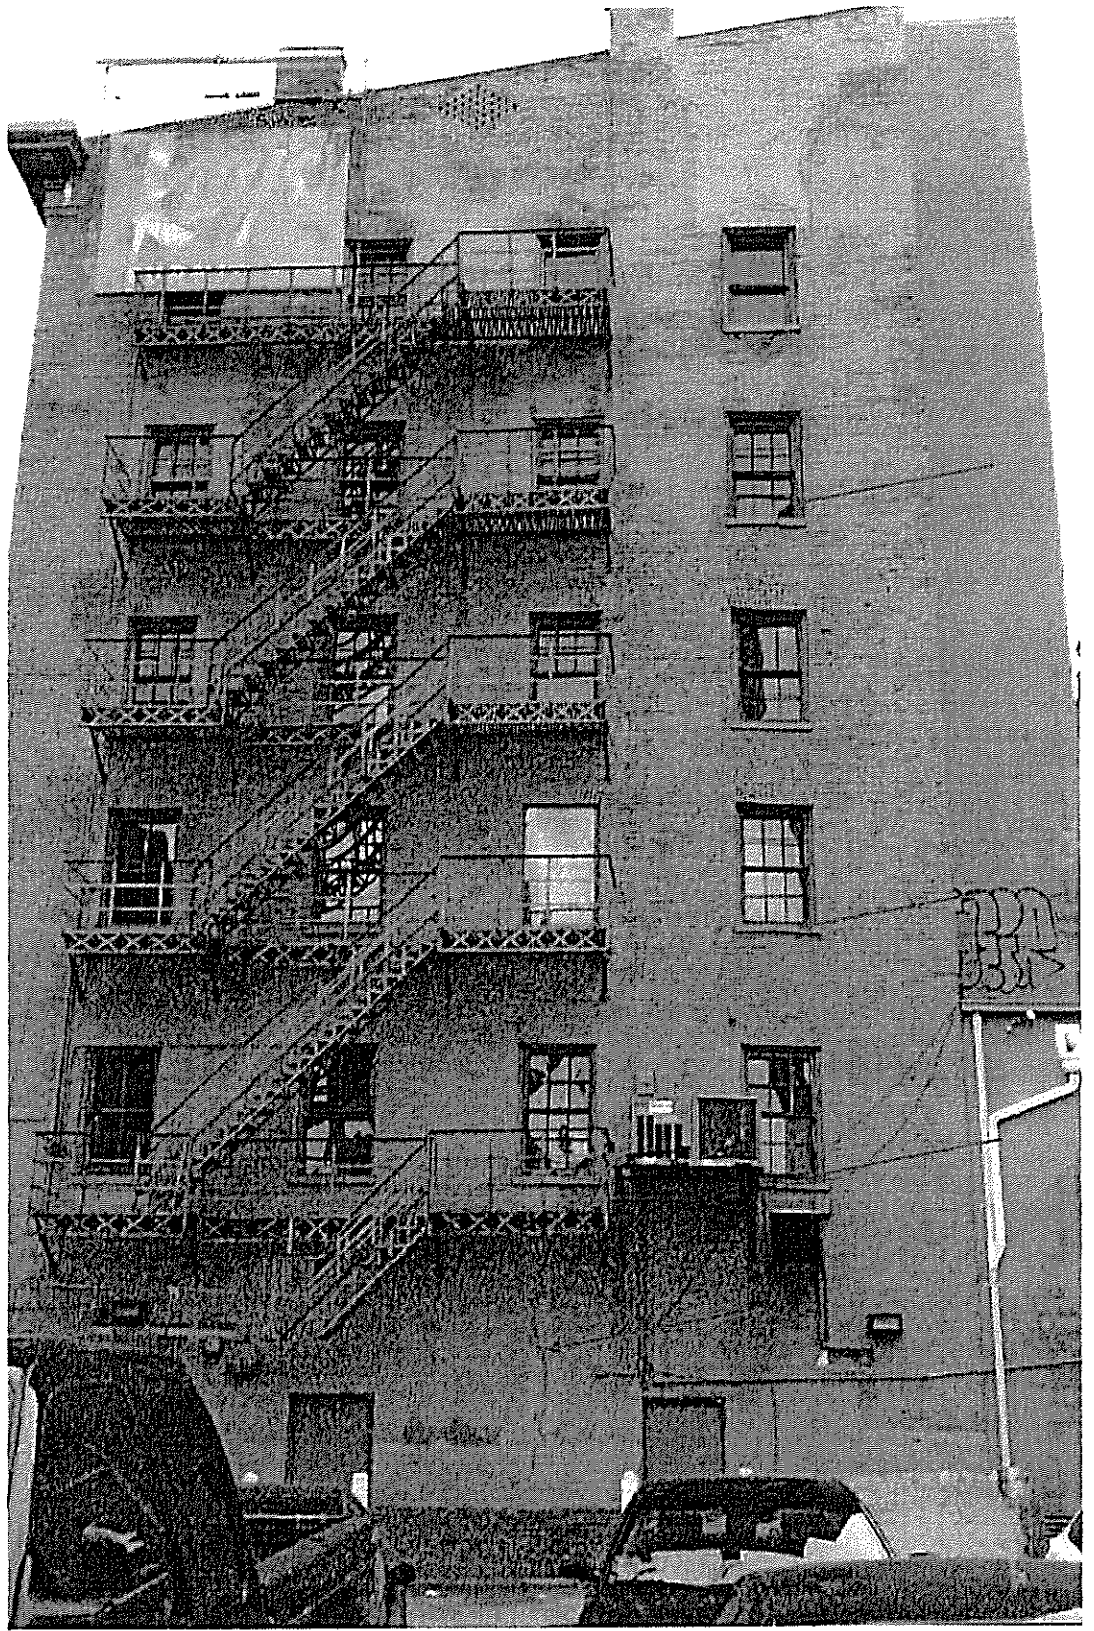
iii. Exterior Masonry

The exterior brick structure also shows signs of settlement and/or failure in several areas, including the western wall. These failures indicate significant structural issues as well as substantial expense to appropriately address and remedy.

The cost to repair the exterior masonry of the building was estimated at \$170,000.

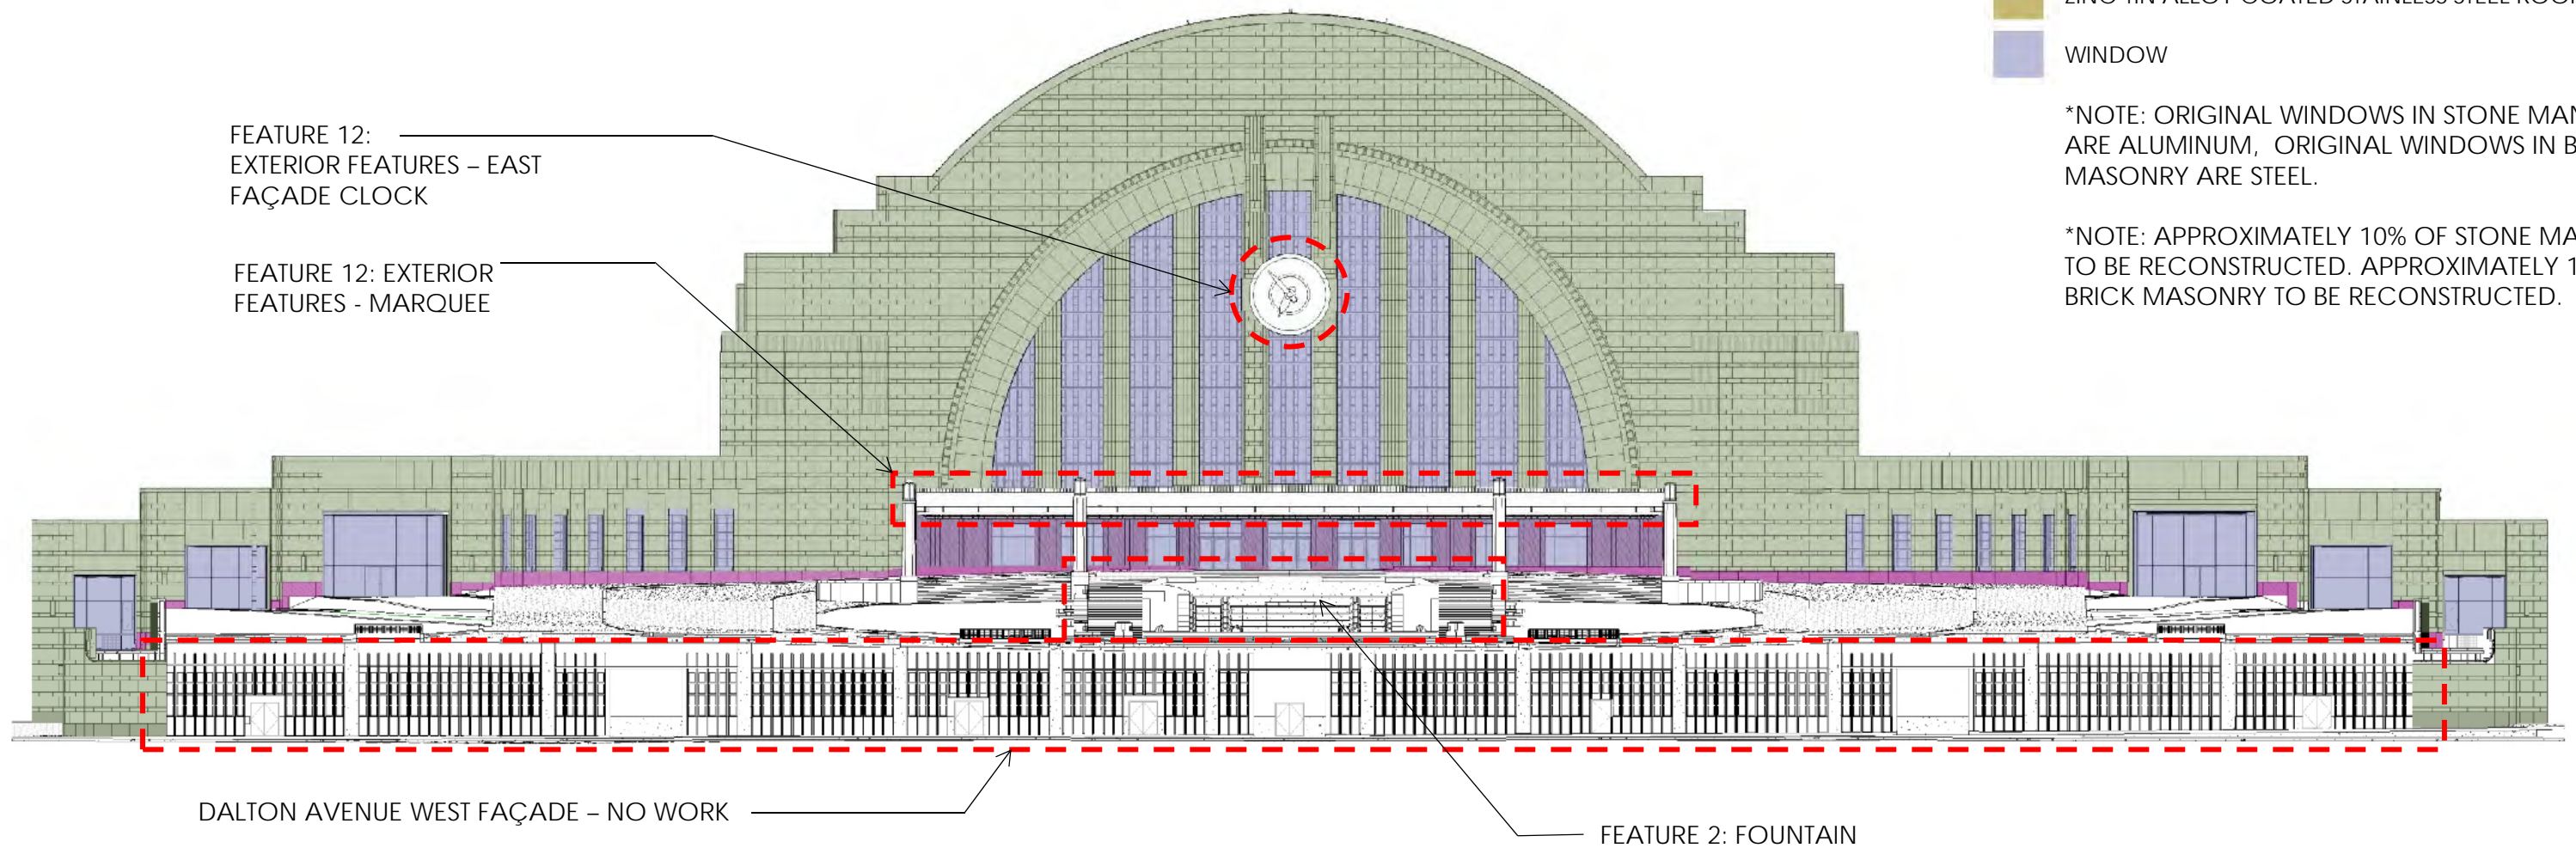
**Exterior Material Key Elevation 2-A
East Elevation**
Cincinnati Union Terminal Restoration & Renovation

*NOTE: APPROXIMATELY 10% OF STONE MASONRY TO BE RECONSTRUCTED. APPROXIMATELY 18% OF BRICK MASONRY TO BE RECONSTRUCTED.

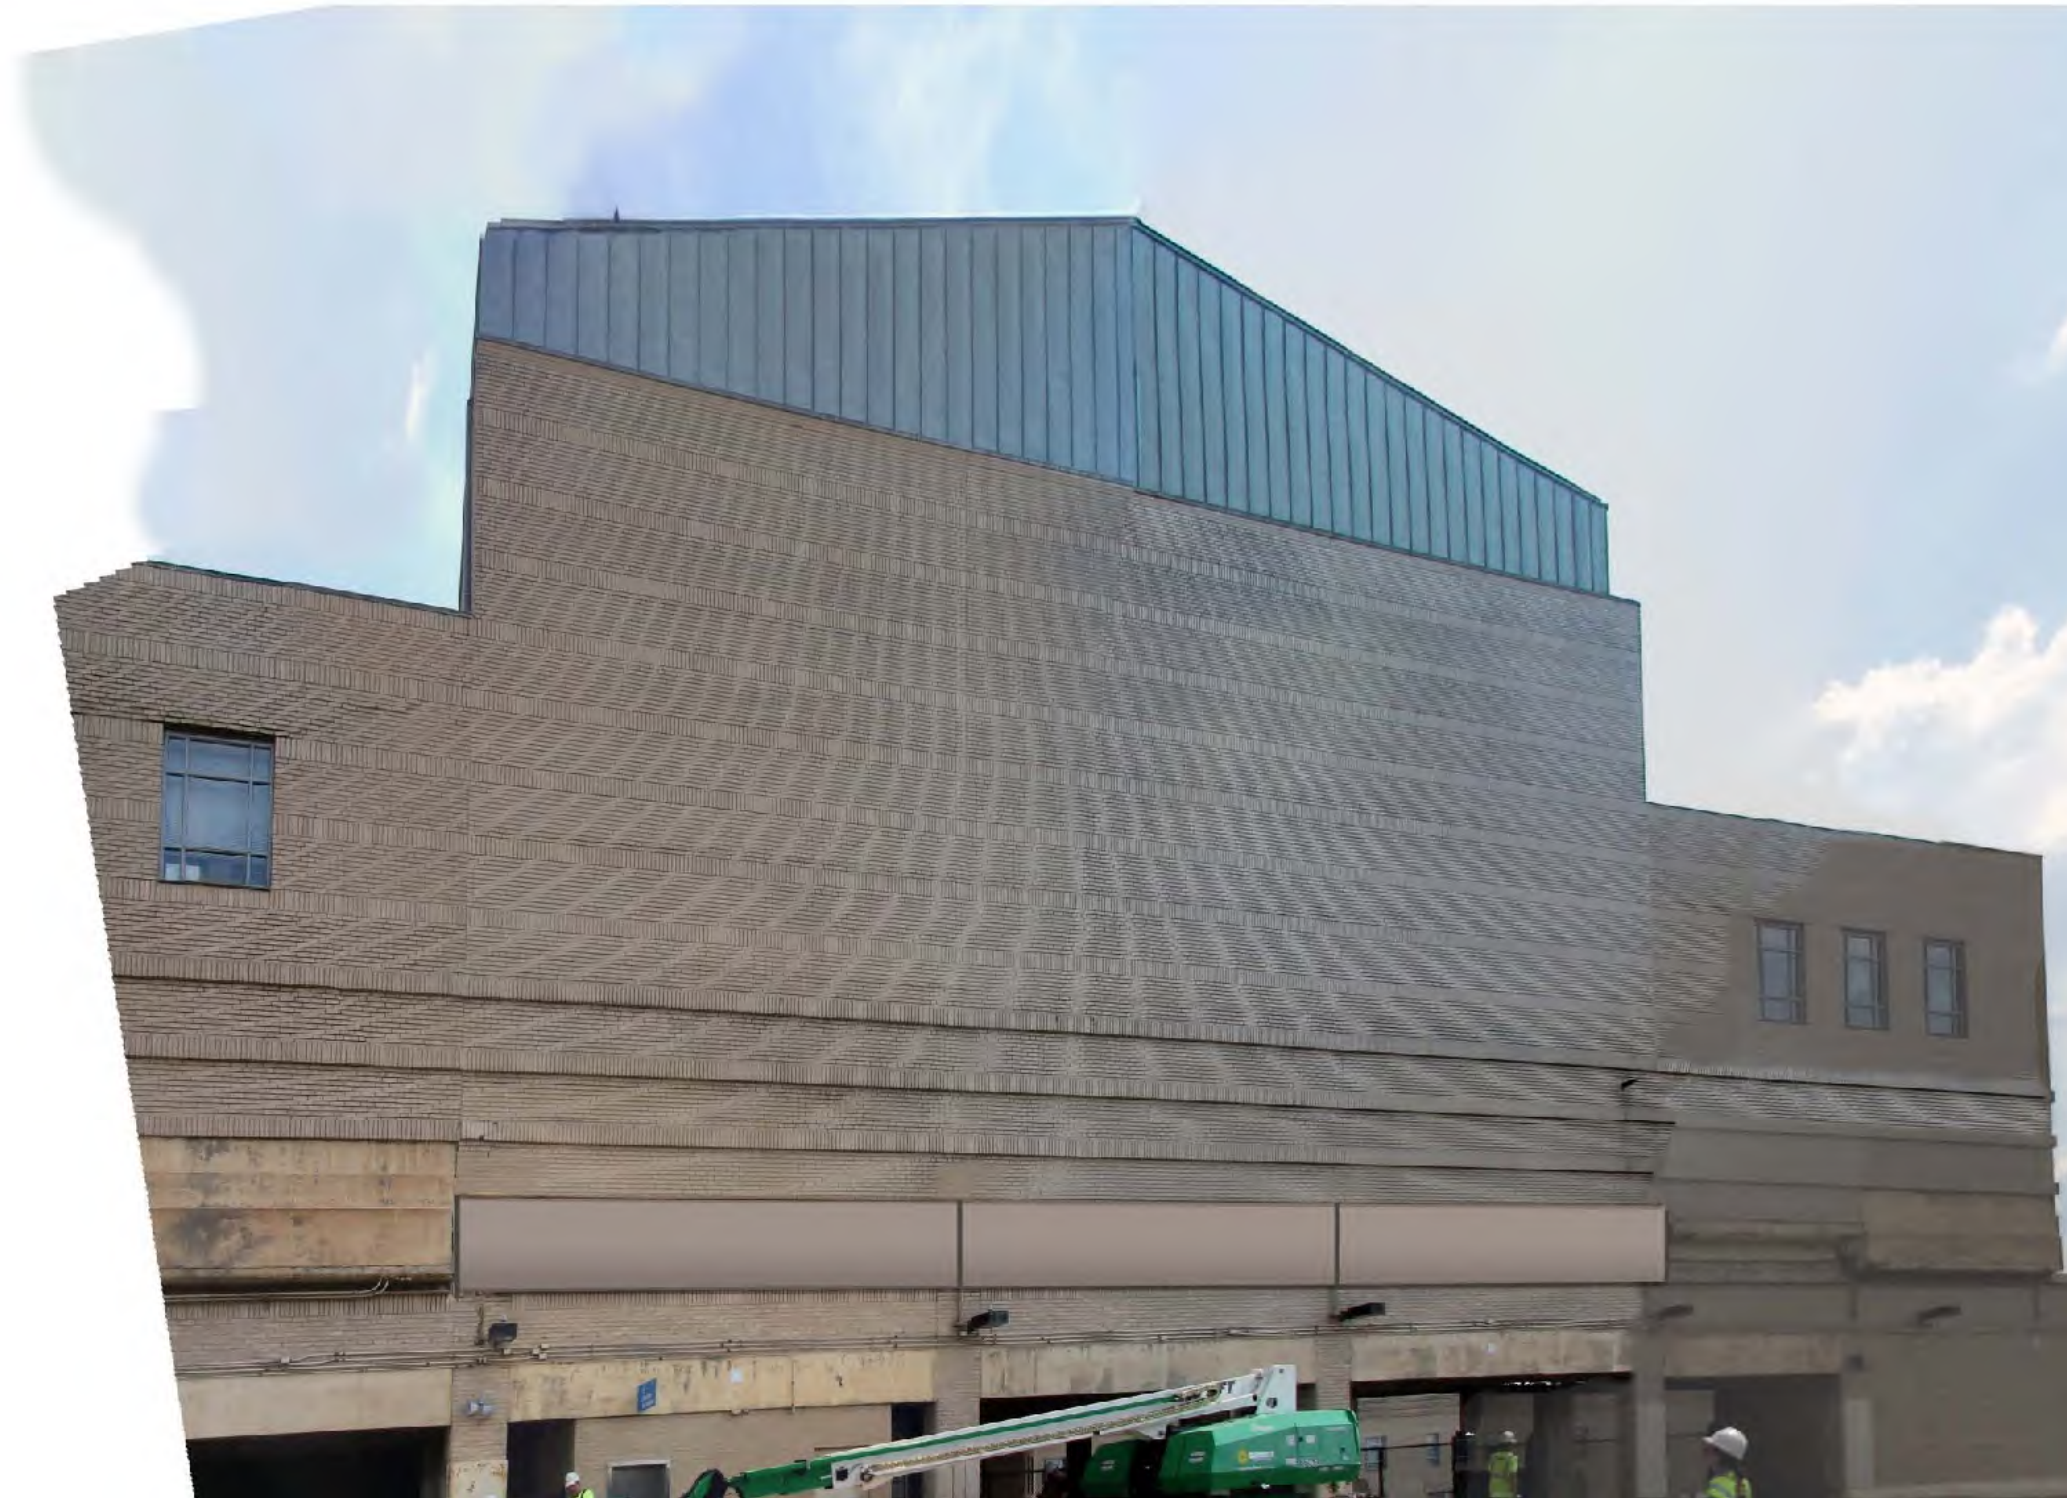
Rendering of rebuilt west elevation brick wall with existing metal west gable roof above.

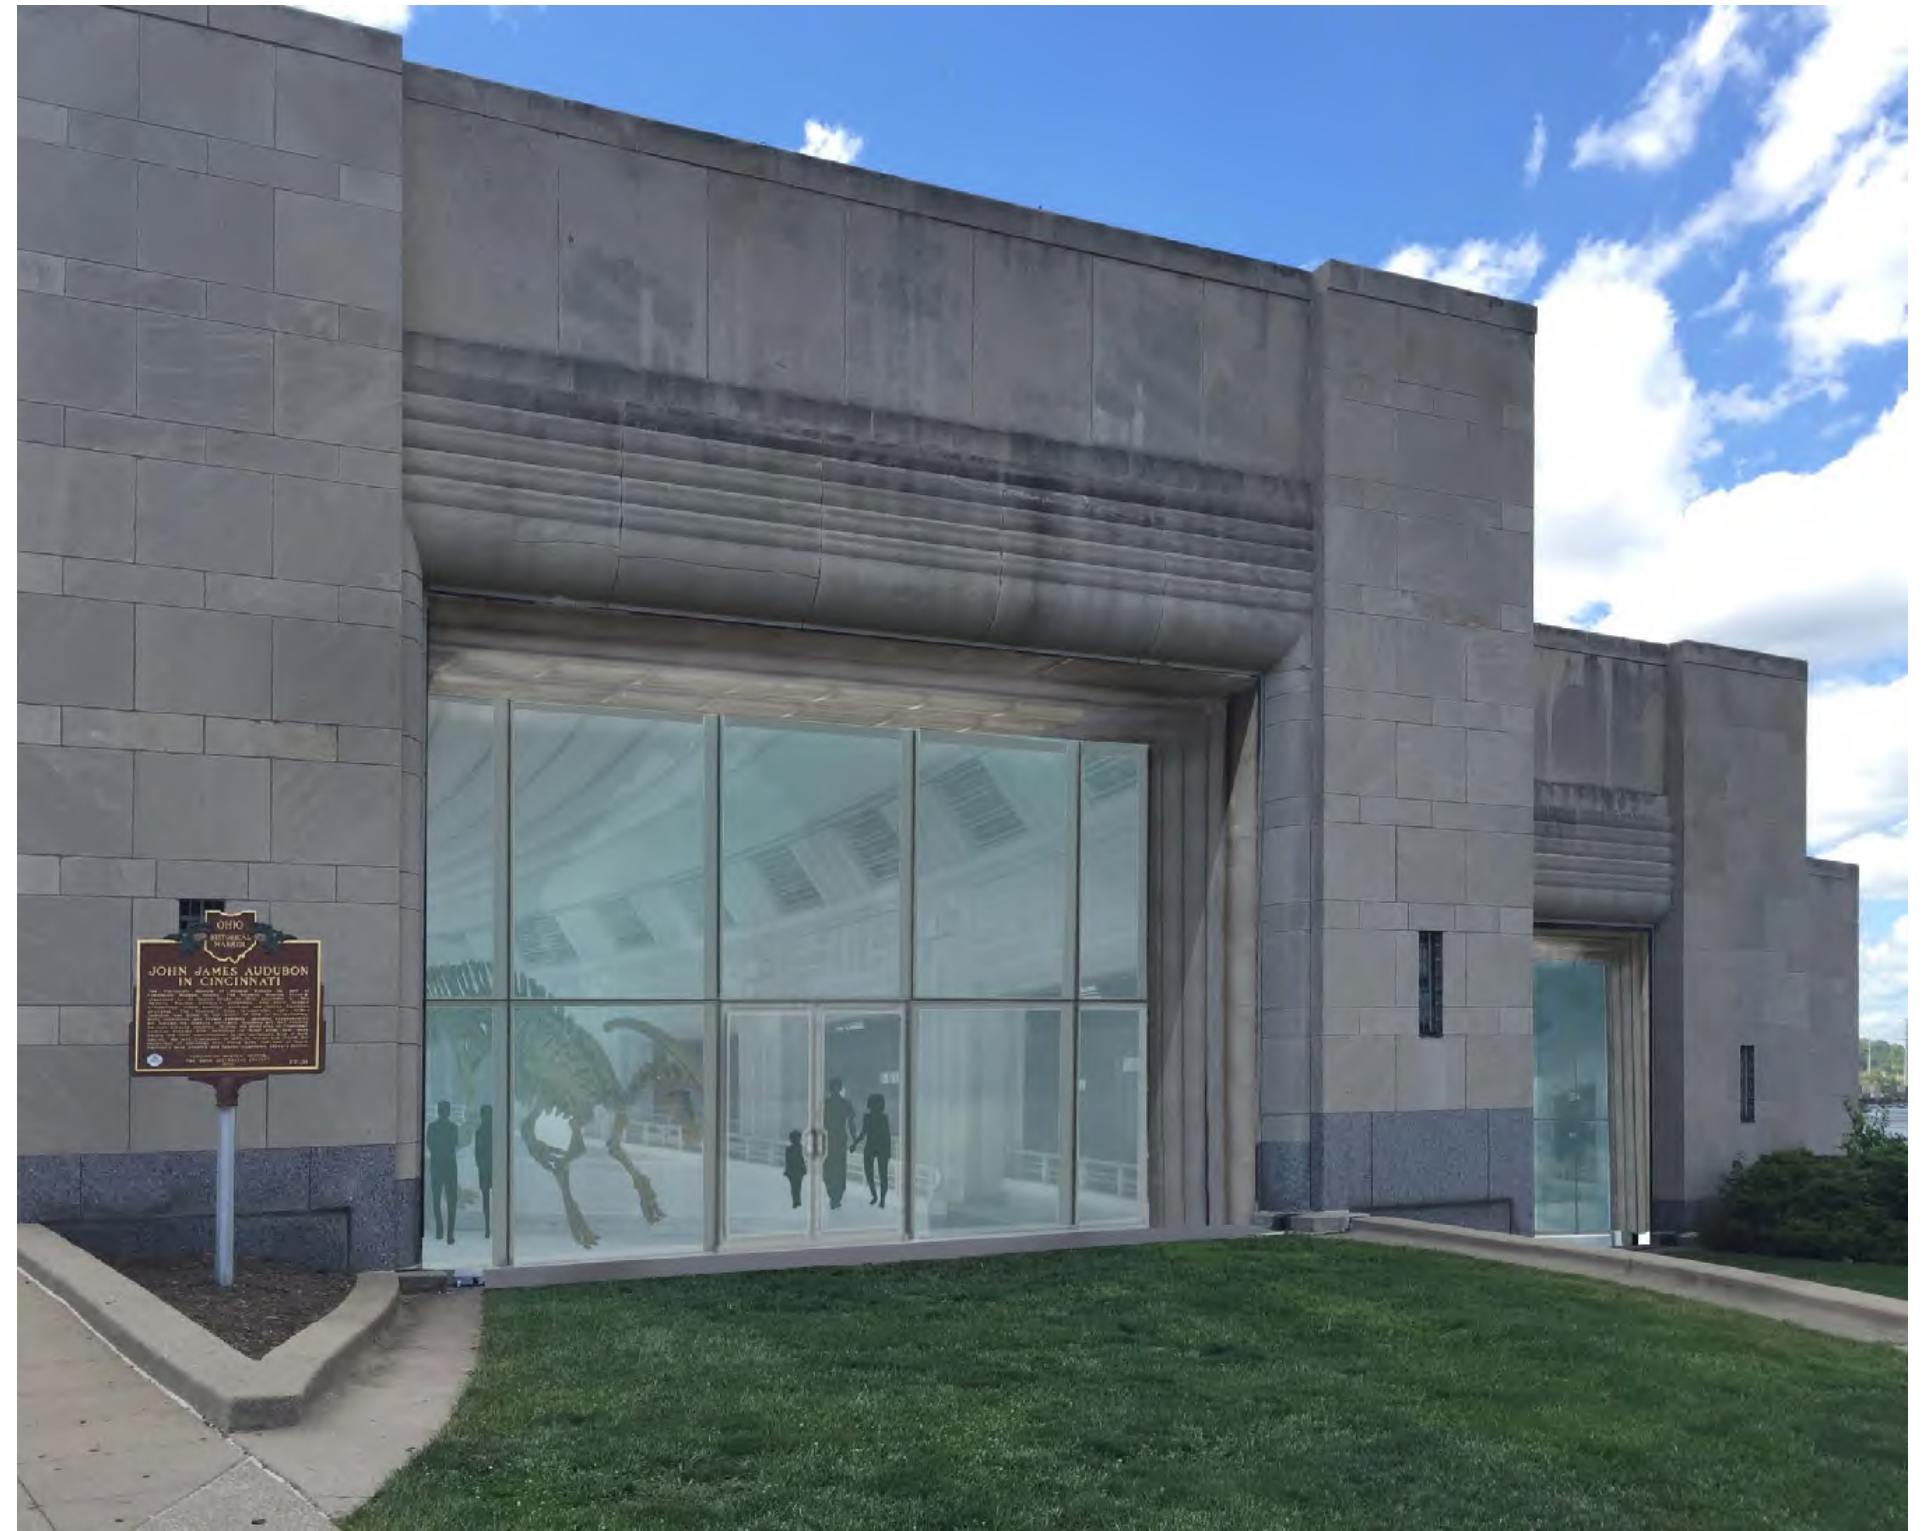
Proposed north ramp portal glazing

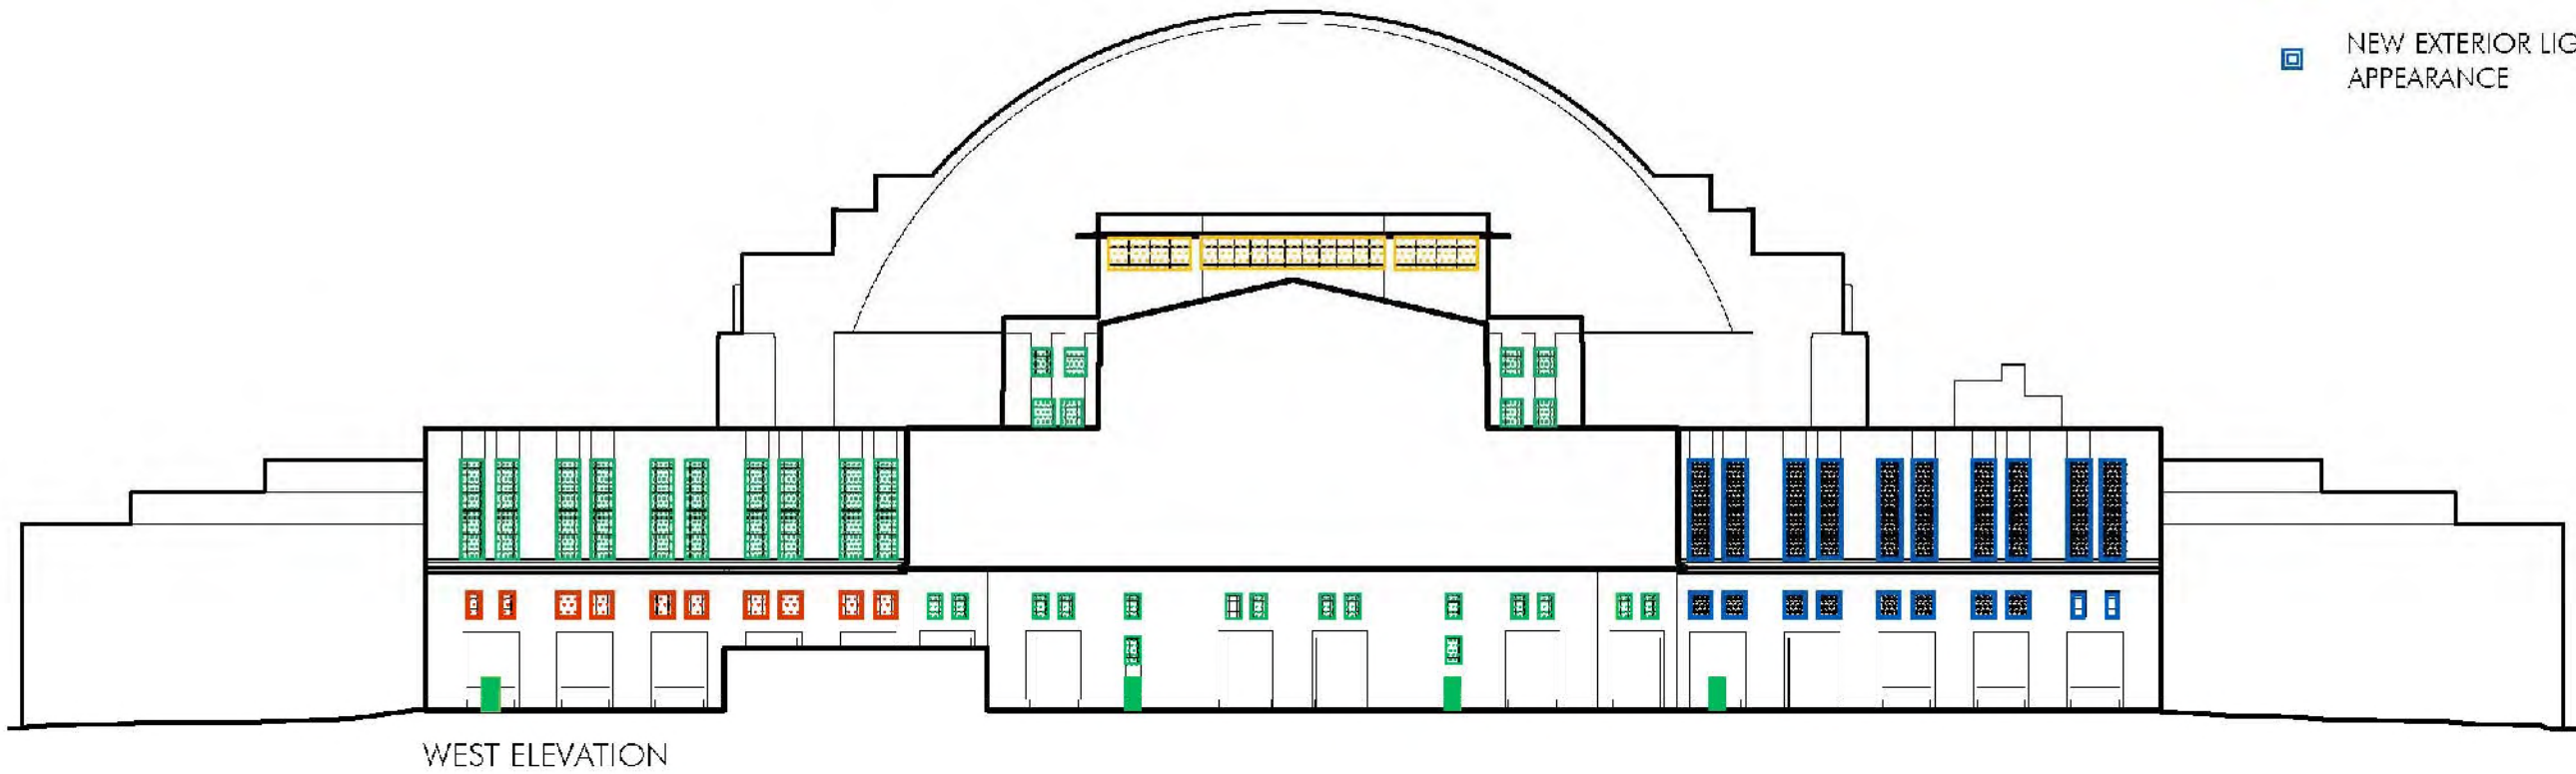
Exterior Scope Drawing 3-H
Openings and Features
 Cincinnati Union Terminal Restoration & Renovation

- OPENINGS AND FEATURES SCOPE KEY:**
-   HISTORIC ALUMINUM WINDOWS TO BE RESTORED
 -   NEW STEEL WINDOWS TO MATCH HISTORIC APPEARANCE
 -   HISTORIC STEEL WINDOWS TO BE RESTORED
 -   EXISTING ALUMINUM REPLACEMENT WINDOWS - NO WORK
 -   EXISTING STEEL REPLACEMENT WINDOWS- NO WORK
 -   STOREFRONT REPLACEMENT AT RAMP PORTALS
 -   EXISTING NON HISTORIC DOORS TO REMAIN
 -   EXISTING OVERHEAD DOORS TO BE REPLACED
 -   HISTORIC LOUVERED OPENINGS TO BE RESTORED
 -   NEW EXTERIOR LIGHTS TO MATCH HISTORIC APPEARANCE
