# GEOLOGIC PERSPECTIVES--THE CINCINNATI EXAMPLE

ROBERT W. FLEMING U.S. Geological Survey Box 25046 Denver Federal Center Denver, Colorado 80225

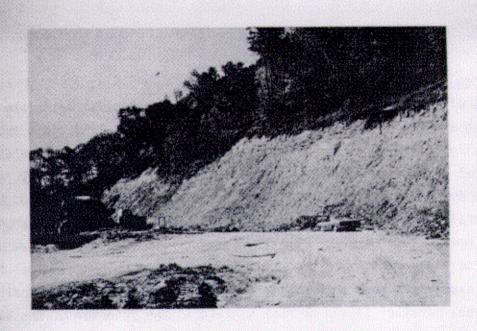
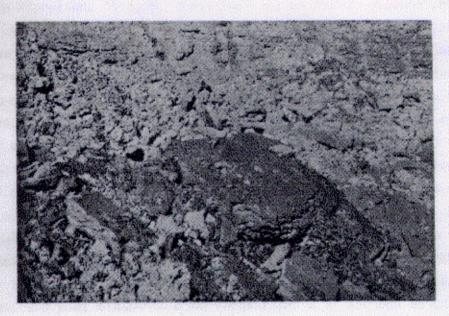
Figure 3.--Photographs of the Kope Formation along Hillside Avenue near Anderson's Ferry.

- a. Excavation into Kope Formation showing its rocklike character. Note accumulated debris at foot of excavation and slide in colluvial material uphill from ready-mixed concrete truck.
- b. Closeup view of a block of shale that is slaking after short exposure. Largest dimension of shale block is about 2 feet (0.6 m) across.

The stability problems, in general, involve not the intact, unweathered bedrock but rather the colluvium derived from the bedrock by weathering. Most of the shales in the bedrock sequence, particularly those in the Kope Formation, are not tightly cemented and slake readily to their constituent grains. Certain hill slopes are covered by a layer of bedrock-derived colluvium that may vary in thickness from a few inches to at least 30 feet (9 m). Figure 3a is a view of a near-vertical cut in the Kope Formation. The interbeds of shale and limestone in this cut are apparently stable. Other similarly cut slopes in the same material, such as at the Newport Shopping Center, Newport, Ky. (fig. 1), have stood for several years without landslide problems. The shale interbeds, however, slake and form a pile of debris at the foot of the cut slope. Figure 3b is a closeup view of a block of previously unweathered shale that has been exposed for only a short time and has already begun to disintegrate.

There have been no published studies of the engineering characteristics of the shales in the area. Observations of the slaking behavior suggest that the shales in the Kope Formation are more susceptible to physical disintegration than shales in other formations in the area. This may be more apparent than real, however, simply because the Kope contains a greater proportion of shale and because it occupies the lower part of most slopes and can collect debris transported by water or creep from upslope.
