## APPLICATION FOR ZONING RELIEF HISTORIC CONSERVATION BOARD PUBLIC HEARING STAFF REPORT

APPLICATION #: ZH20210084  
APPLICANT: PAST  
OWNER: Mohawk LLC  
ADDRESS: **222 Mohawk Street**  
PARCELS: 009500020040  
ZONING: UM  
OVERLAYS: Sohn-Mohawk Historic District  
COMMUNITY: Over-the-Rhine  
REPORT DATE: June 15, 2021

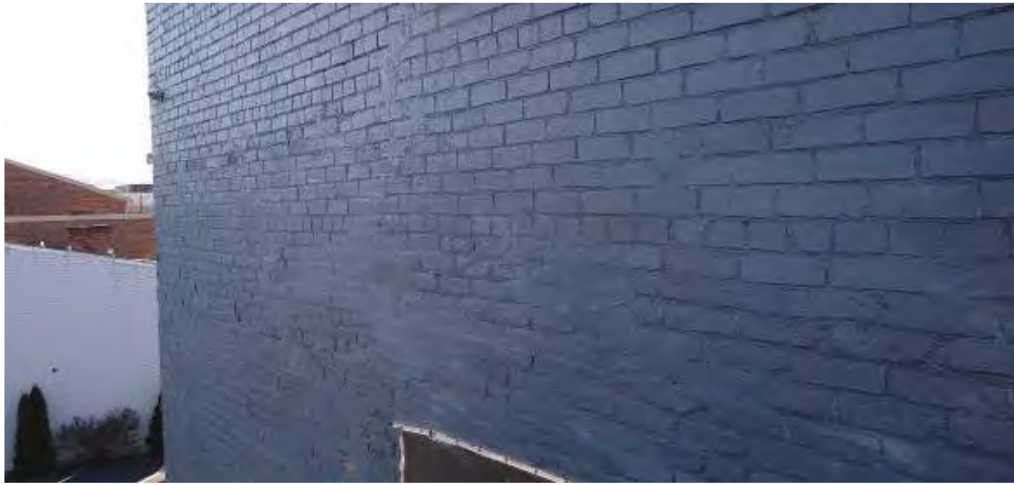
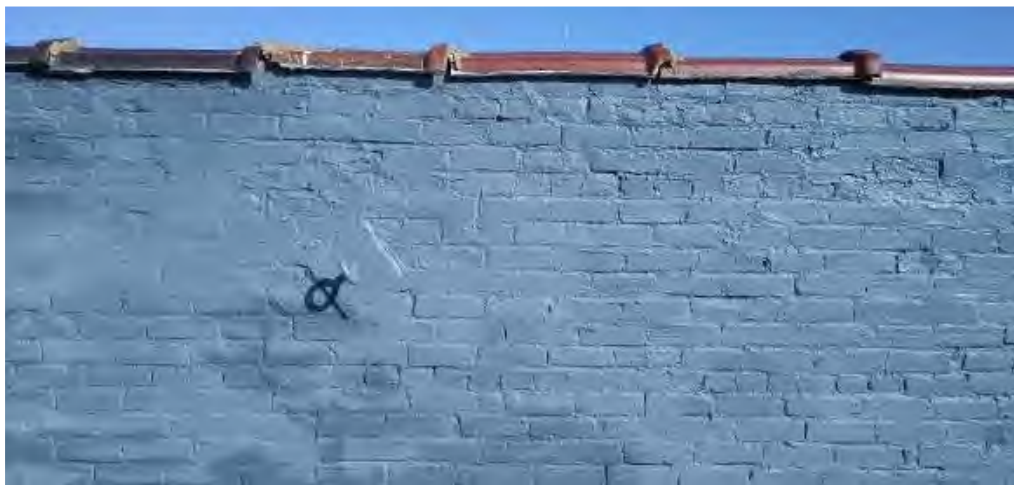
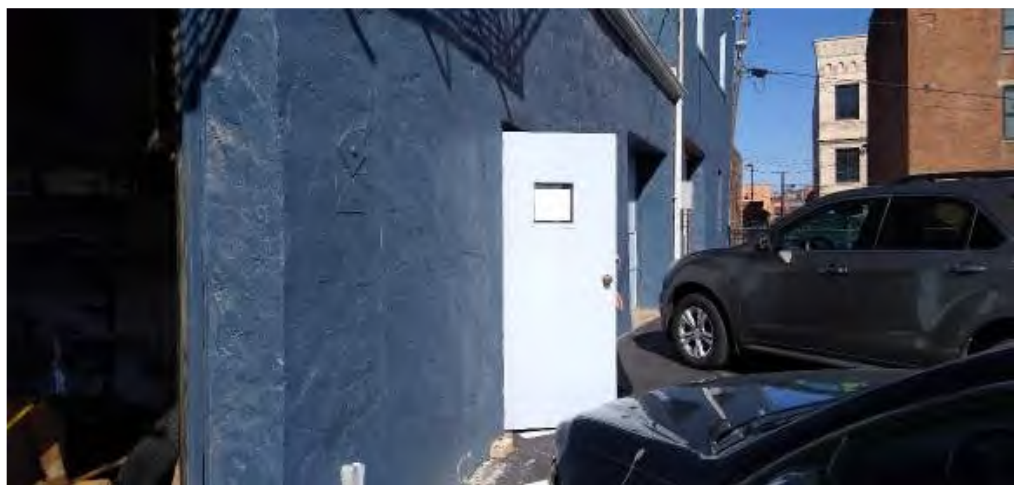
- Parging appears to be covering soft brick and water damage. This parging should be removed and the brick work repaired as needed. Due to the removal of the parging those areas may require up to 50% brick replacement and 100% tuckpointing. Other areas that are just painted may require up to 20% brick replacement and 50% tuckpointing based on some of the conditions observed.

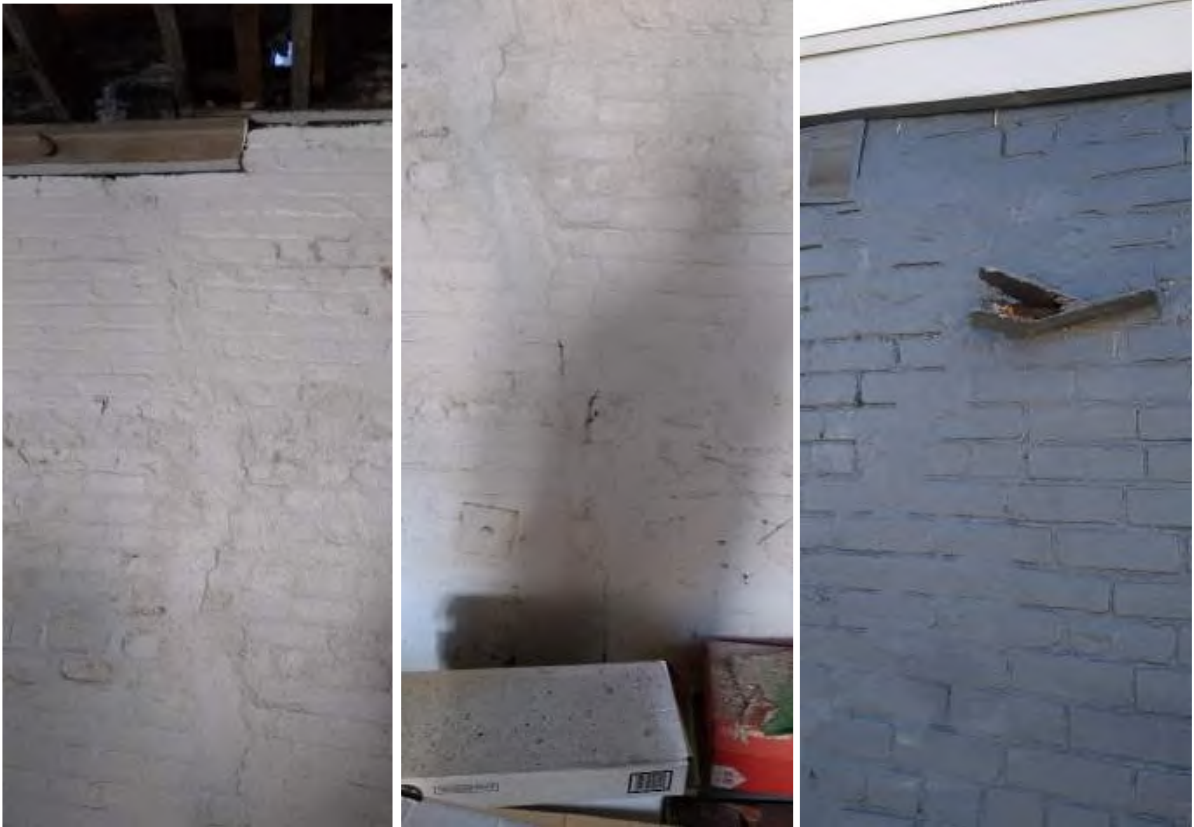
- Significant cracking in the masonry wall was observed. This crack appears to have been poorly repaired and patched over the years. We recommend this portion of the wall be retouched together replacing soft and damaged bricks as they are uncovered.

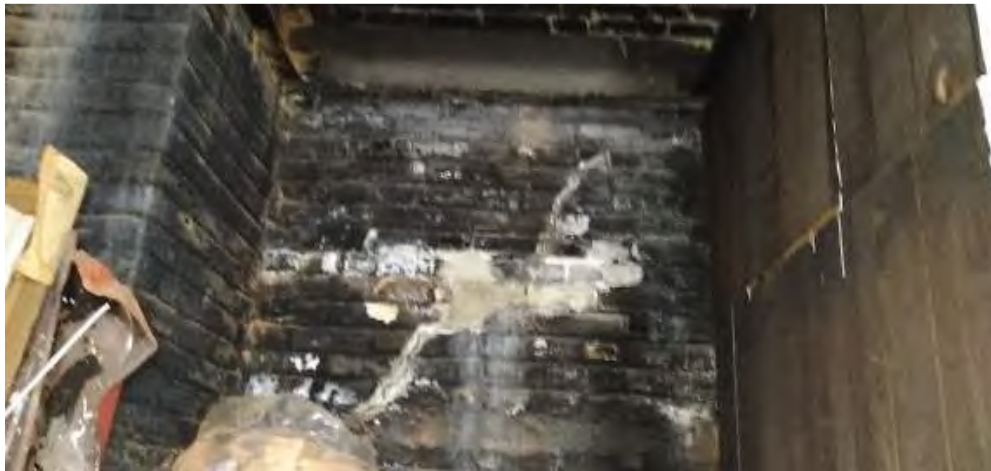
- Existing fire damage was noted at one location. We recommend repairing and/or replacing any compromised bricks and/or rafters in this area.

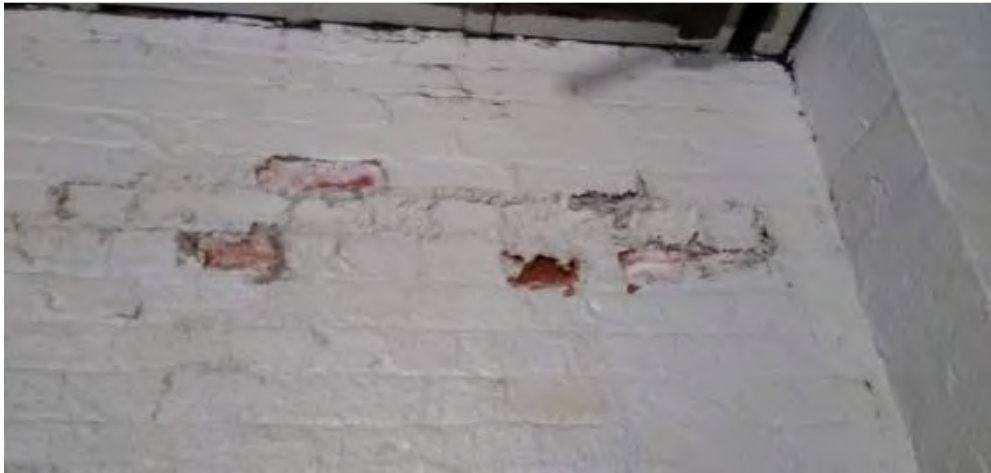
- Soft brick/water damage was noted in a couple locations. We recommend replacing the soft and spalling bricks and tuckpointing the joints as needed. We estimate up to 5% brick replacement and 10% tuckpointing.

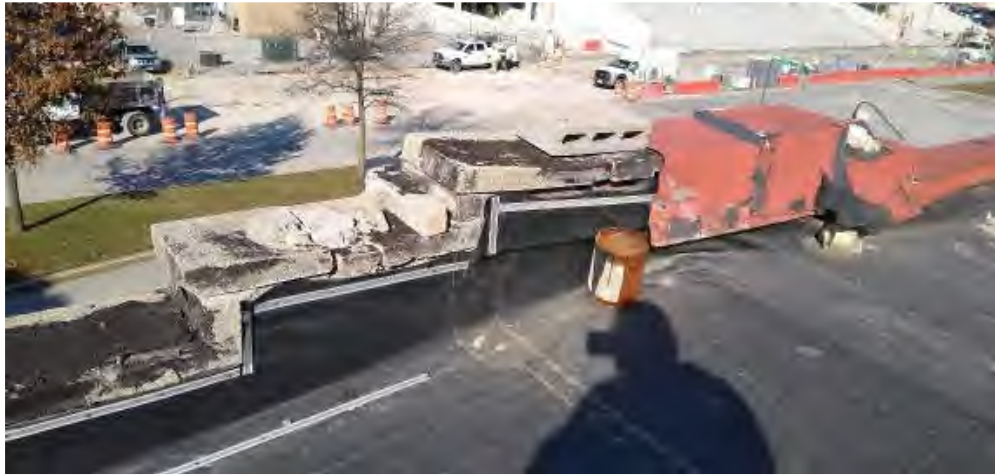
- The existing failed, cracked & loose coping should be replaced and made watertight.

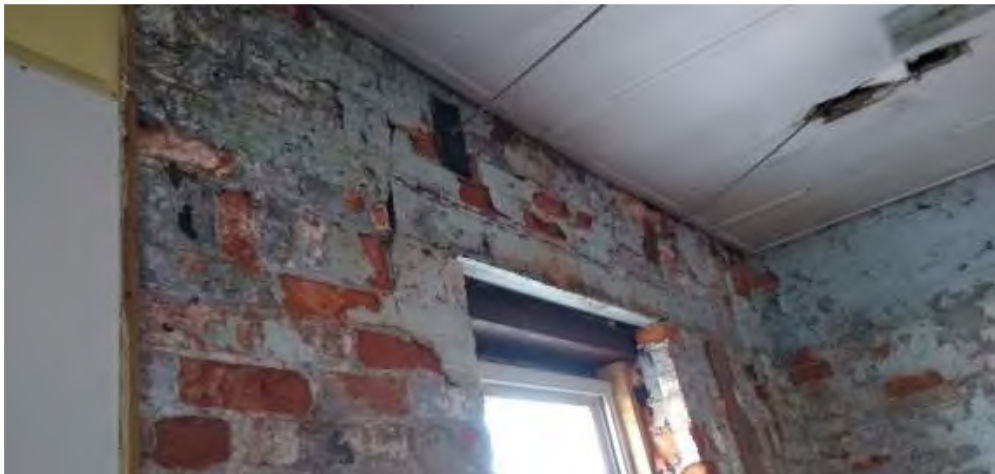
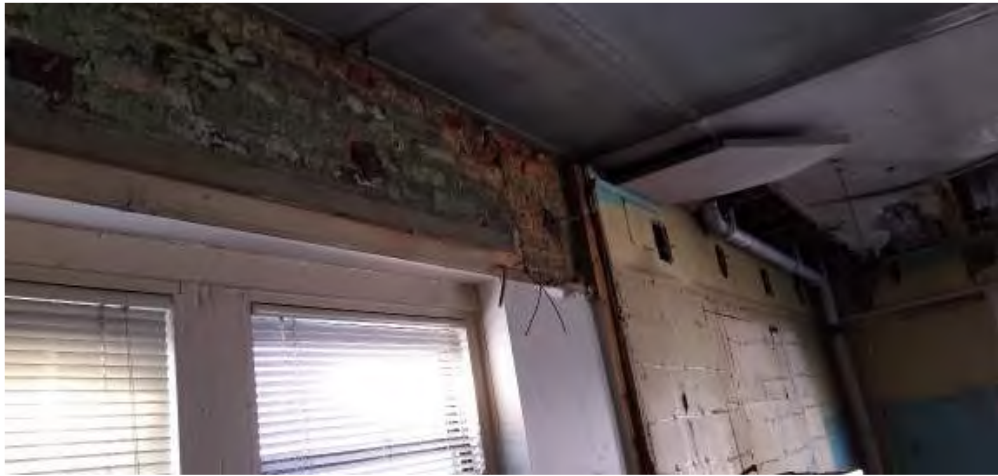
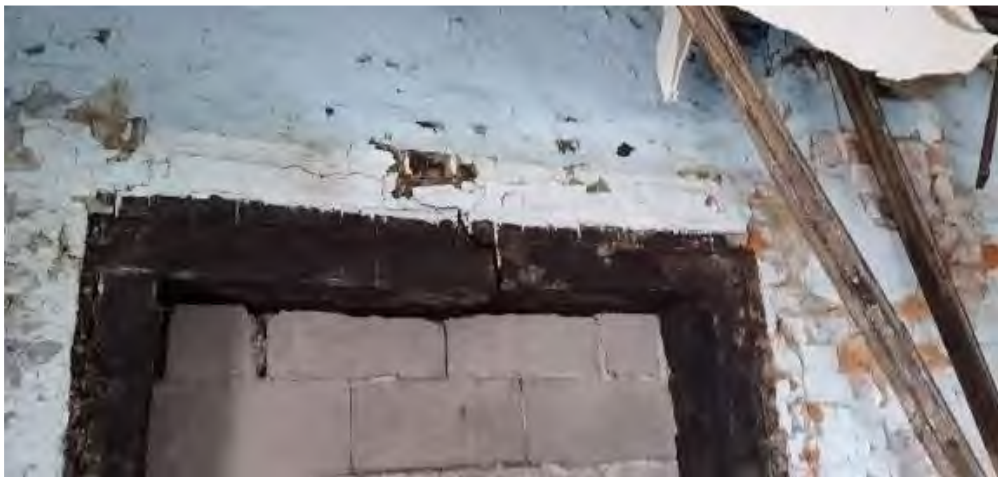
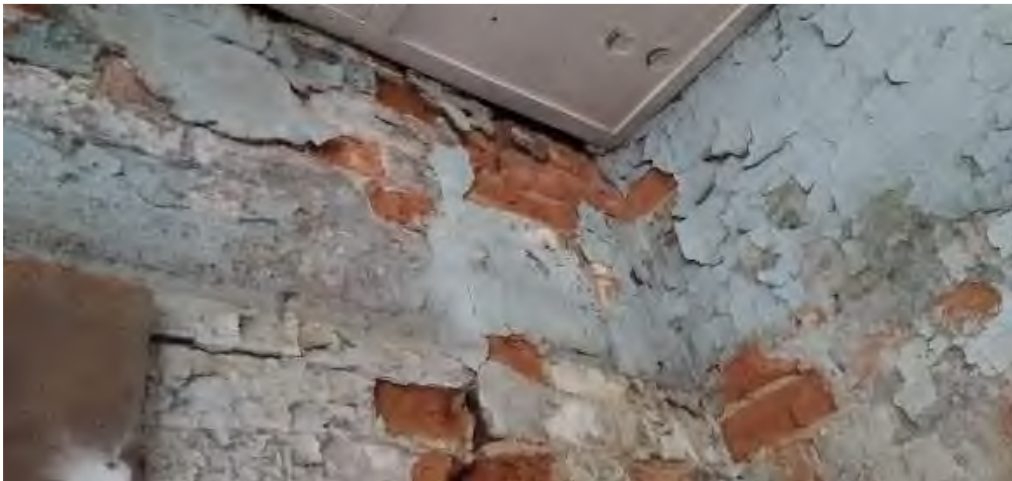
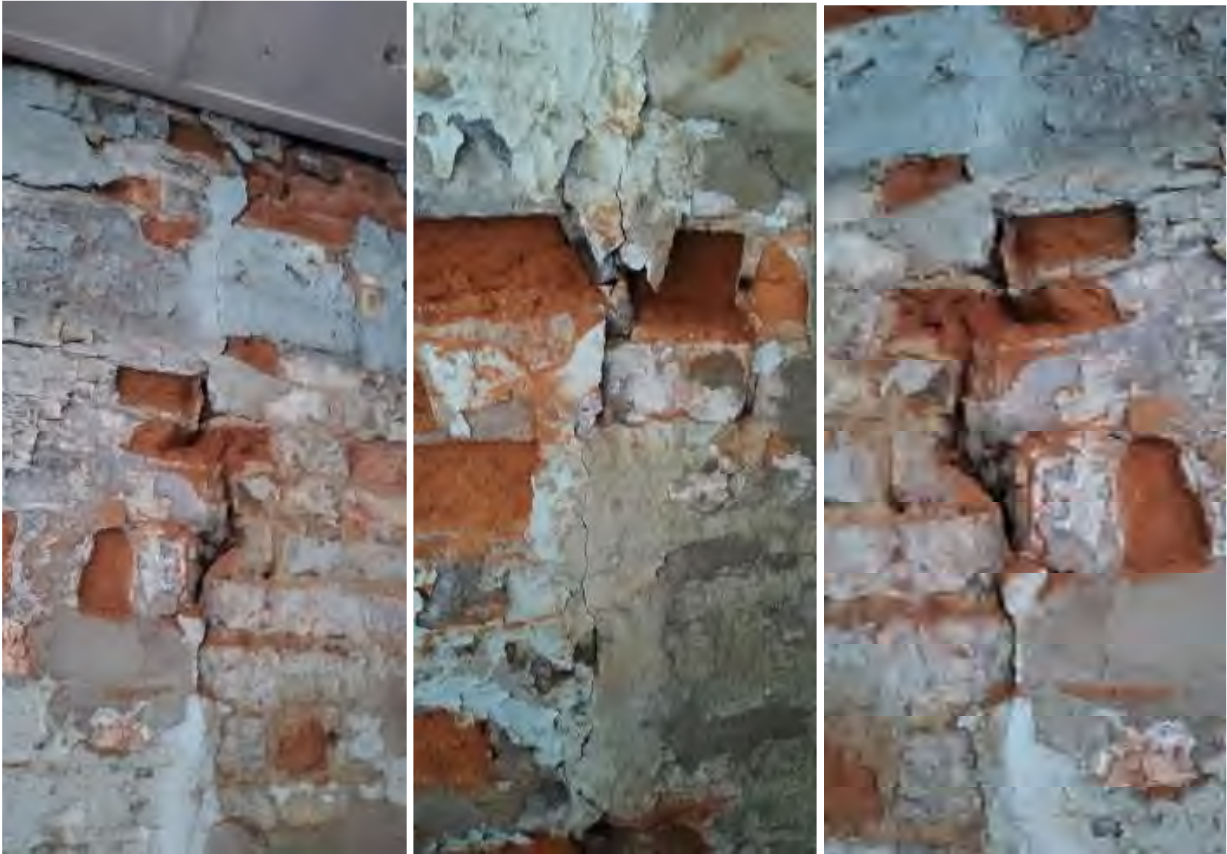
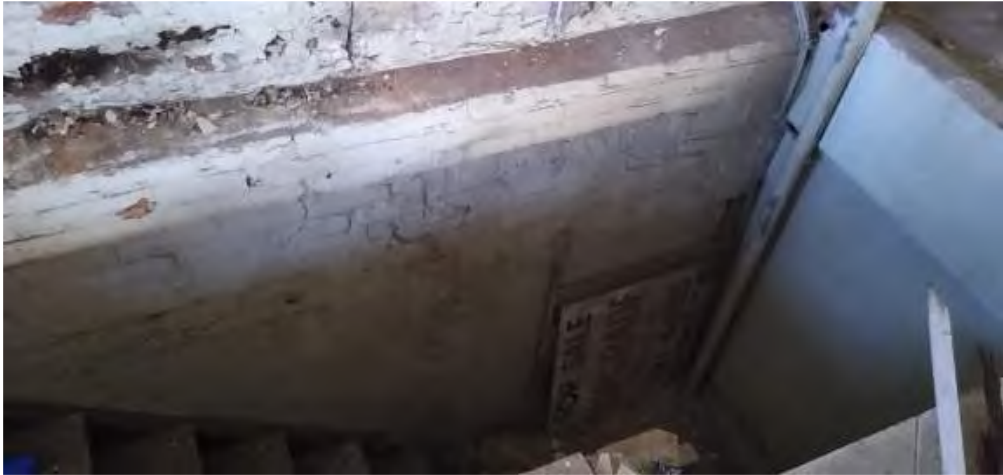
- There are currently wood lintels at all exterior wall openings. These should all be replaced with new precast concrete or galvanized steel lintels.
- Soft brick/water damaged brick was noted at several locations. At the front (west) wall the damage is so severe that we recommend rebuilding the wall due to the significant damage to the brick noted inside and out. Other areas we expect up to 50% brick replacement and 100% tuckpointing.
- The existing masonry tie rods are improperly installed. They need to be replaced with properly installed ties within the floor/ceiling cavity along both the front (west) and side (south) wall.
- The brick wythes appear to have separated as well. We recommend installing helix ties at 16" o.c. each way to prevent any further separation of the wythes.

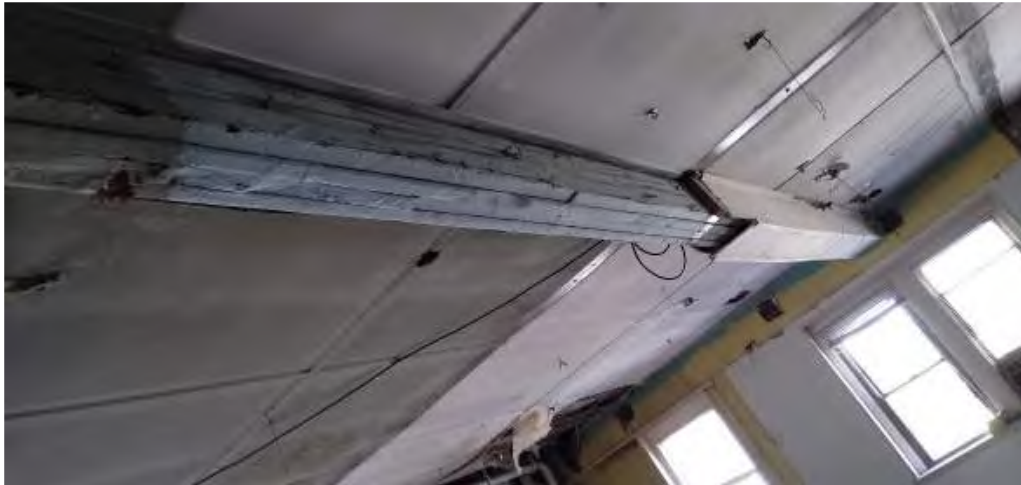
- There is an existing multiply wood beam spanning approximately 27 feet. This is inadequate for most commercial uses and will require reinforcement by sistering either LVL's or steel channels to each side.

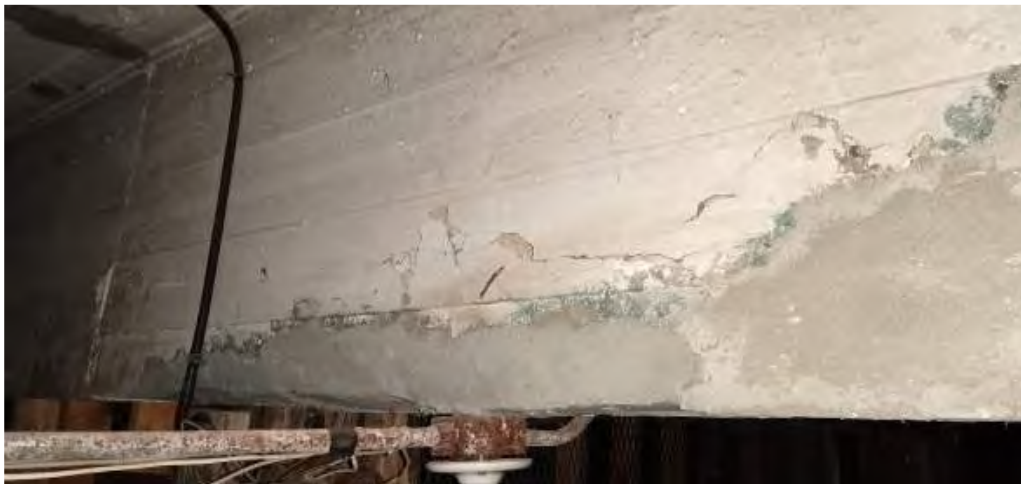
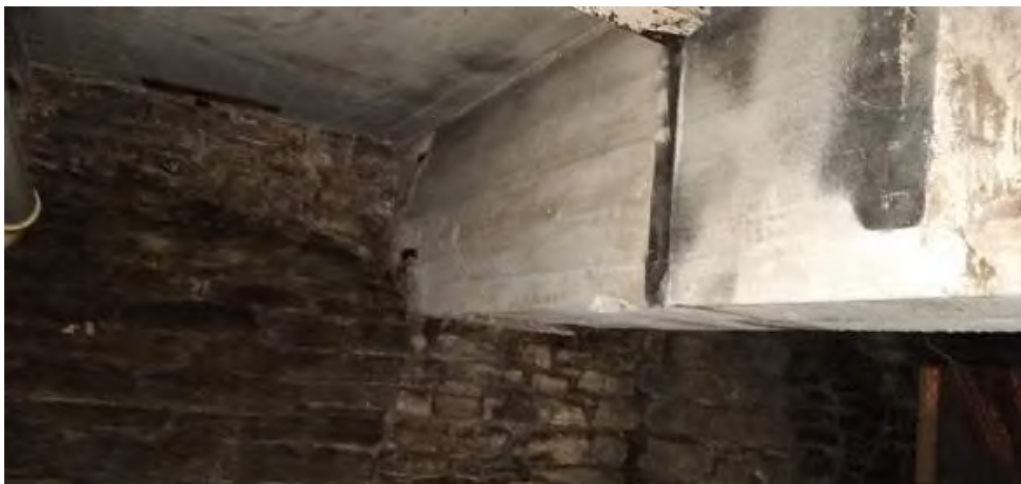
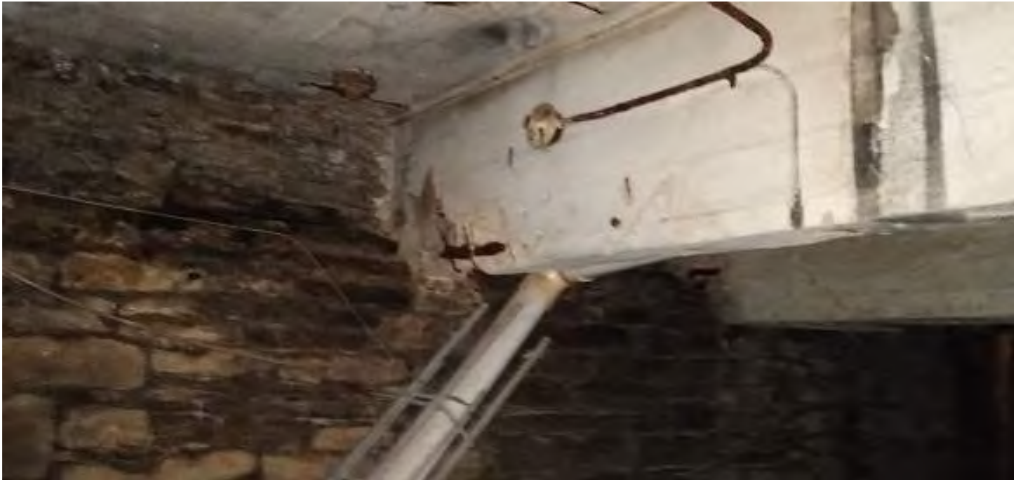
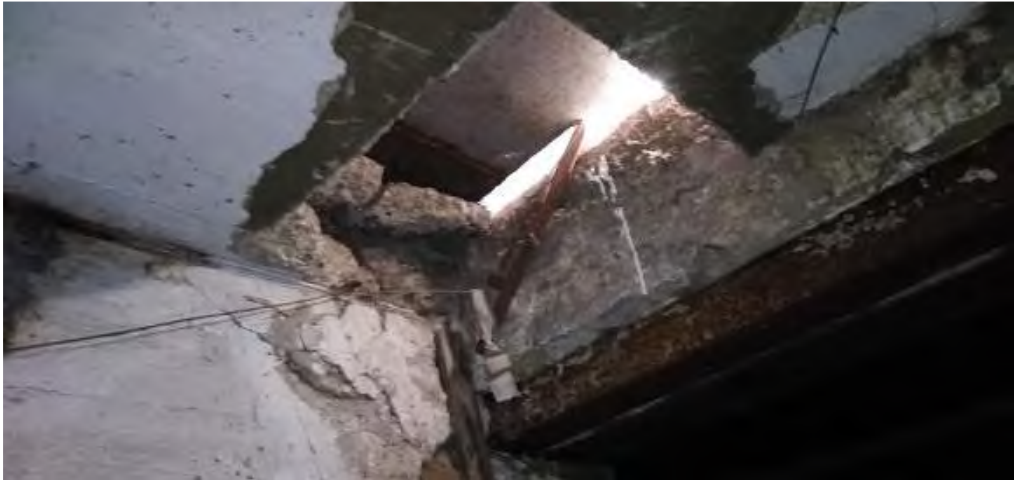
- Concrete beam repair required at exposed rebar/concrete spalls/poor patches.

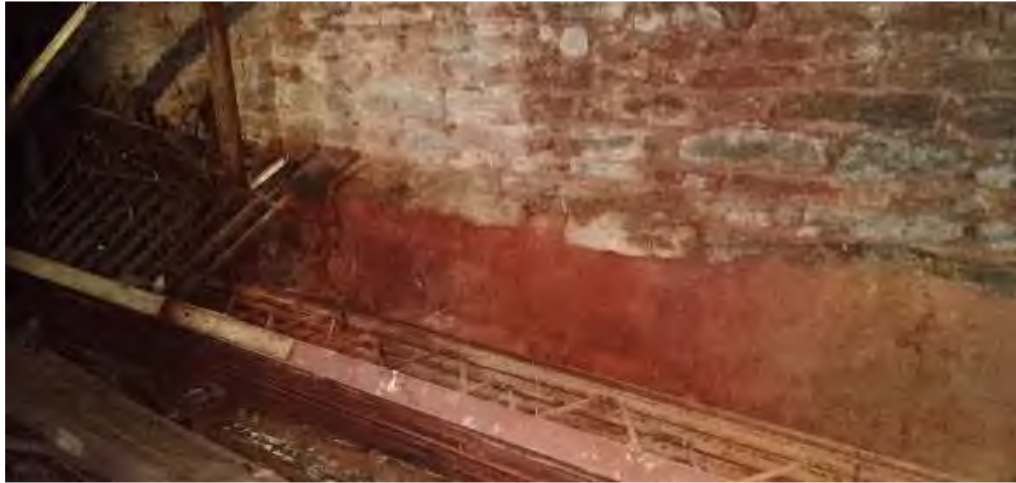
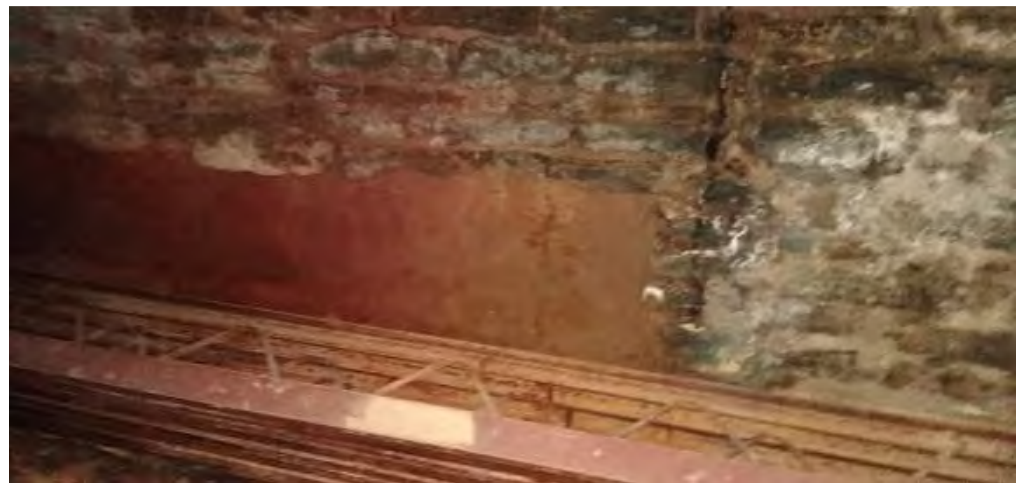
- The rubble stone foundation wall is severely undermined at the northeast corner of the structure. We recommend bench underpinning to prevent any future movement of the wall. For estimating purposes assume a 5'-0" x 5'-0" concrete bench along the undermined portions of wall.

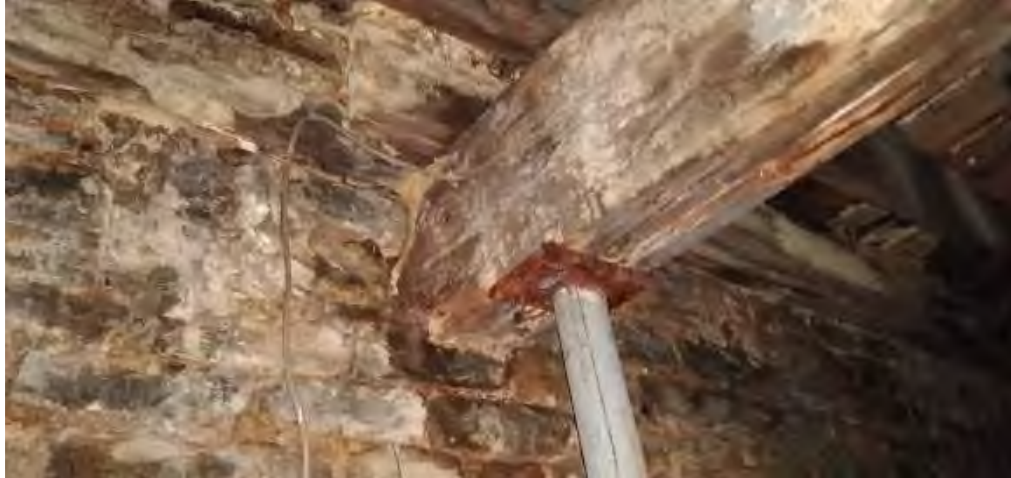
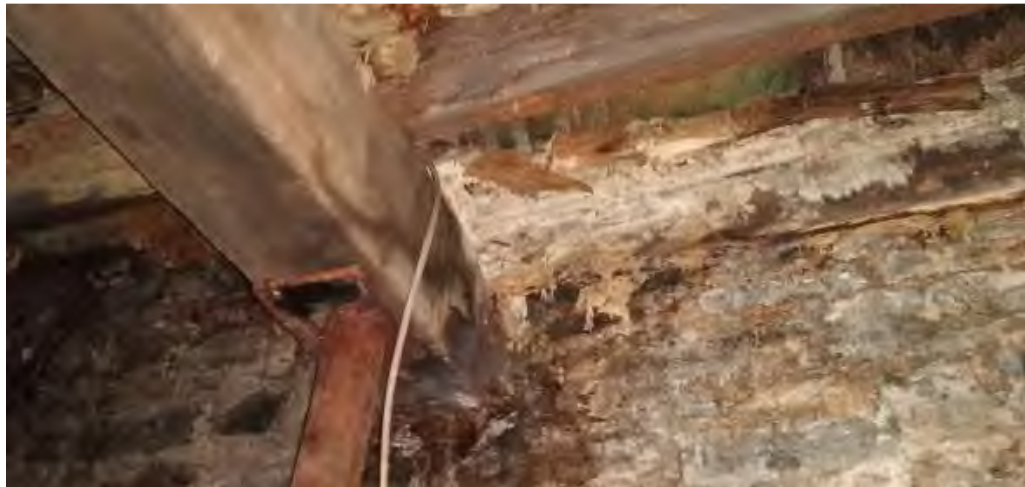
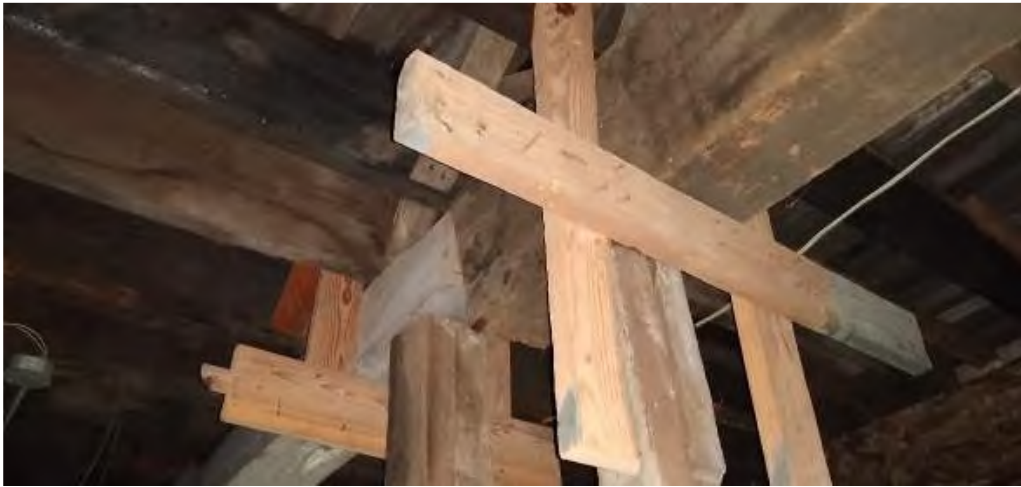
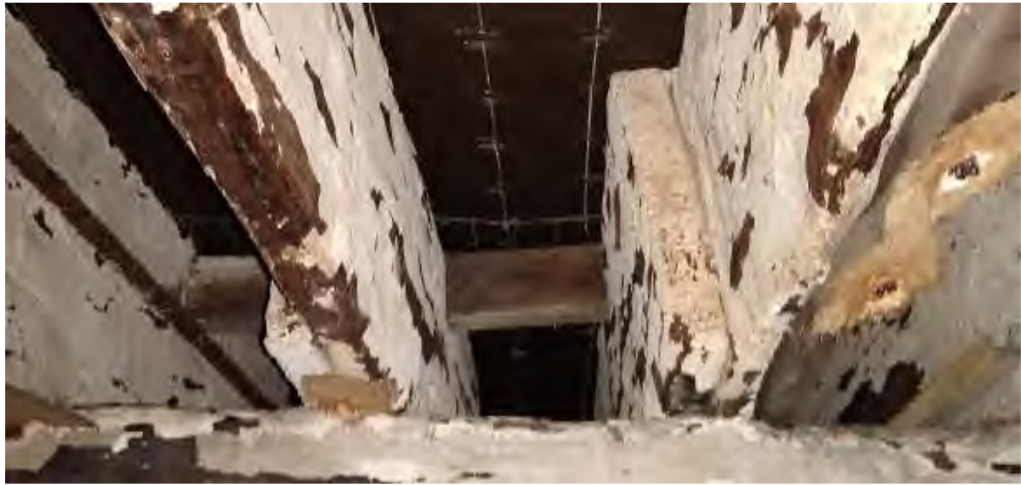
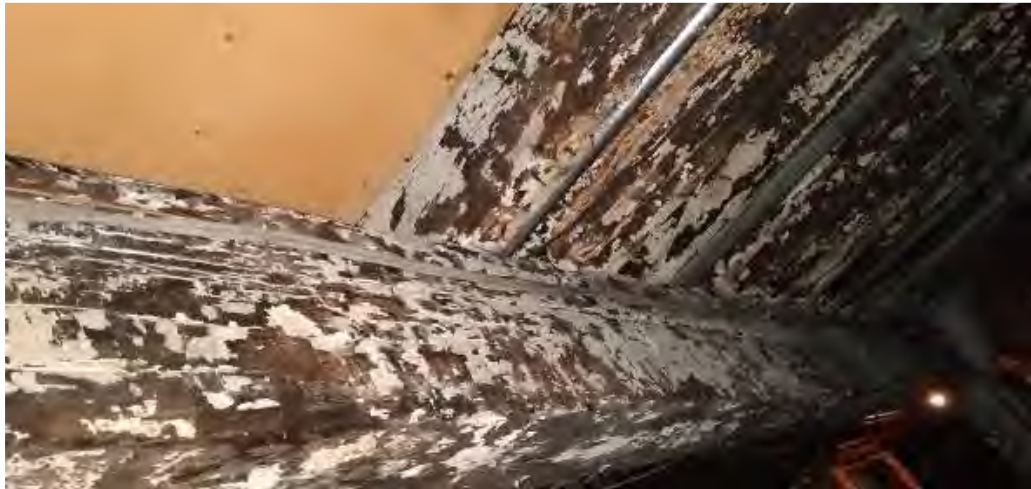
- Rotted and compromised joists were noted throughout the basement (1<sup>st</sup> floor framing). We recommend reinforcing by sistering up to 50% of the joists and replacing up to 25% of the joists.
- The existing post and beam lines appear inadequate. The bearing at several locations has been compromised and some of the footings are questionable, if not completely inadequate. In an effort to level the floors and provide adequate capacity for a commercial development we recommend replacing all posts and footings.

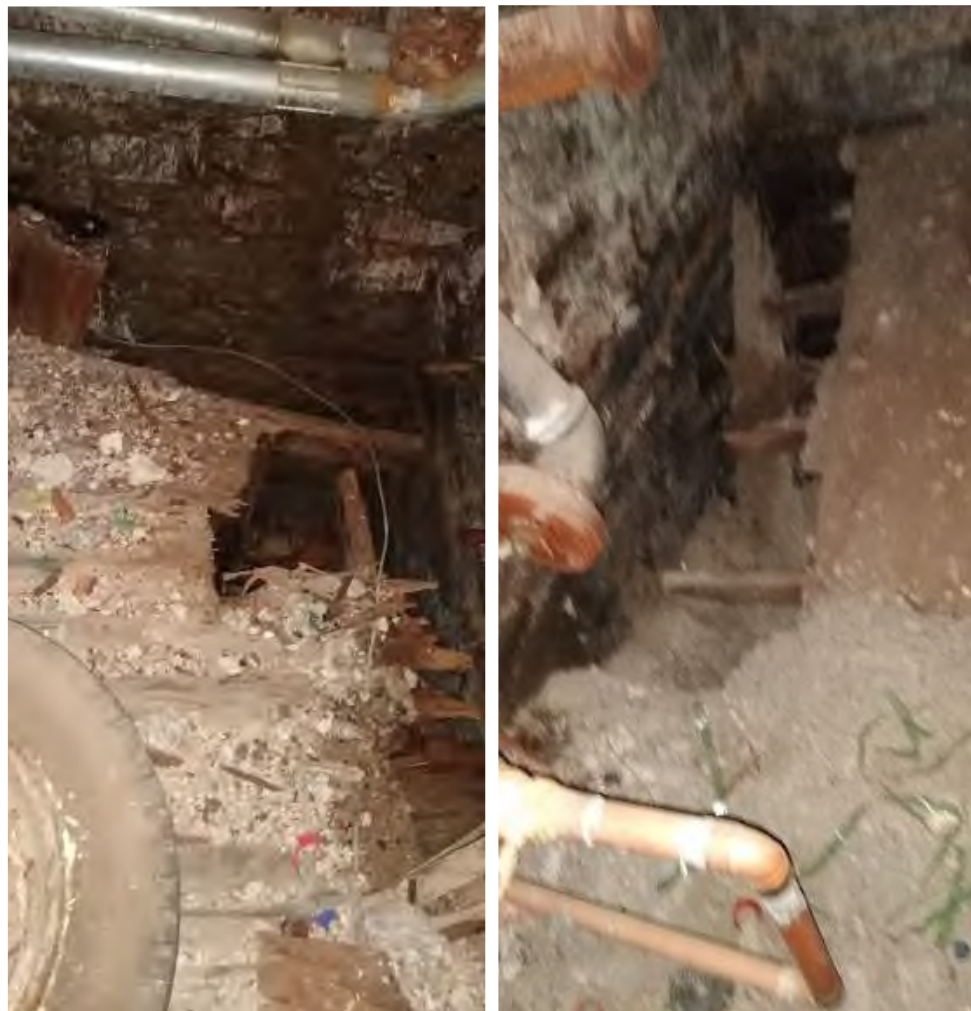
- There is a significant void under the wood basement floor (measuring up to 7 feet deep at some locations). This void is a big unknown with no viable commercial use. We recommend filling all subbasement voids with lean concrete or replace all wood basement floor framing.
