## APPLICATION FOR HISTORIC CONSERVATION DISTRICT DESIGNATION HISTORIC CONSERVATION BOARD PUBLIC HEARING STAFF REPORT

APPLICATION #: N/A  
APPLICANT: Bond Hill Community Council thru Alexis and Wei Liu  
OWNER: Various. See attached excel sheet (Attachment 4)  
ADDRESS: **Properties on Bella Vista Street east of Reading Road**  
PARCELS: Various. See attached excel sheet (Attachment 4)  
ZONING: SF- 4 and RM 1.2  
OVERLAYS: None  
COMMUNITY: Bond Hill  
REPORT DATE: July 8, 2019  
HEARING DATE: Prehearing June 24, 2019- sign in sheet attached.  
July 22, 2019  
STAFF REVIEW: Beth Johnson, Urban Conservator

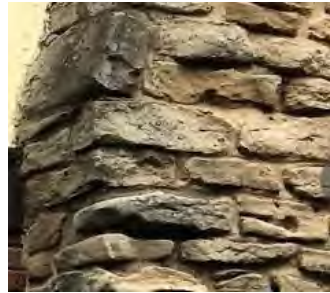
*Masonry in fair condition*

Fair conditions consist of long-term neglect; inadequate protection against the elements; damage from vandalism or small fires; intentional destruction or removal of portions of architectural features. Deterioration at this level may require rebuilding, replicating or replacing architectural features or portions of them.

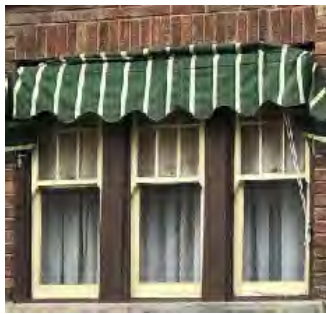
*Wood windows in good condition*

Good conditions consist of typical signs of aging and ordinary exposure from the elements. Deterioration at this level should generally be addressed through repairs or restoration and/or can be sufficiently maintained at its current condition through routine maintenance.

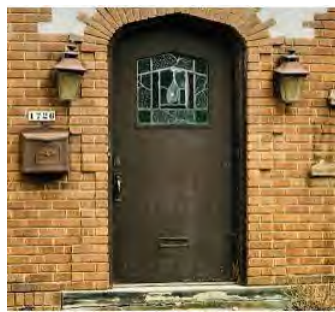
*Wood door in fair condition*

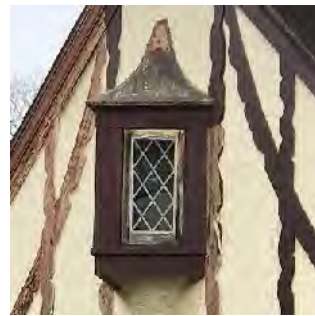
*Wood window in poor condition*

Poor conditions consist of rot, irreparable deterioration, collapse or partial collapse, past removal and destruction of significant architectural features. Architectural features that display poor conditions lack the physical integrity to be repaired or restored.

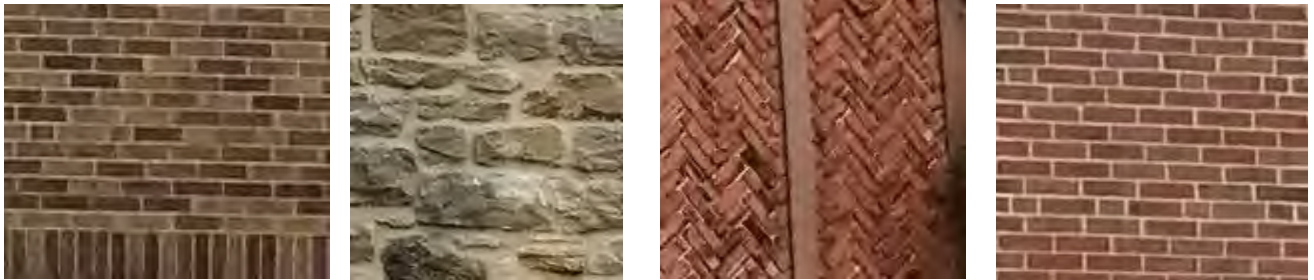
Historic mortar was generally quite soft, consisting of lime and sand and other additives. Stone can include various types of sandstone, limestone, marble, granite, slate and fieldstone and be used in foundations, roofs, and ornamentation. Wood was used as siding and for ornamentation such as cornice brackets. Cast iron can be found in architectural features including building facades and porches.

*Above: Examples of masonry materials and mortar types present in the Historic District*

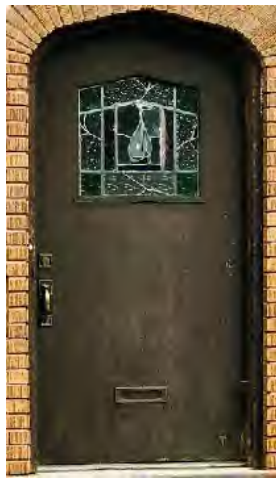
*Tudor Arch door with original leaded stained glass*

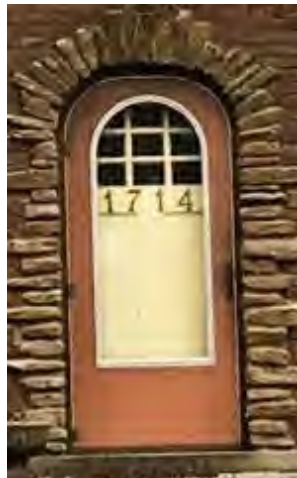
*Rounded arch door with divided lights*

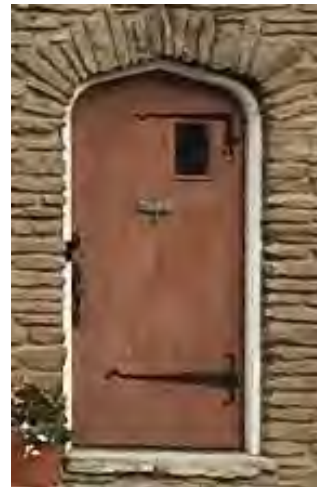
*Tudor arch door with original decorative cast iron straps*

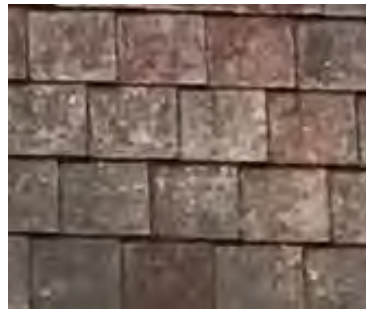
*Asbestos shingles*

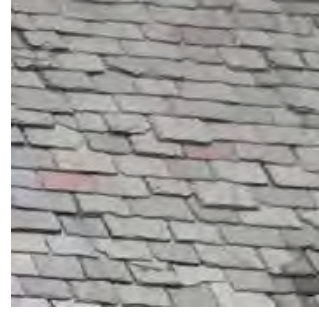
*Slate roofing*

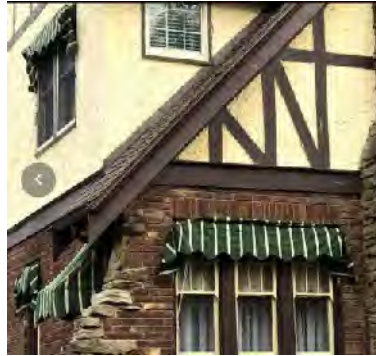
*Accurate canopy location, installation  
and material*

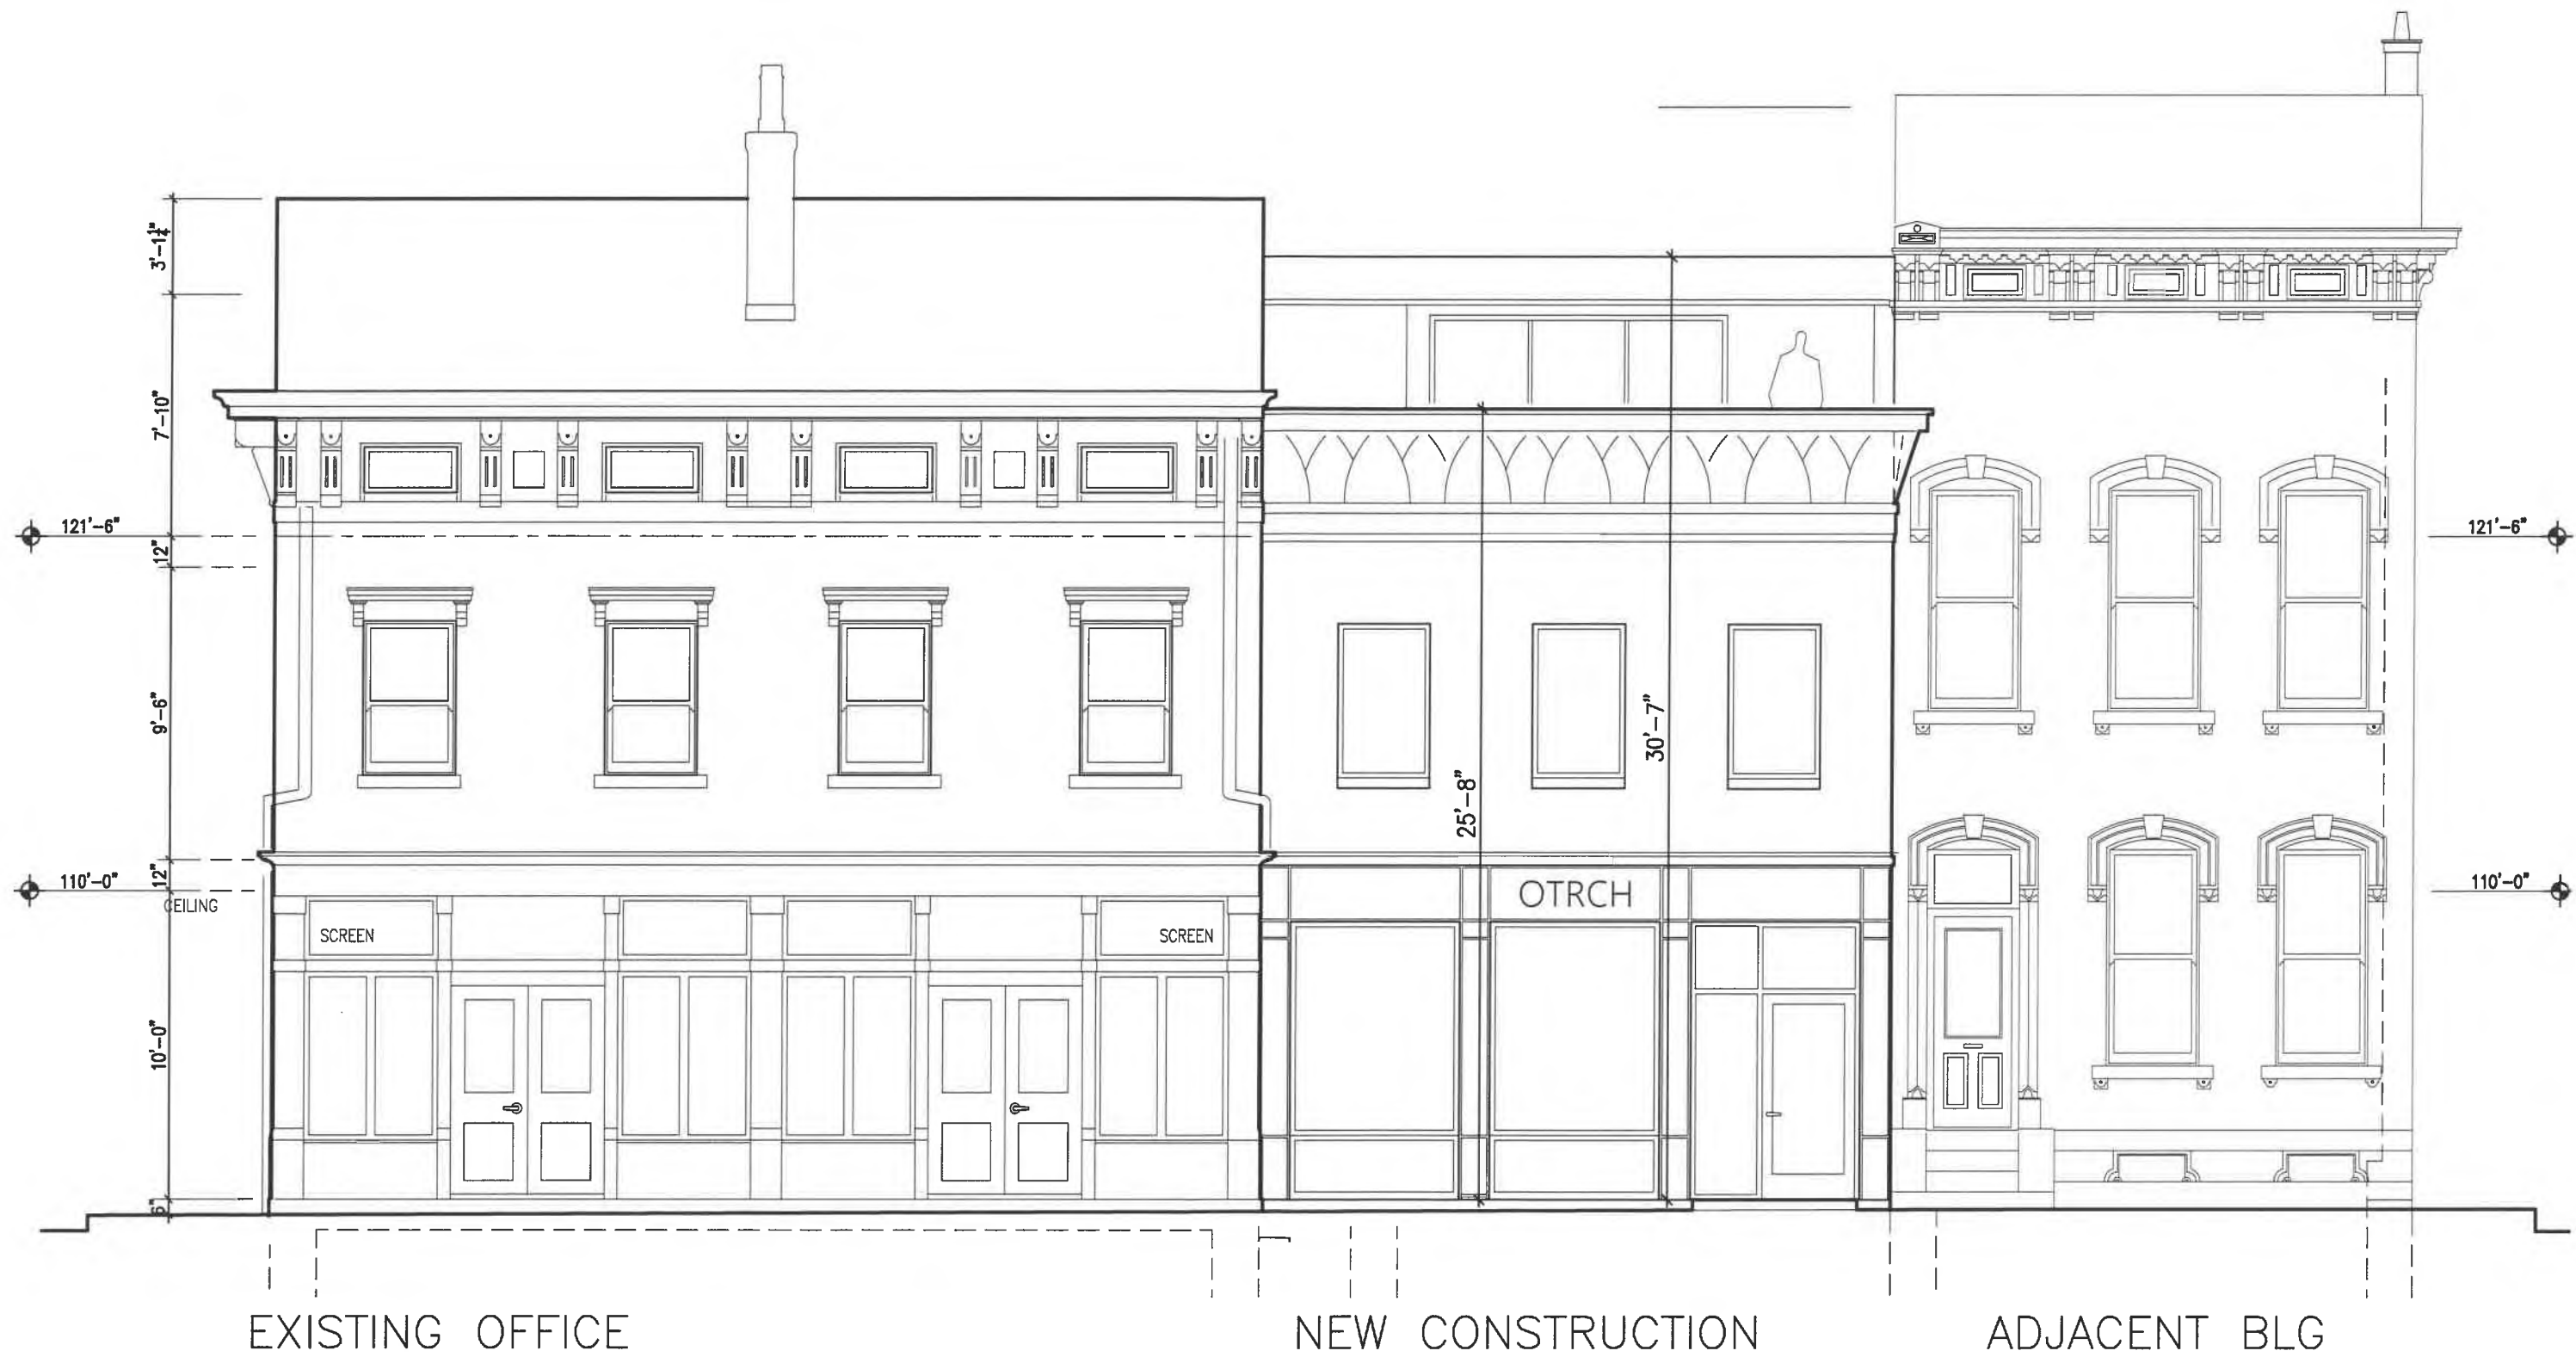
<p>HCB COA APPLICATION</p> <p>OTR COMMUNITY HOUSING</p> <p>114 W 14th St., Cincinnati OTR</p>	<p>FRONT ELEV</p> <p>A4</p>
---	-----------------------------

FRONT ELEVATION

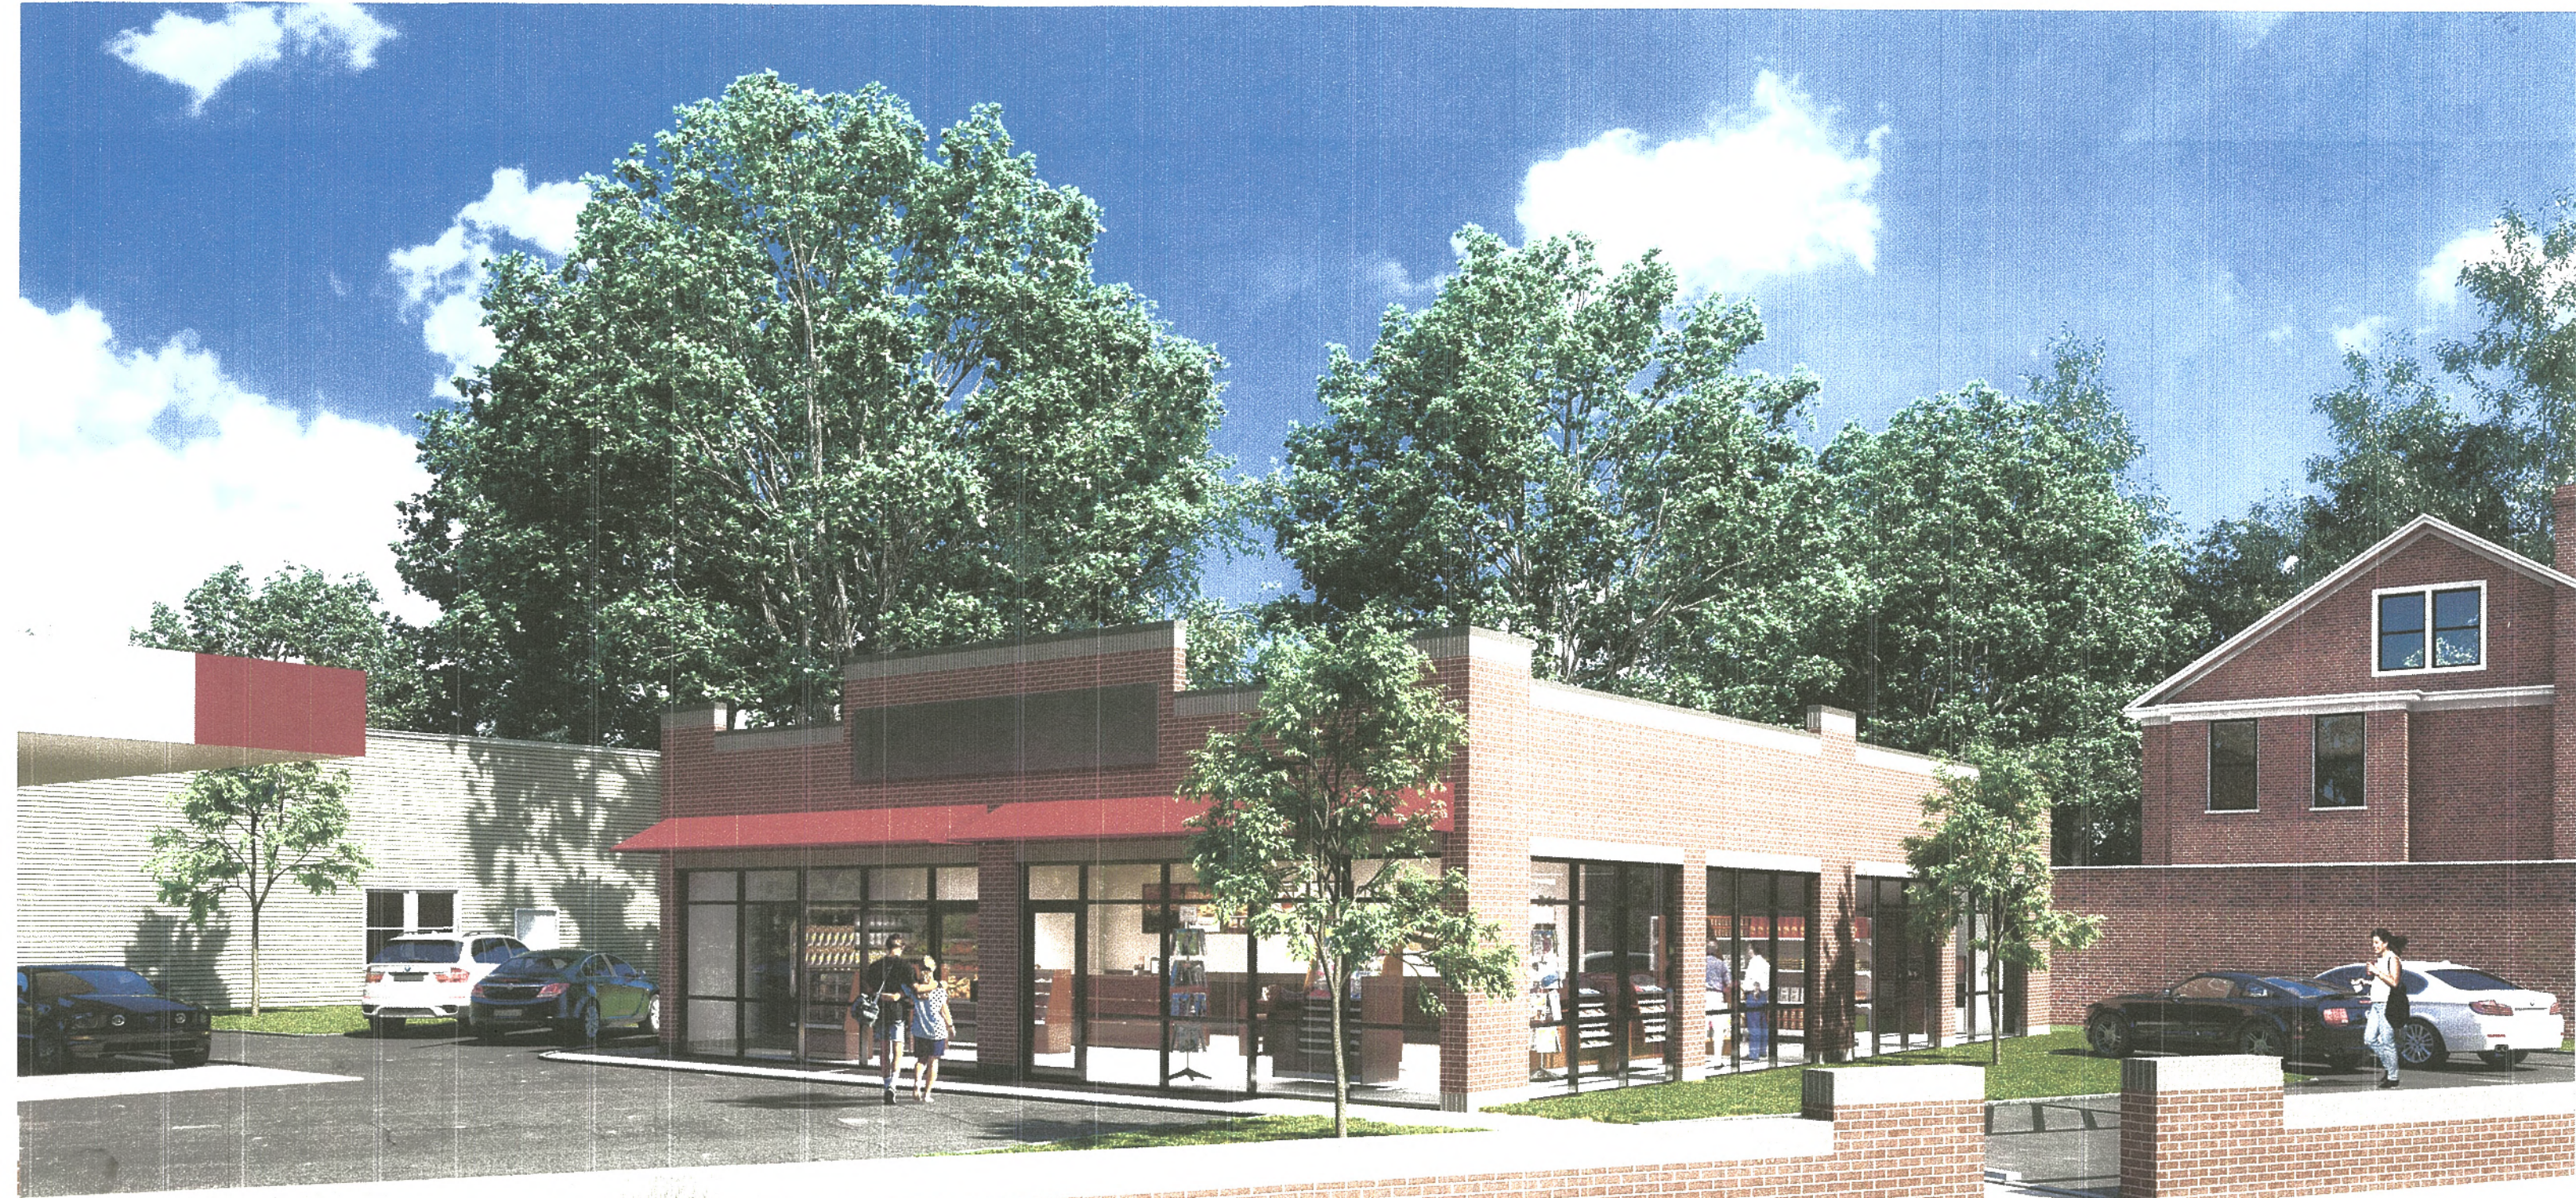
**1 SITE WALL ELEVATION**  
SCALE: 1/4" = 1'-0"

Convenience Store  
6014 Hamilton Avenue  
Cincinnati, OH

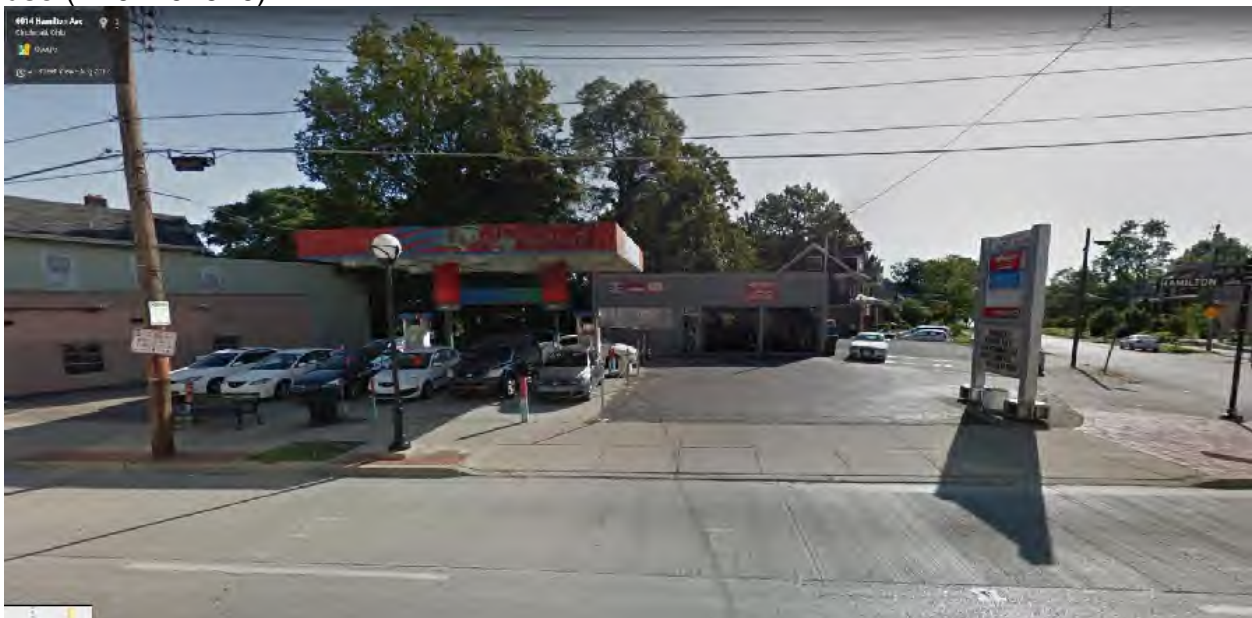
Figure 1. Aug 2017 photo of site depicting illegal Vehicle Sales use. Image courtesy of Google.

The subject property at 6014 Hamilton Ave is presently only a Vehicle Repair use. Fuel Sales was abandoned by the property owner/applicant since 2015, but a vehicle repair business has continued operation throughout the period since the Fuel Sales ceased. The tanks and pumps were put into temporary closure and permits filed with BUSTER for this closure. The City can verify that that the Fuel Sales use was abandoned, meeting the requirements of Sec. 1447-07, Abandonment of Nonconforming Use, through Google Streetview photographs as well as through the result of a Zoning Code violation, when the property owner was cited for Vehicle Sales, a prohibited use on the property upon the portion of the property that was previously occupied by the Fuel Sales use (B201704910)

The existing building is a non-contributing building to the College Hill Historic District and is a circa 1950's concrete block building (former Sohio station) that was remodeled and expanded into its current configuration by the 1990s. The building has garage doors on both street frontages and a 4 pump gas fueling station within a flat canopy.

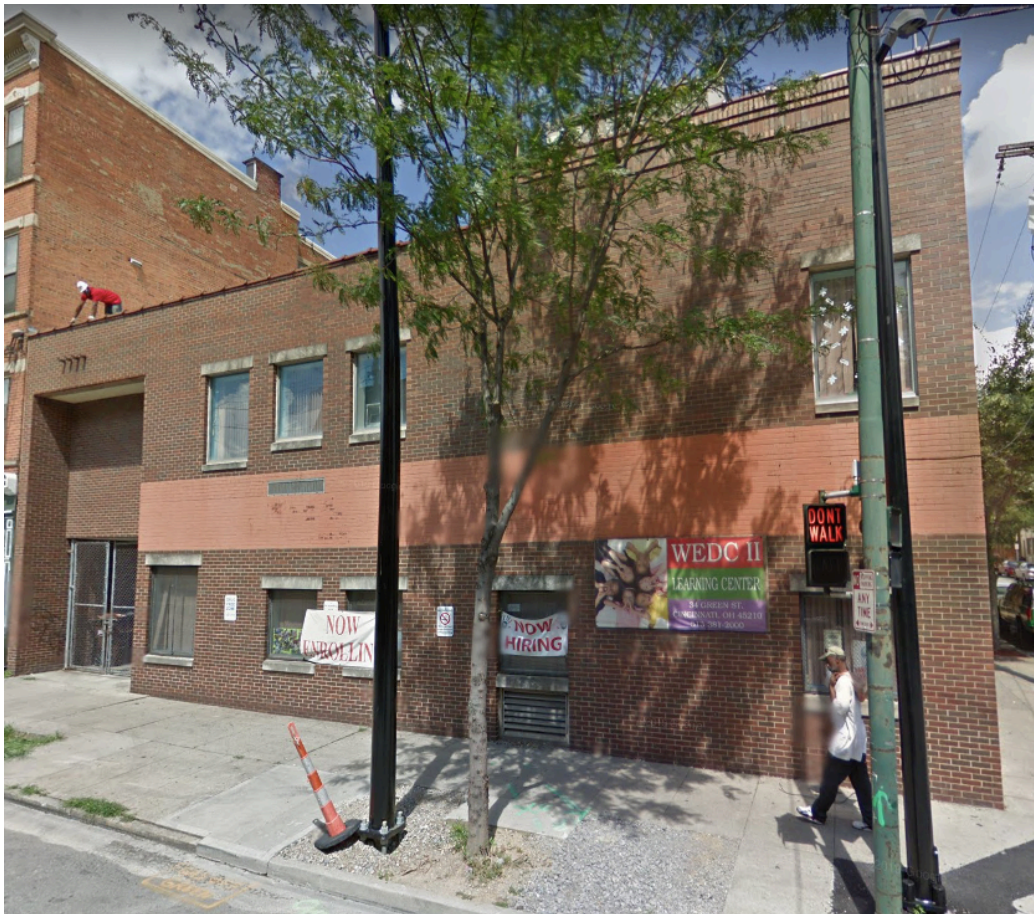
**EAST ELEVATION**

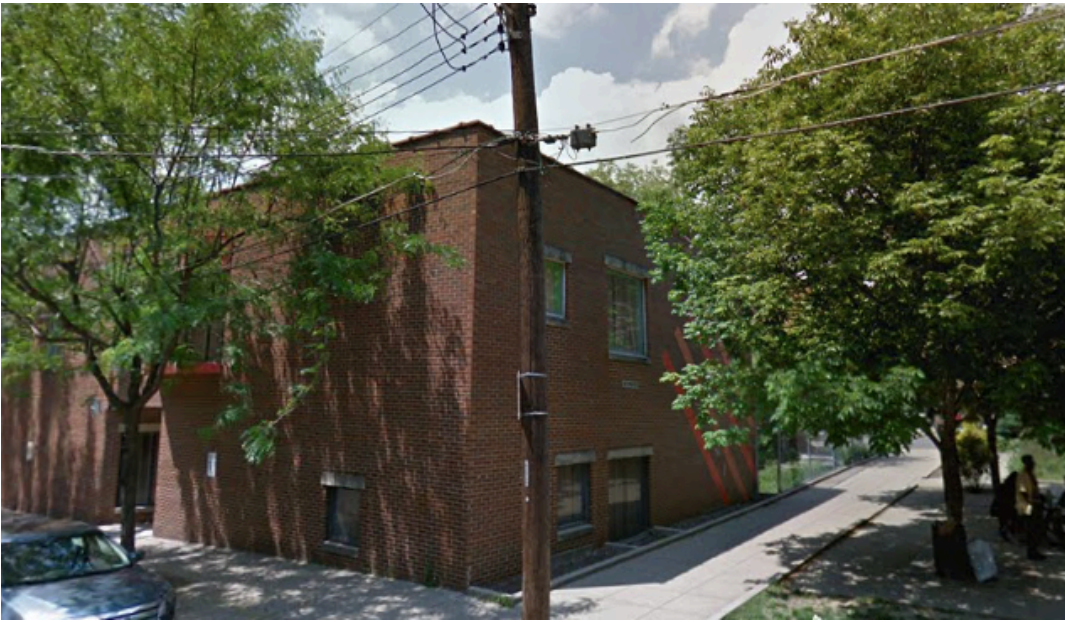
**WEST ELEVATION**

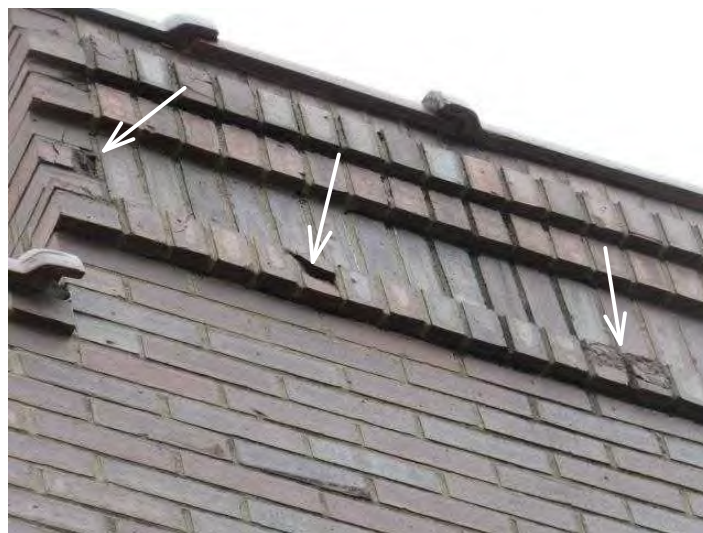
1. Marginal Type: Brick - **Spalling: There are damaged brick on the left wall from spalling. The damaged brick should be replaced by a qualified contractor.**

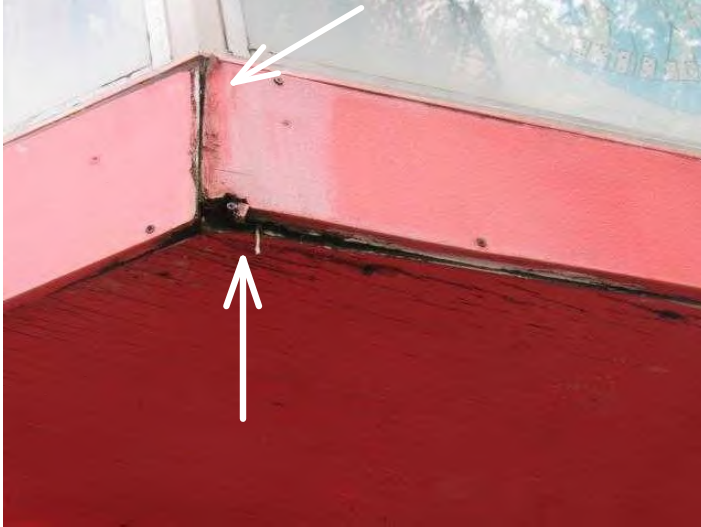
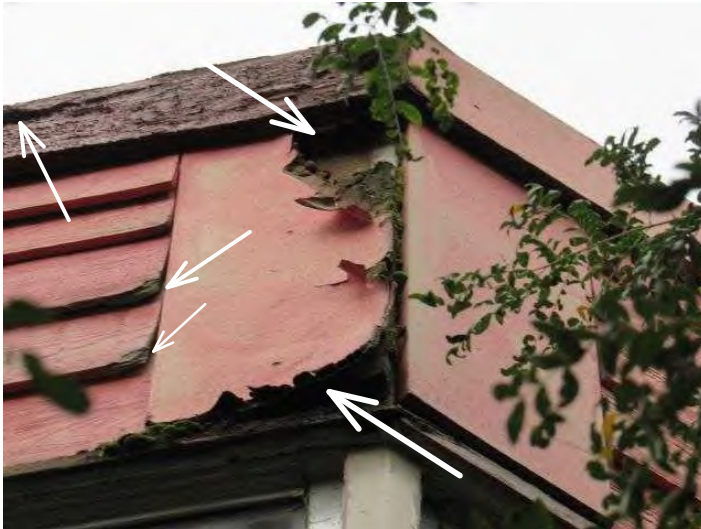
Trim: (continued)

- 3. Defective
- 4. Acceptable
- 5. Defective

- 6. Acceptable

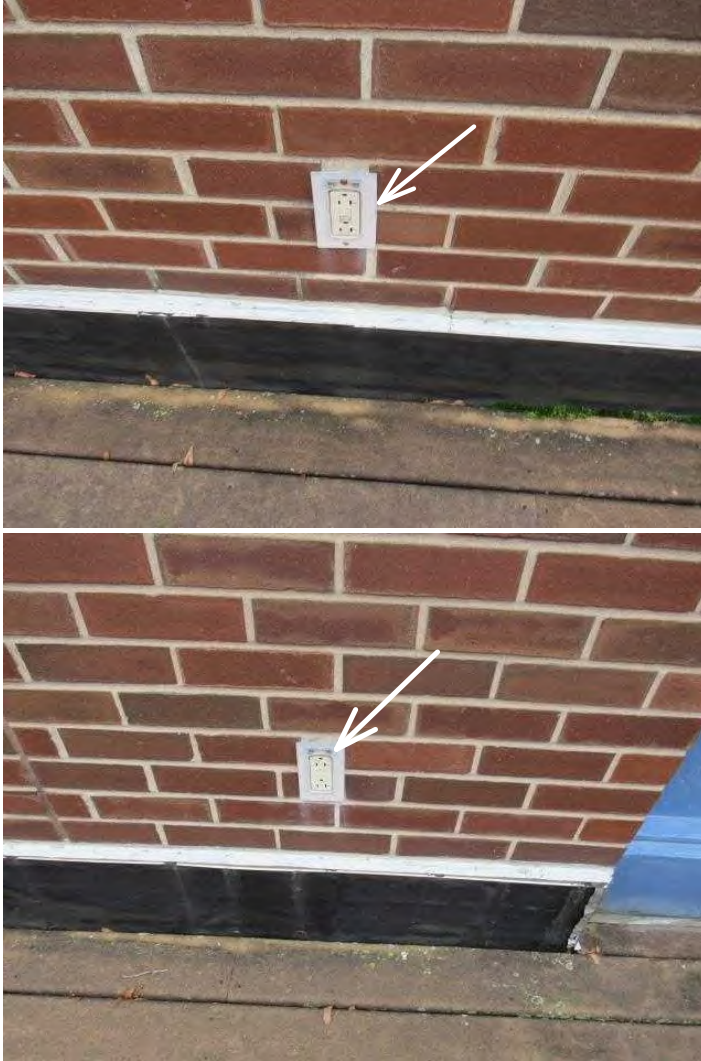
Exterior Electric Outlets: 110 VAC GFCI - **Failed GFCI: There are GFCI outlets on the rear exterior wall at the deck level that has failed and does not trip. The outlets needs to be replaced. Exterior cover plates need to be installed as well.**

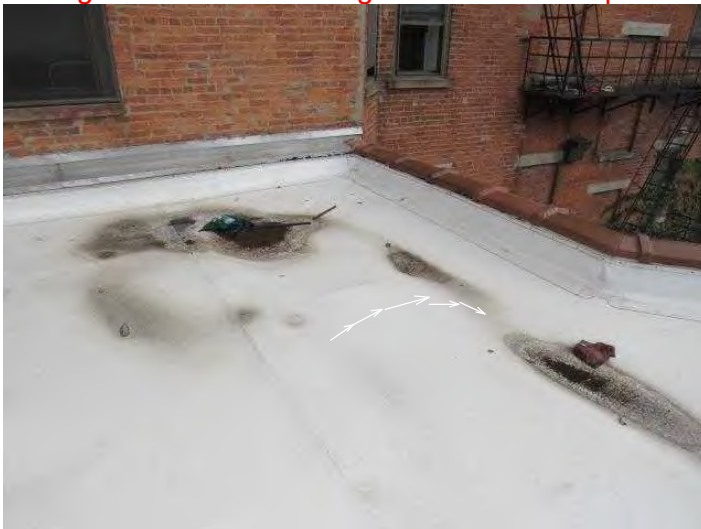
**The membrane under the deck on the rear of the building may be damaged in a few locations under the deck. There are several areas on the ceiling below that have water damage. The Trex flooring and floor framing will need to be removed and repairs made to the membrane or if the damage is too great the membrane will need to be replaced. The flashing around the roof drain may be faulty as well resulting in leaks in the ceiling below. There is damaged flashing and damaged membrane in a few areas above the deck level on the building walls. All damaged roofing material and flashing will need to be replaced.**

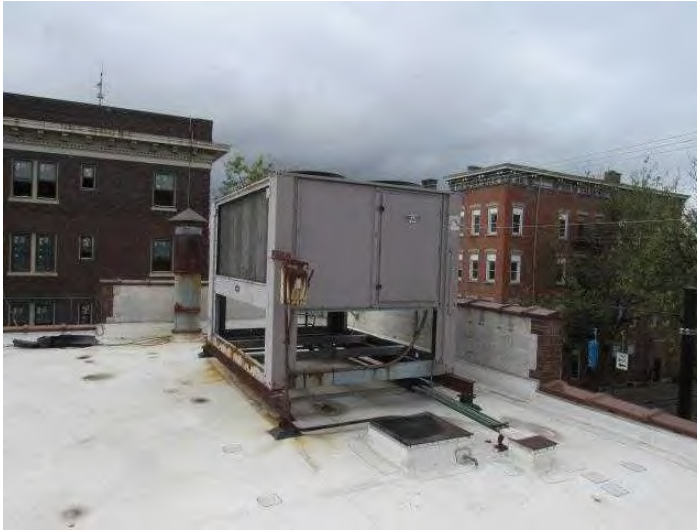
### Roof Unit AC System

1. Not Inspected A/C System Operation: Needs Service - There is no evidence that the air conditioning system has been serviced within the last few years. The roof unit and chillers in the basement should be serviced by a qualified HVAC contractor.
2. Manufacturer: Carrier
3. Type: Air cooled Capacity: Undetermined
4. Approximate Age: 1997
5. Not Inspected Evaporative Coil: Not Inspected - Not Visible: The evaporator coil in the plenum could not be inspected due to the fact that it is inside of the furnace plenum and the plenum was not disassembled to access the coil.
6. Acceptable Installation Method: Roof mount - Installation OK: There were no problems with the installation of this unit at this time.

7. Service Connection: 240 volt AC Temperature Differential: None taken, too cold to test.
8. Acceptable Electrical Disconnect: Exterior

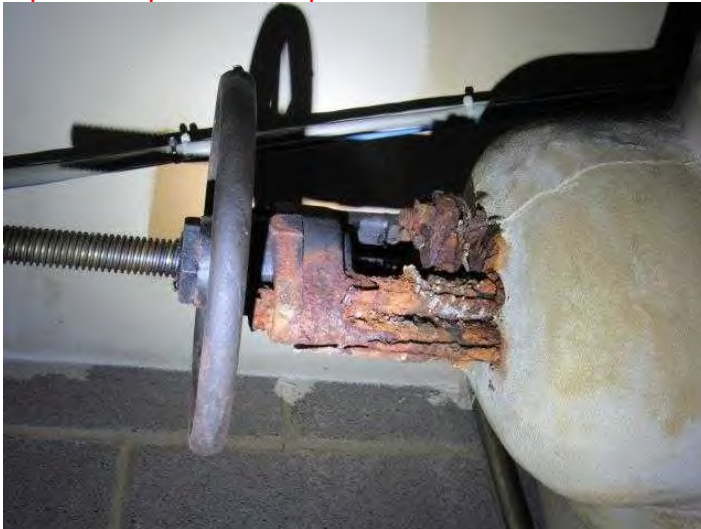
- 1. Defective Heating System Operation: Boiler 3-500,000 BTU units as one boiler - See "Distribution" below.
- 2. Approximate Age 38 yrs
- 3. Type: Gas Fired Boiler Capacity: 1,500,000 BTU
- 4. Fuel: Natural Gas Temperature Differential: N/A
- 5. Acceptable Burners and Elements: Proper Operation
- 6. Defective Distribution: Pipes/Convectors - **There are several boiler system water line pipe joints leaking. There is excessive rust on many of the pipes and joints and valves. This is evidence that the boiler system has not been maintained and or serviced for several years. A qualified HVAC contractor with expertise in commercial grade boiler systems should be contacted to determine repair or replacement options.**

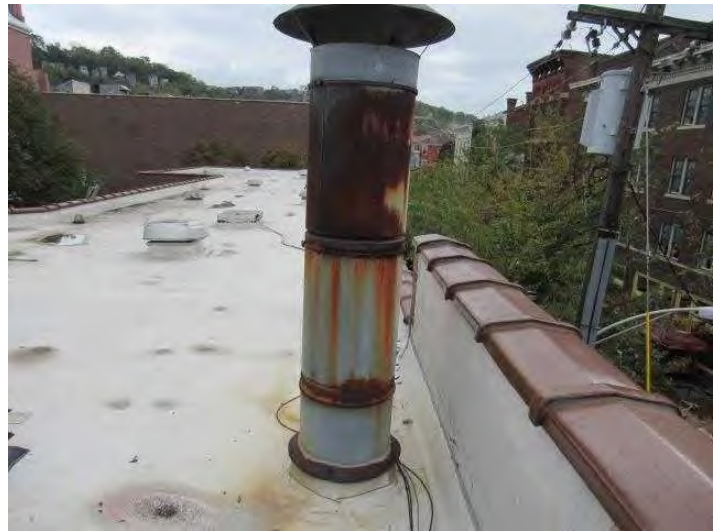
7. Defective Venting: Galvanized Steel - **The rusted furnace flue vent on the roof should be replaced.**

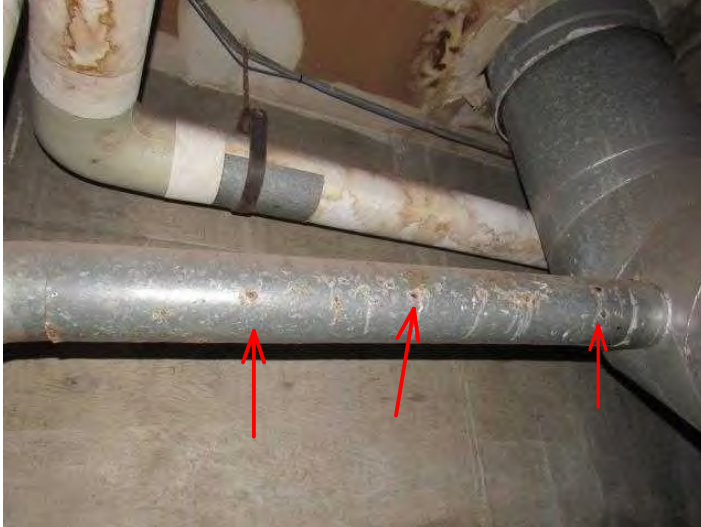
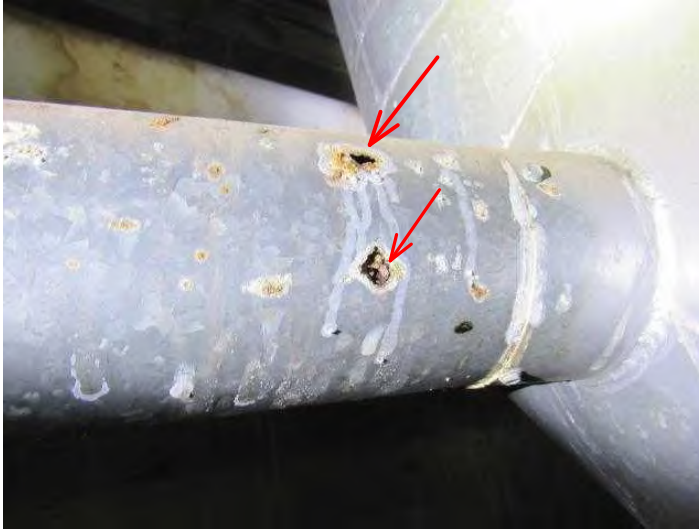
Venting: Galvanized Steel - Rust/Corrosion Holes in the Flue Pipe: There are rust and or corrosion holes in the flue pipe. The damaged flue pipe needs to be replaced.

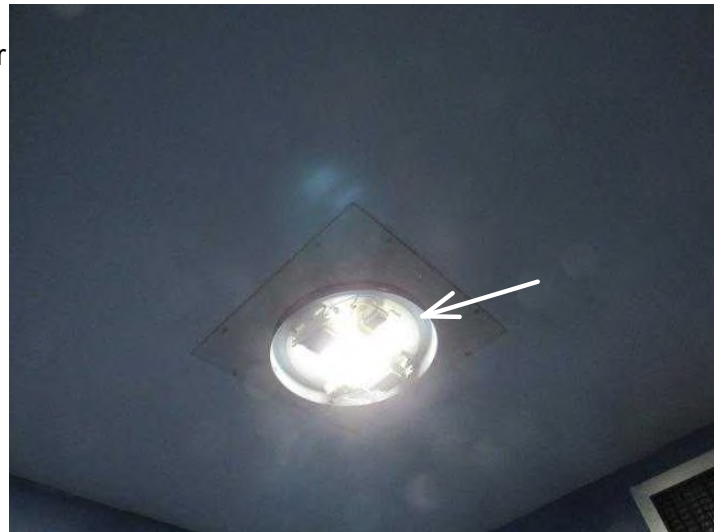
- 43. Acceptable Ceiling: Drywall
- 44. Acceptable Walls: Drywall
- 45. Acceptable Floor: Finished floor covering
- 46. Acceptable Doors: Wood
- 47. Acceptable Electrical: 110 vac - The class dome is missing on the ceiling light. The light cover needs to be replaced.

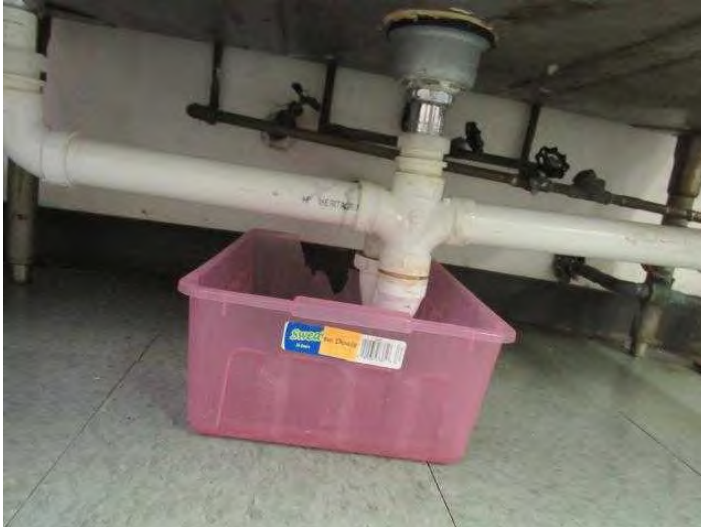
1. Not Inspected Cooking Appliances:
2. Air Gap Present? No
3. Not Inspected Refrigerator: Not part of this inspection report.
4. Acceptable Sink: Stainless Steel
5. Defective Electrical: 110 vac - **Add GFCI to Kitchen: A GFCI outlet needs to be installed to all locations within 6' of the sink This is a safety concern and needs immediate repair by a licensed electrician.**
6. Acceptable Faucets: Double Handle
7. Defective Traps: PVC - **Active Drain Leak: There is an active leak in the sink drain that should be repaired by a licensed plumber.**

**There is a broken PVC drain on the other sink that needs repair by a qualified plumber.**

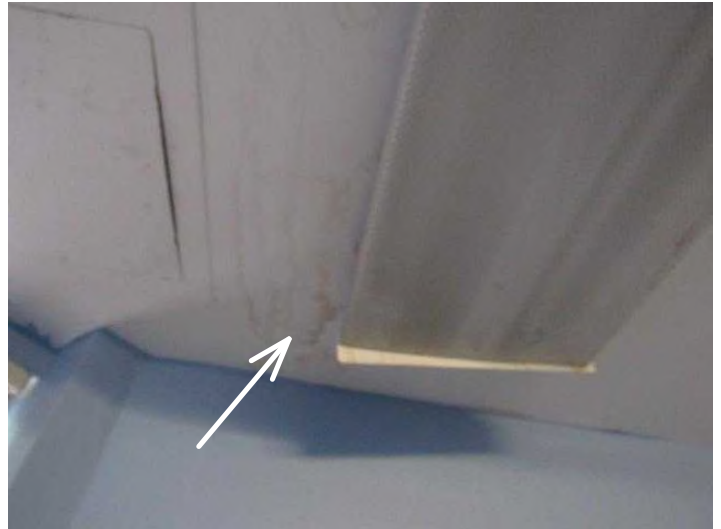
- 1. Defective Ceiling: Drywall - **Moisture Damage:**  
**There is water staining on the ceiling from past leaks. The plumbing or boiler lines above will need to be inspected for leaks and repaired as needed.**

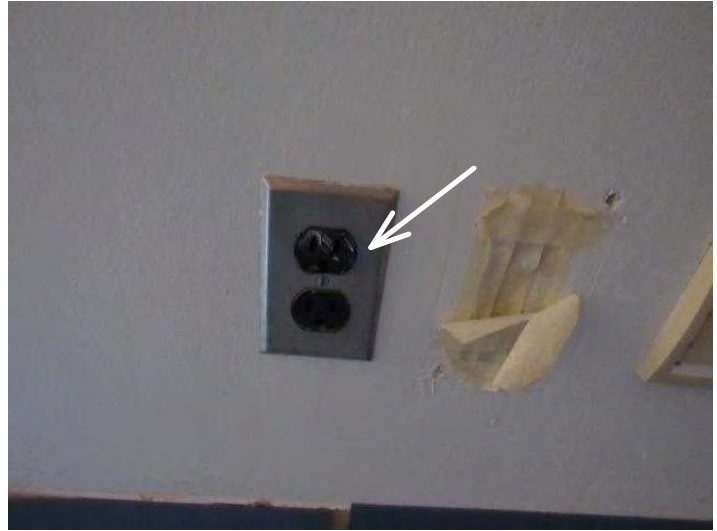
- 9. Acceptable Walls: Drywall
  - 10. Acceptable Floor: Finished floor covering
  - 11. Acceptable Doors: Wood
  - 12. Acceptable Windows: Double Pane
  - 13. Defective Electrical: 110 vac - **Loose Outlets: There is a loose outlet on the wall that needs to be secured. This is a safety concern. Repairs should be accomplished by a licensed electrician.**
- Damaged Outlet: There is a damaged outlet that needs to be replaced.**

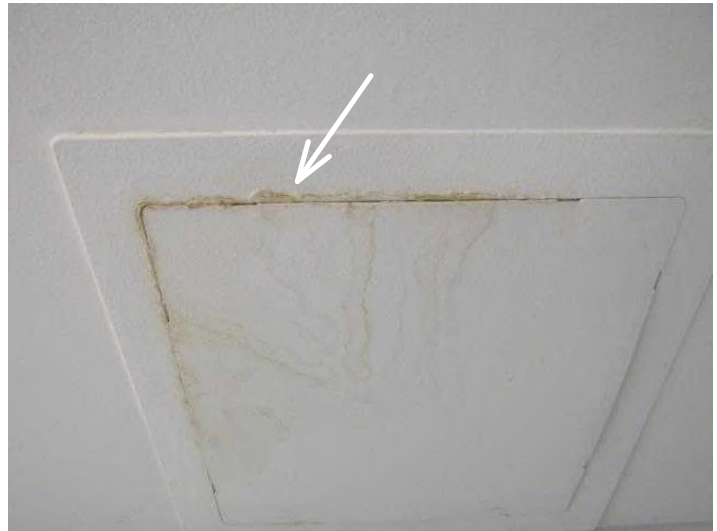
- 15. Defective Ceiling: Drywall - **Moisture Leaks: There is water staining on the ceiling from past leaks. The plumbing or boiler lines above will need to be inspected for leaks and repaired as needed.**

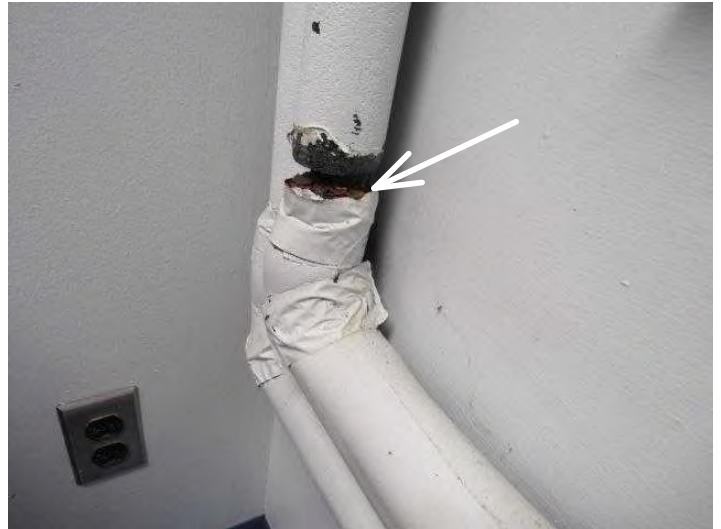
21. Defective HVAC Source: Main HVAC System -  
There is a rusted boiler pipe that needs to be replaced.

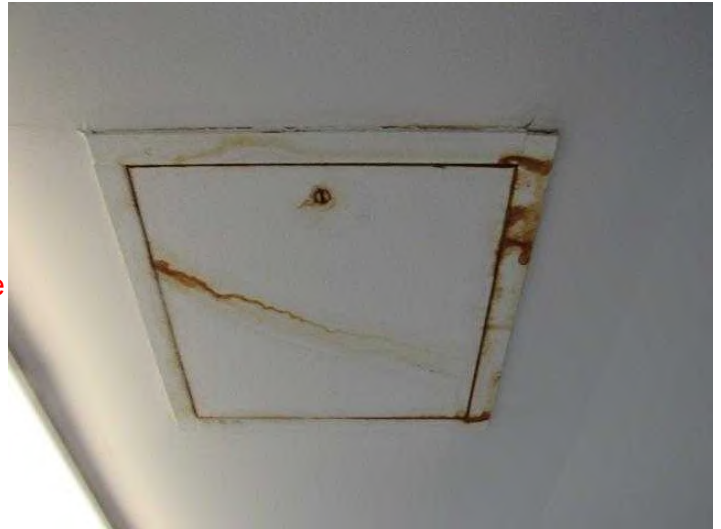
**The access door screw was rusted and the access could not be opened. There may be an active leak in this area from the boiler lines or perhaps a bathroom or kitchen area above.**

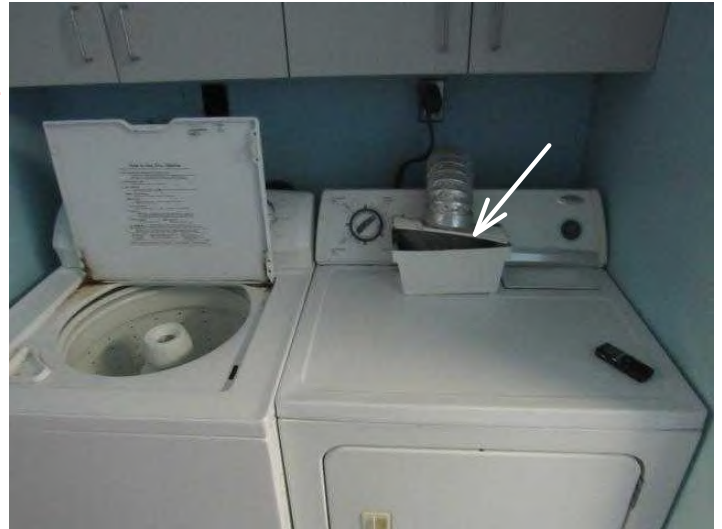
- 25. Defective Laundry Area: 1st floor hall - The dryer vent is venting into the building and needs to be vented to the exterior of the building. A qualified contractor will need to make repairs.

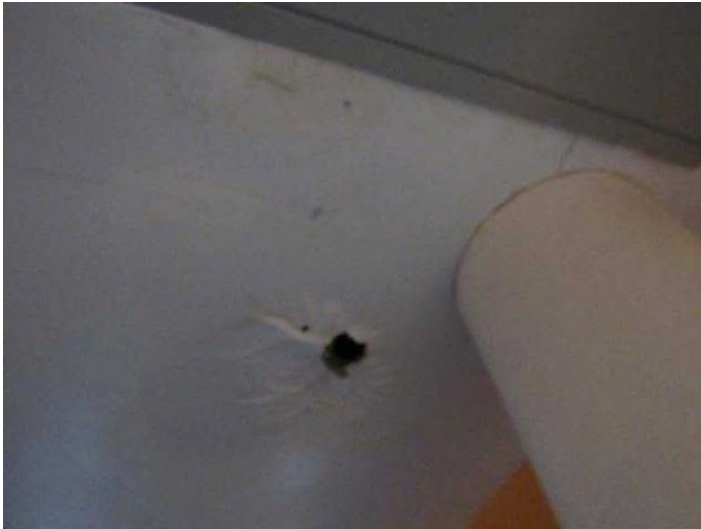
- 26. Defective Ceilings: Drywall - Moisture Damage: There is water staining and damage on the ceiling from past leaks. The plumbing or boiler lines above will need to be inspected for leaks and repaired as needed.

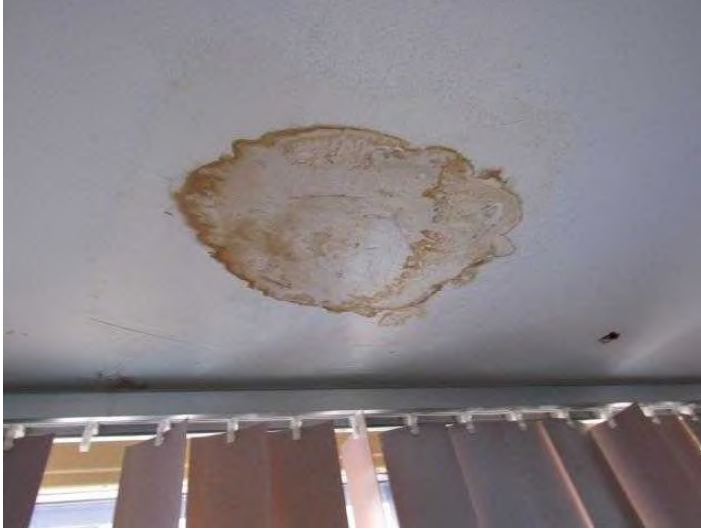
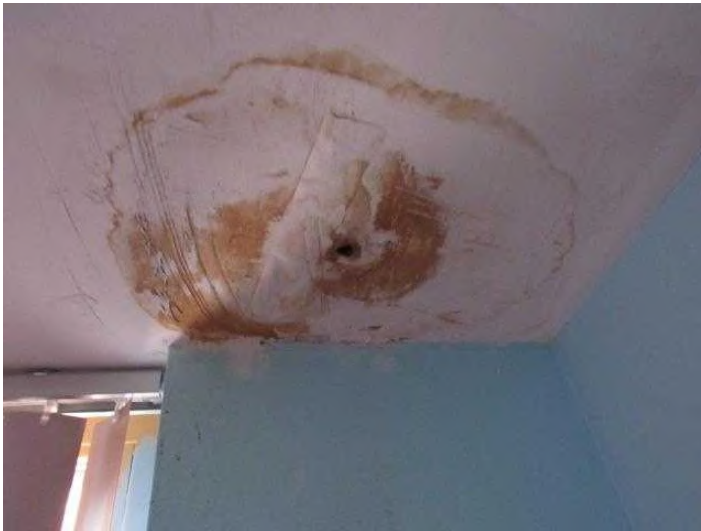
- 40. Defective Ceilings: Drywall - **Moisture Damage: There is water staining on the ceiling that was tested with a moisture meter and found to be dry at the time of inspection. The roof flashing or other roof penetrations should be monitored in the future for leaks and repaired as needed.**

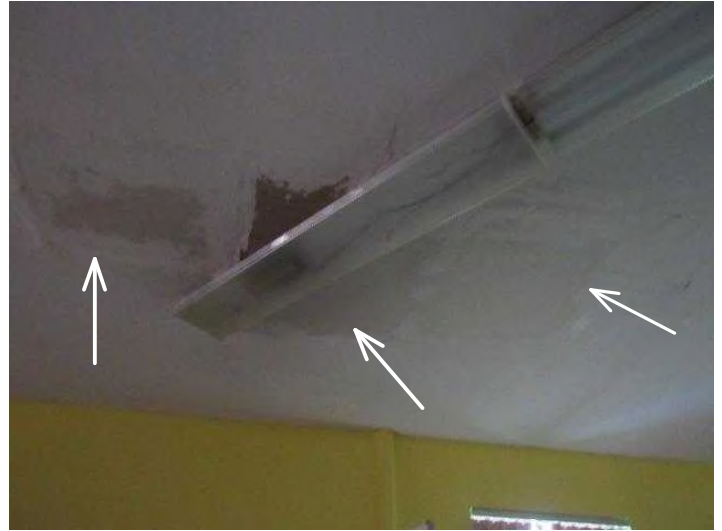
- 49. Acceptable Doors: Wood
  - 50. Acceptable Windows: Double Pane
  - 51. Acceptable Electrical: 110 vac
  - 52. Acceptable HVAC Source: Main HVAC System
  - 53. Acceptable Sink: Stainless Steel
- 2nd floor classroom far right side Room
- 
- 54. Marginal Ceilings: Drywall - **Additional drywall repair is needed to the ceiling.**

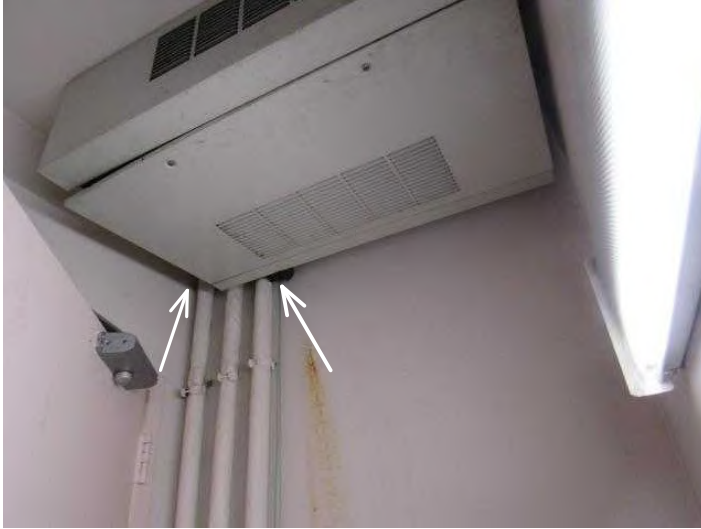
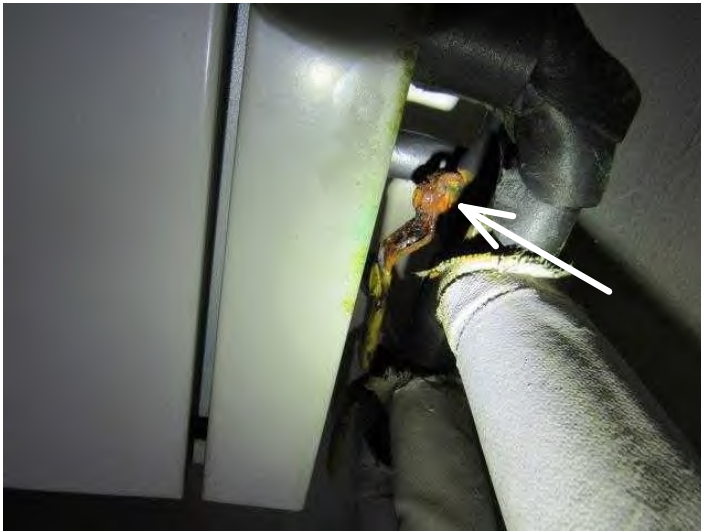
Electrical: 110 vac  
HVAC Source: Main HVAC System - **There are two shut off valves for the water lines to the radiator that are leaking and need to be repaired by a qualified HVAC contractor.**

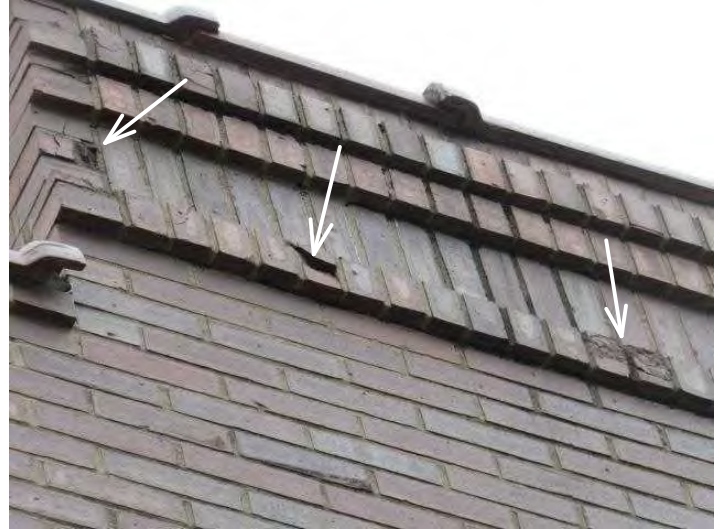
1. Most areas Exterior Surface Type: Brick - Spalling: There are damaged brick on the left wall from spalling. The damaged brick should be replaced by a qualified contractor.
