## APPLICATION FOR HISTORIC CONSERVATION DISTRICT DESIGNATION HISTORIC CONSERVATION BOARD PUBLIC HEARING STAFF REPORT

APPLICATION #: N/A  
APPLICANT: Bond Hill Community Council thru Alexis and Wei Liu  
OWNER: Various. See attached excel sheet (Attachment 4)  
ADDRESS: **Properties on Bella Vista Street east of Reading Road**  
PARCELS: Various. See attached excel sheet (Attachment 4)  
ZONING: SF- 4 and RM 1.2  
OVERLAYS: None  
COMMUNITY: Bond Hill  
REPORT DATE: July 8, 2019  
HEARING DATE: Prehearing June 24, 2019- sign in sheet attached.  
July 22, 2019  
STAFF REVIEW: Beth Johnson, Urban Conservator

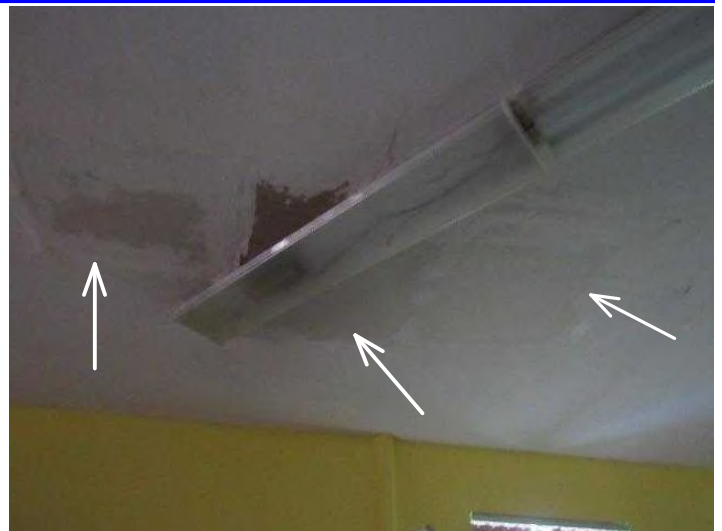
4. 2nd floor classroom far right side Room Ceilings: Drywall - Additional drywall repair is needed to the ceiling.

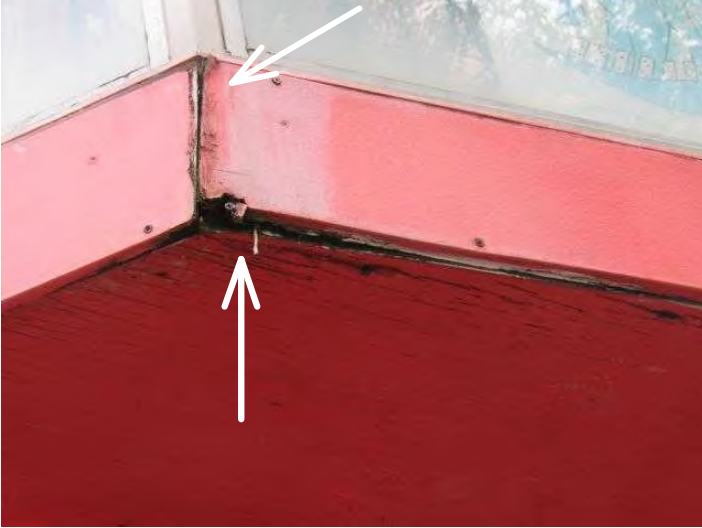
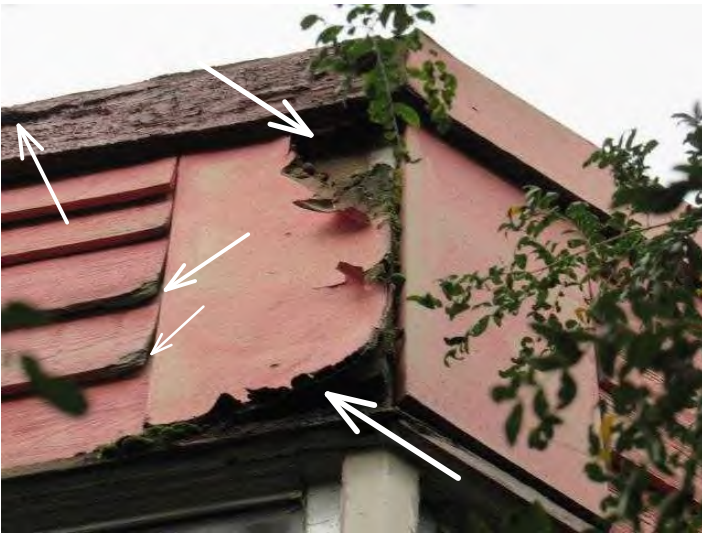
1. Trim: Wood - There is moisture damaged wood and other composite material on the exterior of the bay window on the 2nd floor on the front of the building. All moisture damaged material will need to be replaced. Due to the amount of damage the entire bay window area may need to be rebuilt.

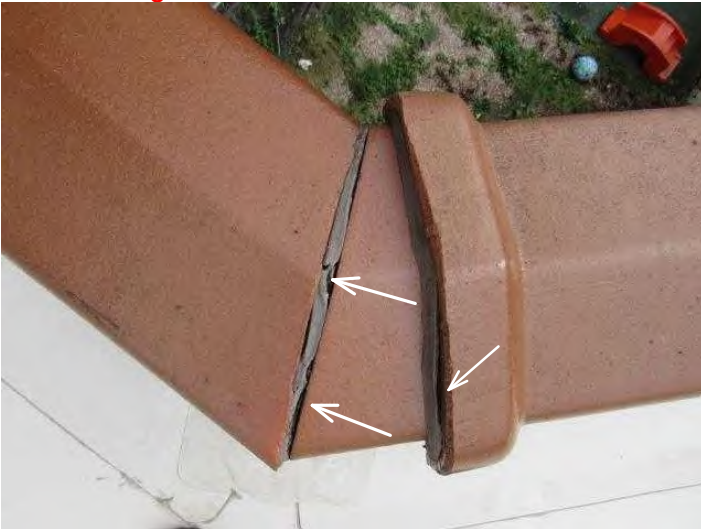
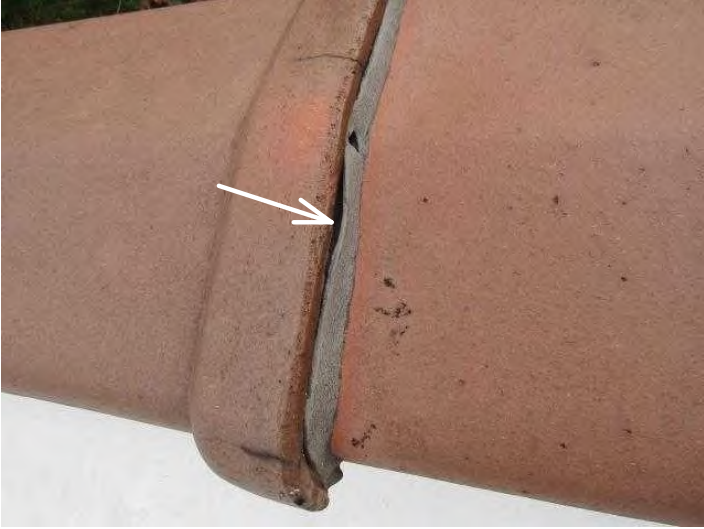
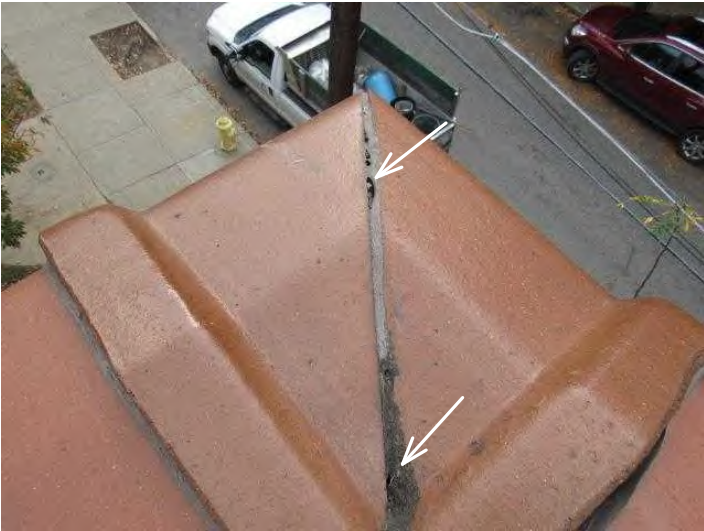
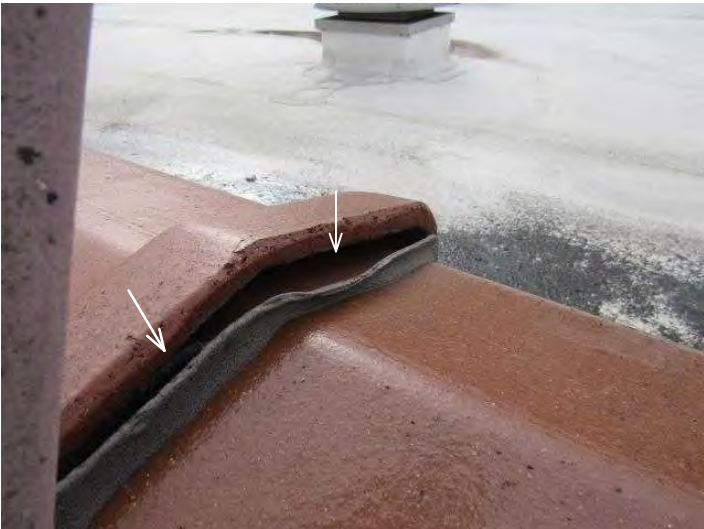
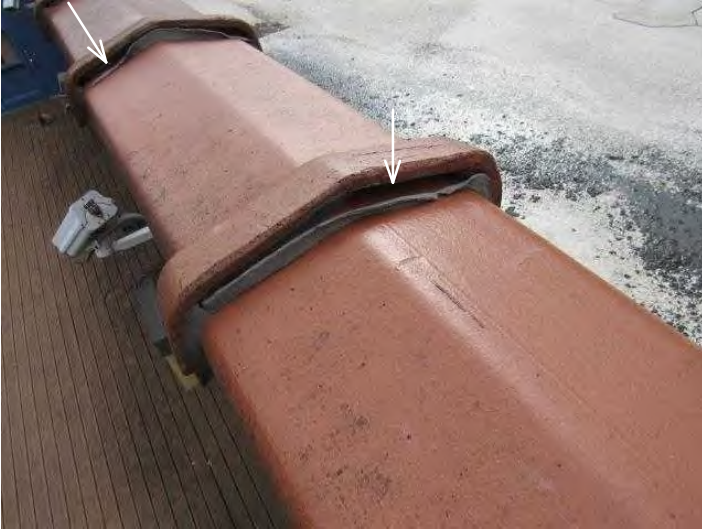
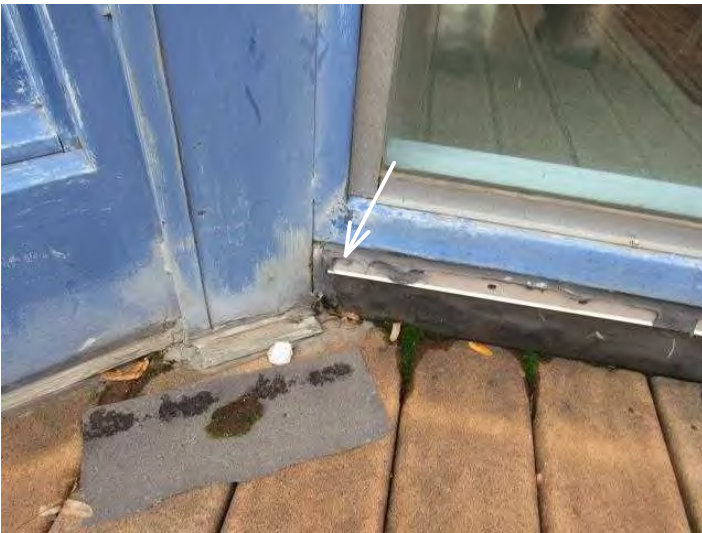
6. Flashing: Rubber, Metal, Clay Tile - The parapet wall cap is clay tiles. The joints were caulked at one time, but the caulk at the joints has failed and separated. All of the failed caulk needs to be removed and the joints re-caulked.

Flashing repairs are needed at the roof membrane. A qualified roofer should make all repairs needed to the roof flashing and membrane.

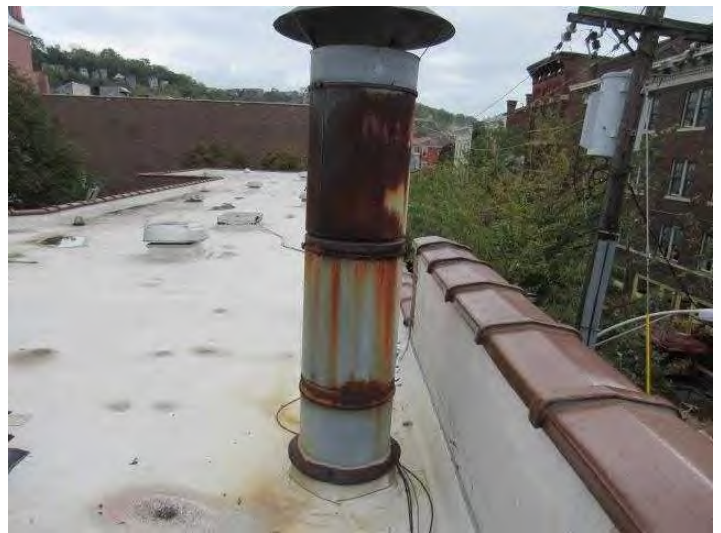
10. Basement Heating System Venting: Galvanized Steel -  
The rusted furnace flue vent on the roof should be replaced.

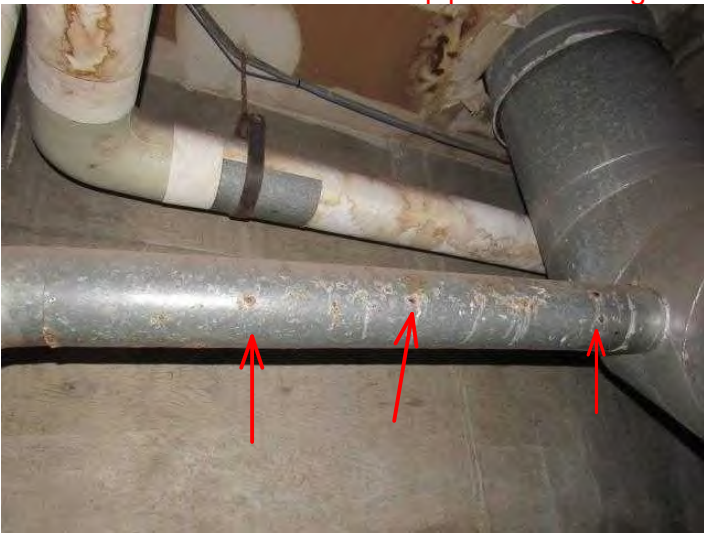
11. Basement Water Heater Venting: Galvanized Steel - Rust/Corrosion Holes in the Flue Pipe: There are rust and or corrosion holes in the flue pipe. The damaged flue pipe needs to be replaced.

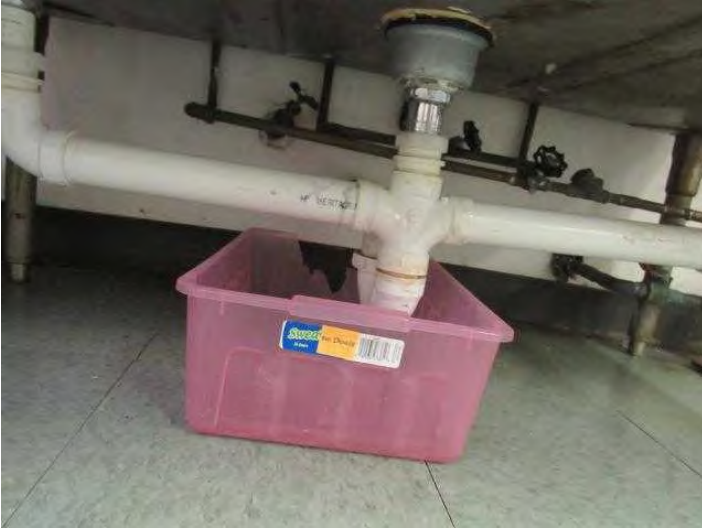
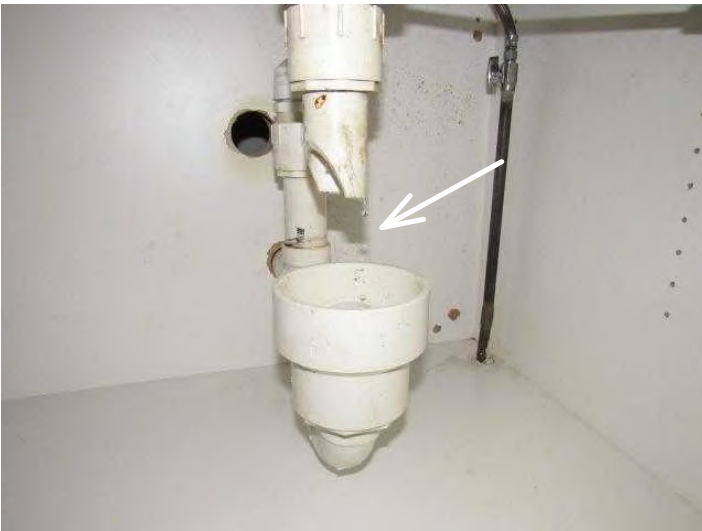
17. 2nd floor kitchen Employee Lounge Traps: PVC - **Active Drain Leak: There is an active leak in the sink drain that should be repaired by a licensed plumber.**

**There is a broken PVC drain on the other sink that needs repair by a qualified plumber.**

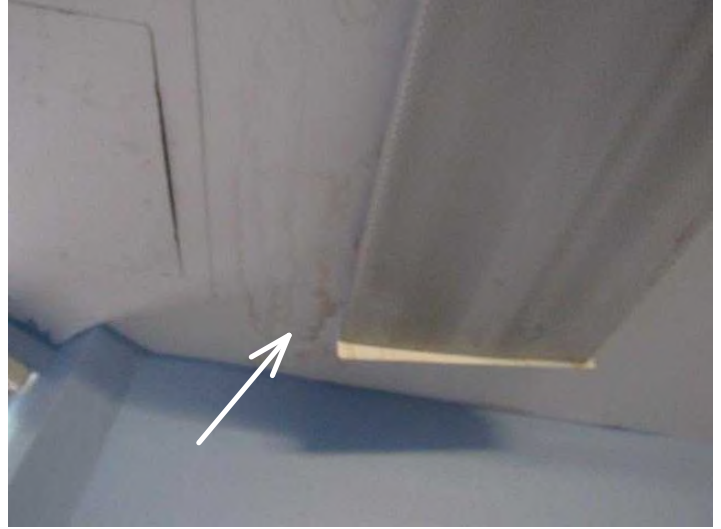
18. Left front Office Space Ceiling: Drywall - **Moisture Damage:** There is water staining on the ceiling from past leaks. The plumbing or boiler lines above will need to be inspected for leaks and repaired as needed.

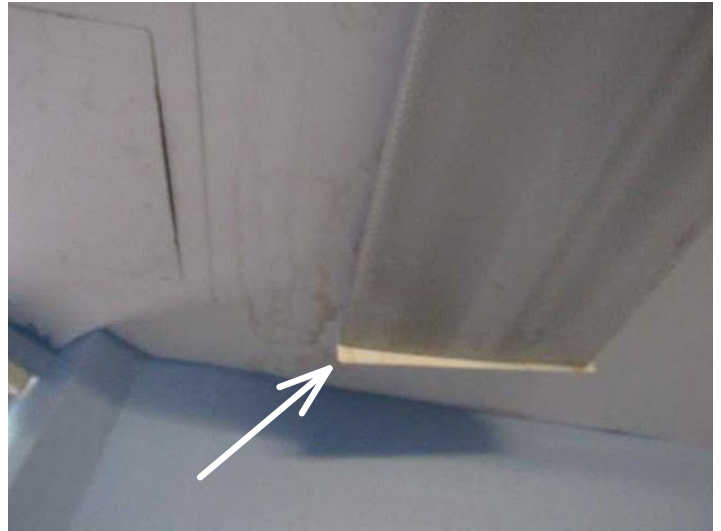
19. Left front Office Space Electrical: 110 vac - **The ceiling light fixture is loose and needs repair.**

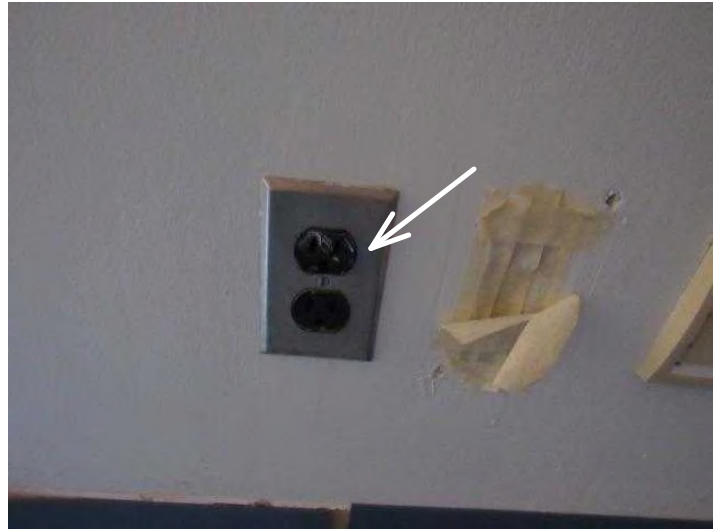
20. Left middle 2-joined offices Office Space Electrical: 110 vac - **Loose Outlets:** There is a loose outlet on the wall that needs to be secured. This is a safety concern. Repairs should be accomplished by a licensed electrician.

**Damaged Outlet:** There is a damaged outlet that needs to be replaced.

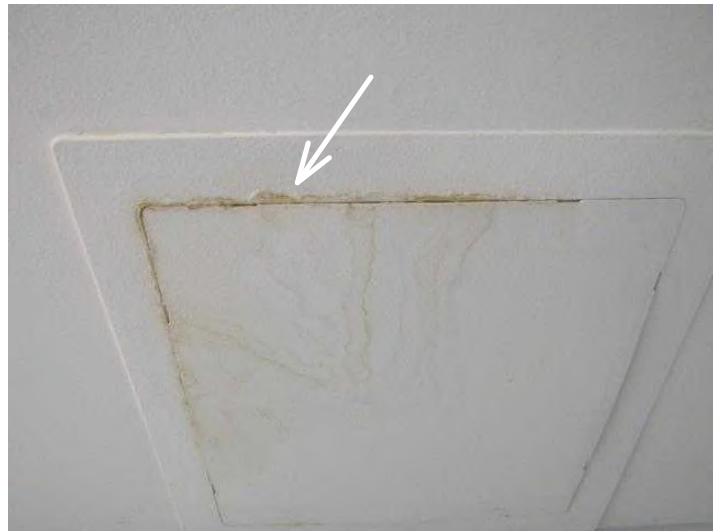
21. Left rear Office Space Ceiling: Drywall - **Moisture Leaks:** There is water staining on the ceiling from past leaks. The plumbing or boiler lines above will need to be inspected for leaks and repaired as needed.

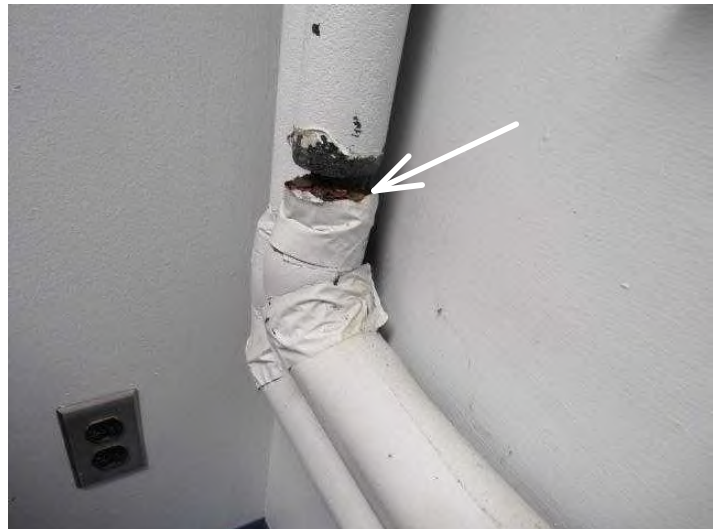
22. Left rear Office Space HVAC Source: Main HVAC System - **There is a rusted boiler pipe that needs to be replaced.**

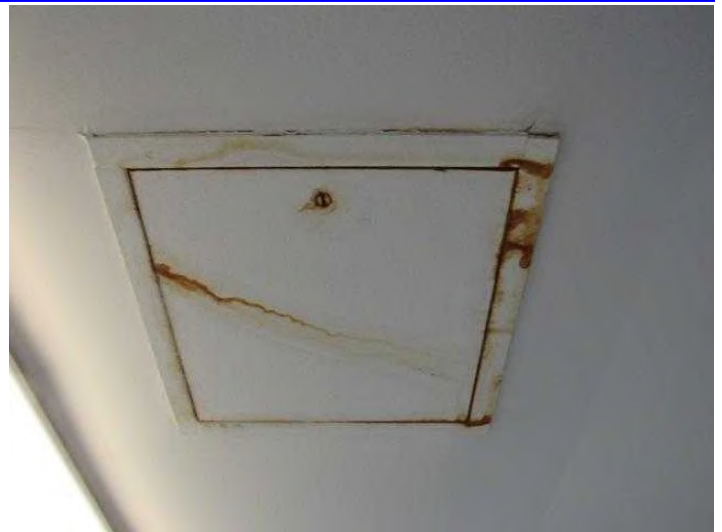
24. 1st floor left hallway Room Ceilings: Drywall - **Moisture Leaks: There is water staining on the ceiling from past leaks. The plumbing or boiler lines above will need to be inspected for leaks and repaired as needed.**

The access door screw was rusted and the access could not be opened. There may be an active leak in this area from the boiler lines or perhaps a bathroom or kitchen area above.

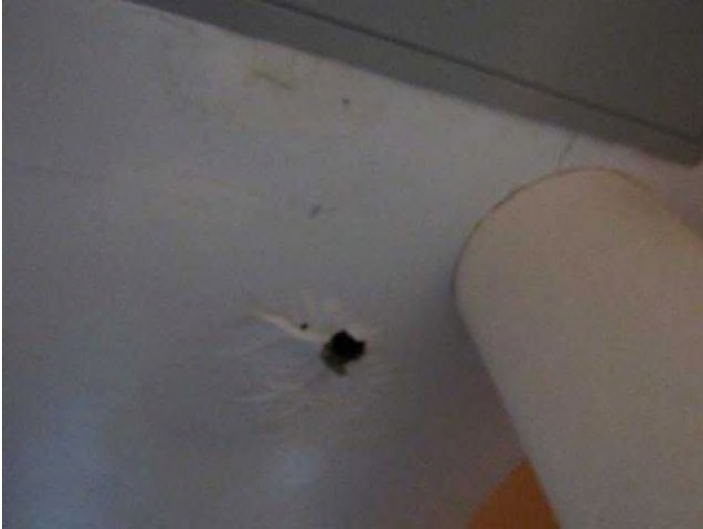
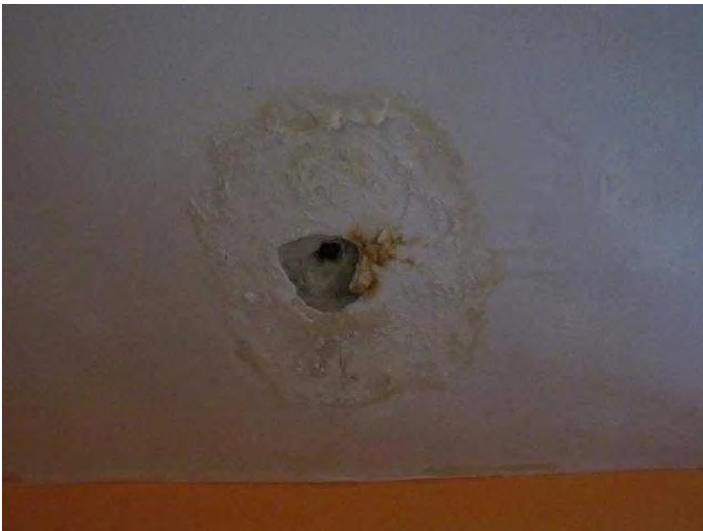
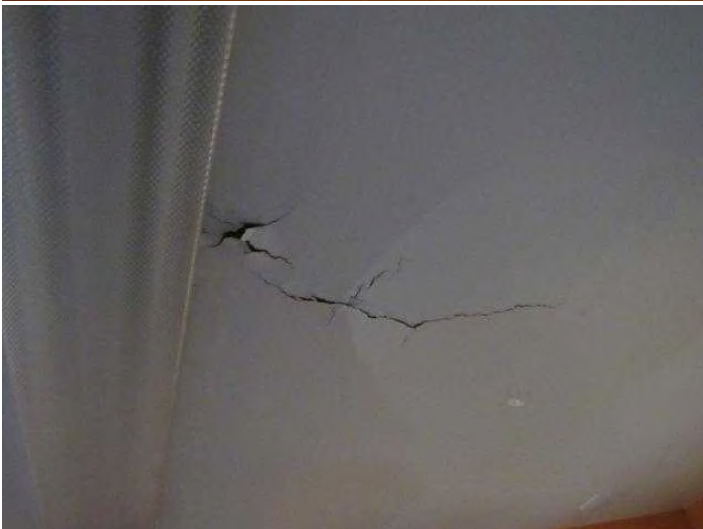
28. 1st floor middle daycare classroom Room Ceilings: Drywall - **Moisture Damage: There is water staining and damage on the ceiling from past leaks. The plumbing or boiler lines above will need to be inspected for leaks and repaired as needed.**

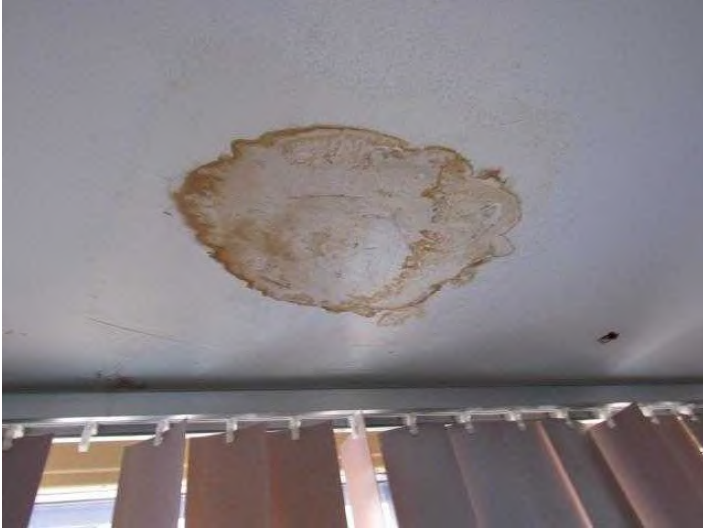
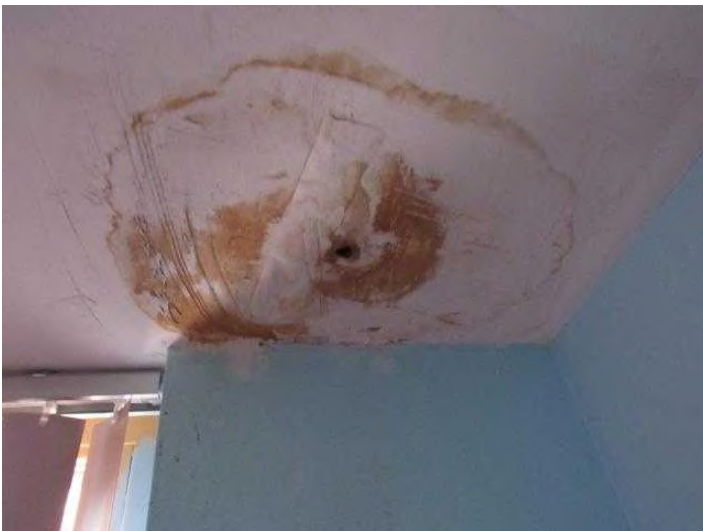
30. 2nd floor hall area in front of the kitchen Room Ceilings: Drywall - **Moisture Damage:** There is water staining on the ceiling that was tested with a moisture meter and found to be dry at the time of inspection. The roof flashing or other roof penetrations should be monitored in the future for leaks and repaired as needed.

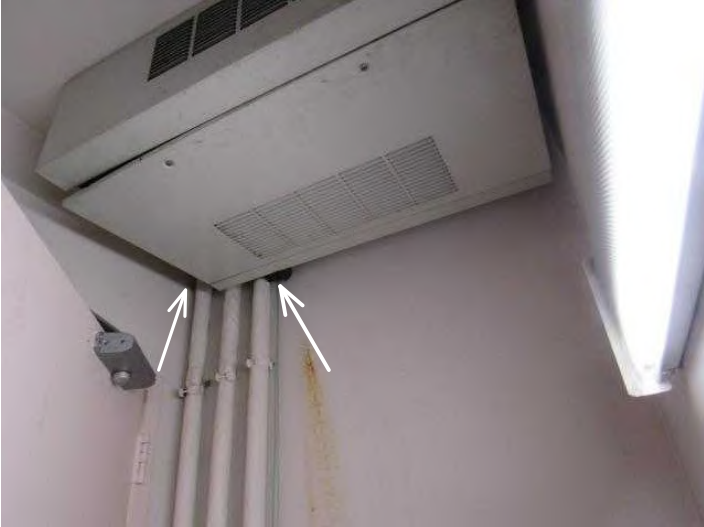
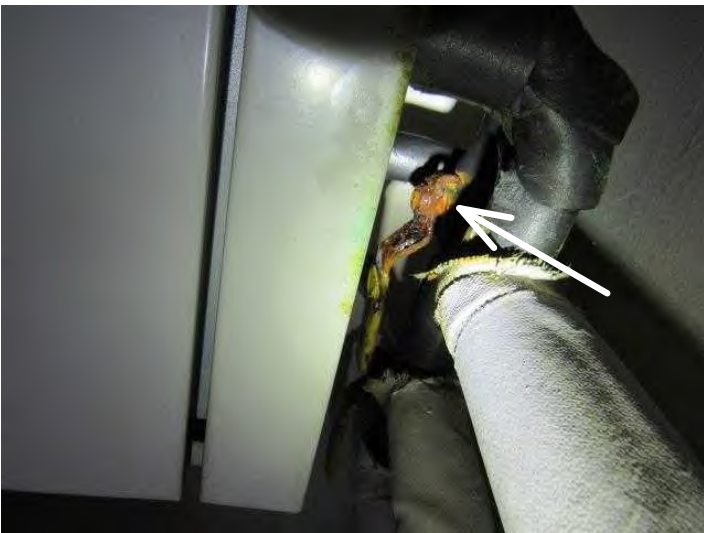
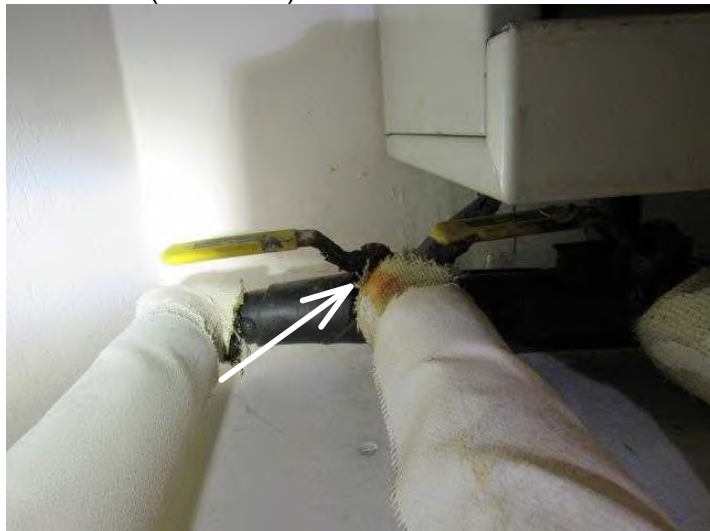
33. 2nd floor front hallway Room HVAC Source: Main HVAC System - There are two shut off valves for the water lines to the radiator that are leaking and need to be repaired by a qualified HVAC contractor.

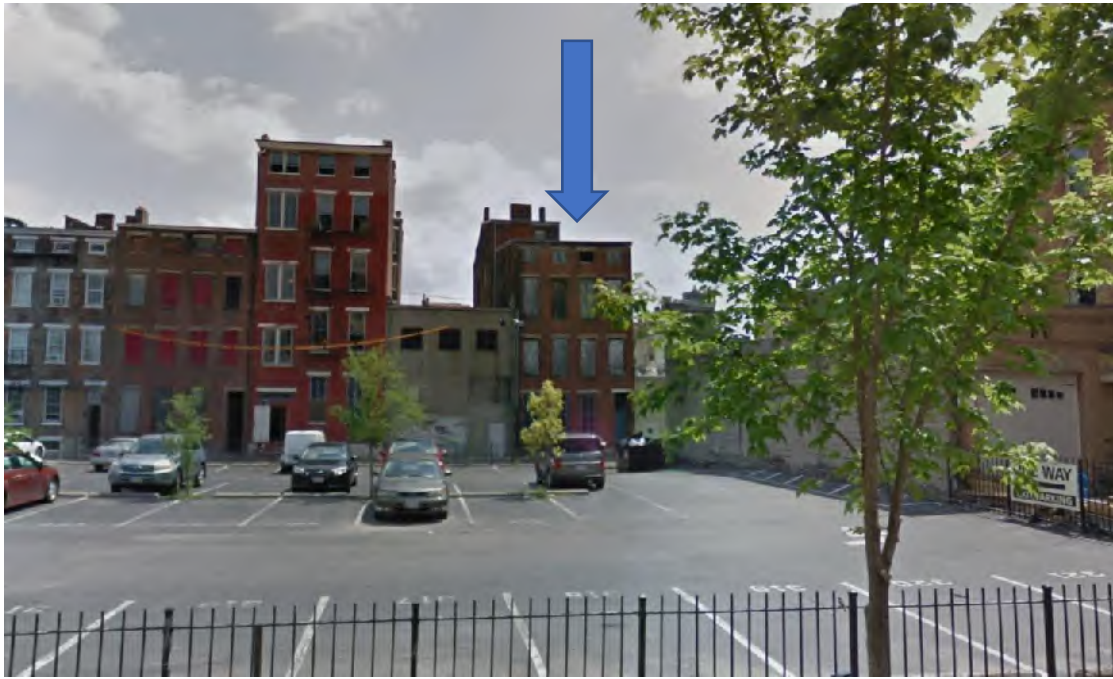
Figure 2: Picture of the rear building at 1725 Elm Street from Elm street provided by Google Street Views.

- 5/20/2019- Continuation of B201706214- More brick has fallen from the building at the base and from the top.
  - 06/04/2019- Continuation of B201706214- Inspection noted more bricks have failed. Rear building is structurally unsafe and dangerous. Owner will be cited for criminal prosecution.

*The building is in a condition that would require a minimum of 2 walls to be potentially completely removed, the basement repaired/rebuilt, and then the walls rebuilt. This stabilization would be required prior to any rehabilitation work in the building. This would require that the north and west walls be taken down, the basement repaired/rebuilt and then the walls rebuilt. As much of the brick has water damage, spalling, or cracking, much of the brick would not be able to be reused.*

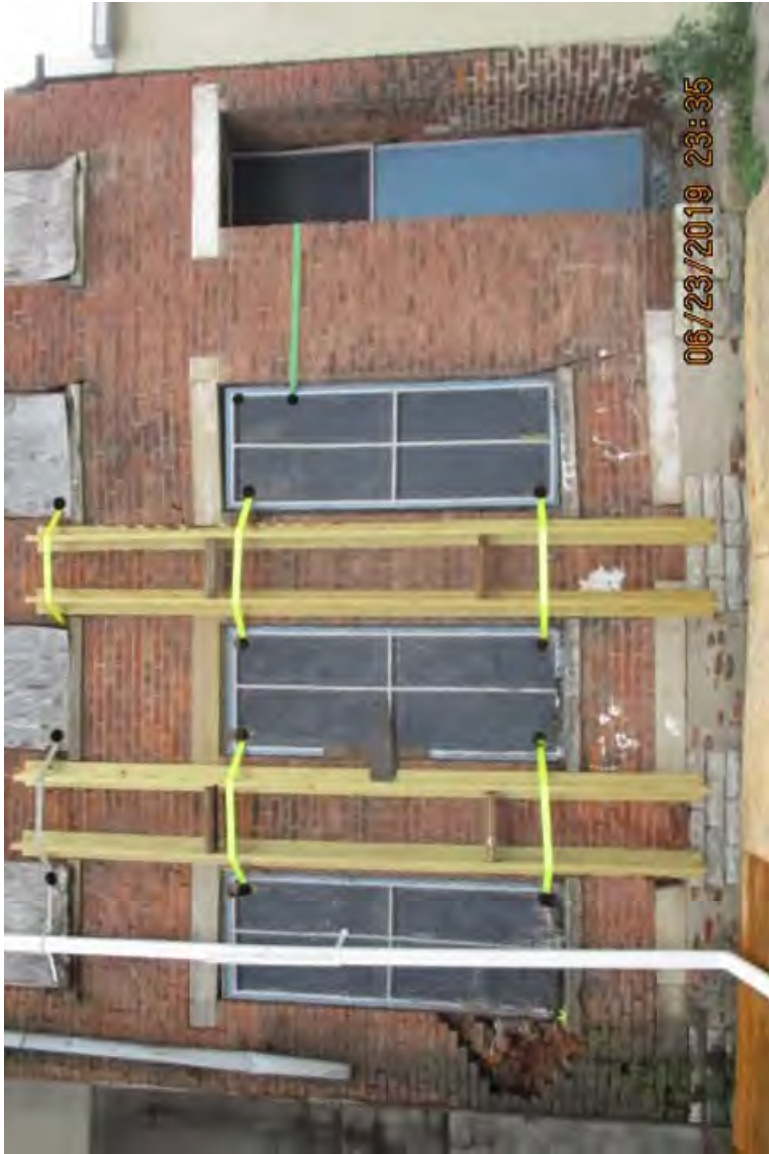
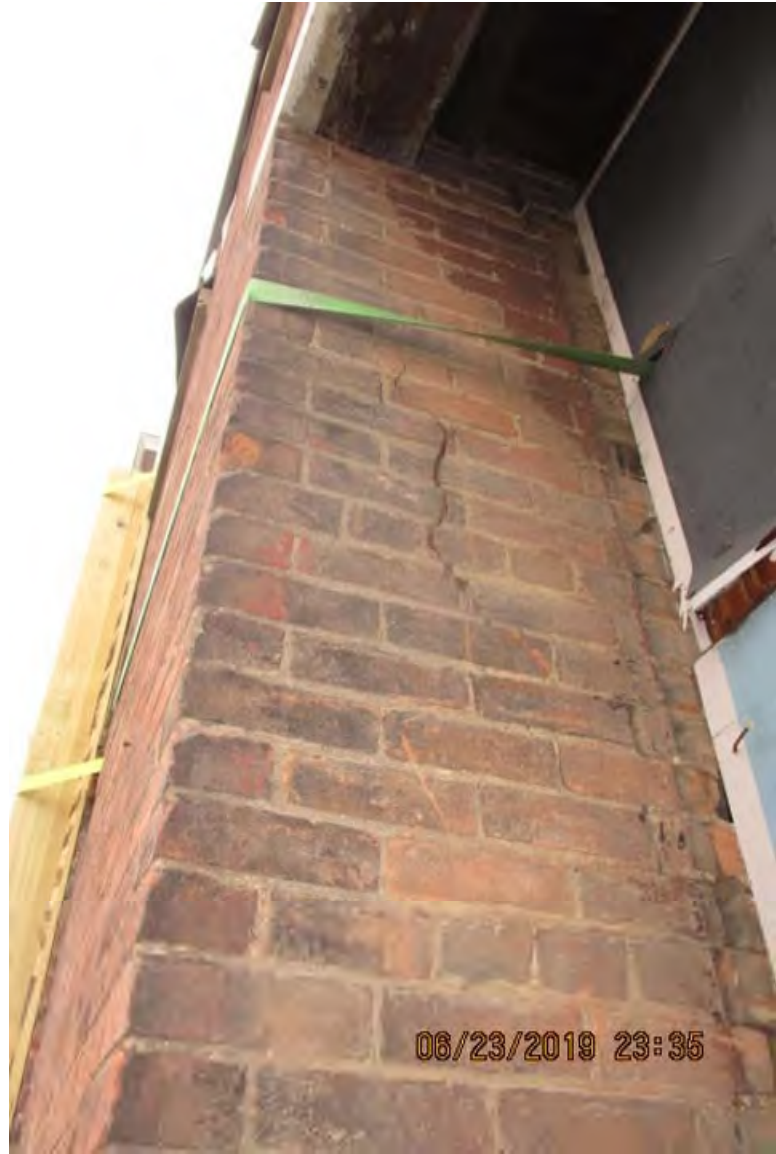
1725 Elm  
Rear Bldg  
West Facade

From what I can tell, the base of this wall has failed allowing the masonry to shift downward creating a slight bulge outward relative to the stone foundation. My reconnaissance of the basement revealed three openings in this stone portion of the wall each having wood headers that appear to

have significantly rotted. Thus, the brick masonry over these openings are not adequately supported and with the rot and continual deterioration of the soft brick, this rear wall is subject to a complete and sudden collapse. There are many issues affecting this wall, but the greatest is the saturation of the brick and wood headers that has led to deterioration and failure. In comparison of earlier photos from google earth and other satellite images, much of the exterior brick displacement observed has occurred in the past year or so and from verbal accounts from those who have looked at this building more recently, a great majority of the failed brick has shifted and fallen over the past week. Most of the exterior stone lintels were observed to be cracked, have failed bearing support and or shifted causing the masonry above to separate. With the gaps, water has been attaching the inner wythes and wood headers. I suspect that the inner wythe headers (constructed of wood) over each opening has been compromised by rot as well.

It is my concern with the recent heavy rains, this rear wall is subject to a collapse. Thus, closing this alley and protecting the area from pedestrians is vital during the period in which this building is being evaluated. From what I could see during my very limited observation (access was limited with deteriorated and missing sections of floors), the north wall did not appear to be in much better condition. The inner wythes of this north wall appear to have sustained water damage beyond a simple repair. Thus, it is my opinion that action needs to be taken immediately to bring these walls down in a controlled manner. Since this rear building is not attached to the front building at this address, it is recommended that consideration be given to raze this structure with intent of saving the taller building facing Elm Street. The option of demolishing this structure in lieu of the risk and cost associated with any stabilization effort can be justified as this building has been let to deteriorate for too long and may be past the point of saving. Buildings such as these get beyond a reasonable level of being safe and become too much of a liability in trying to salvage.

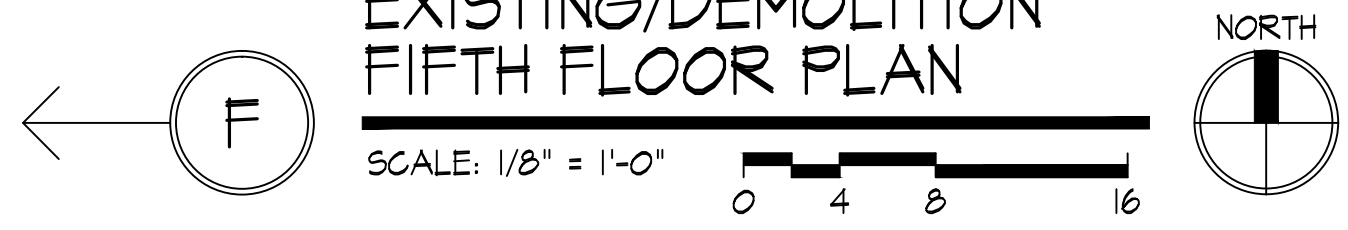
**EXISTING/DEMOLITION FIFTH FLOOR PLAN**

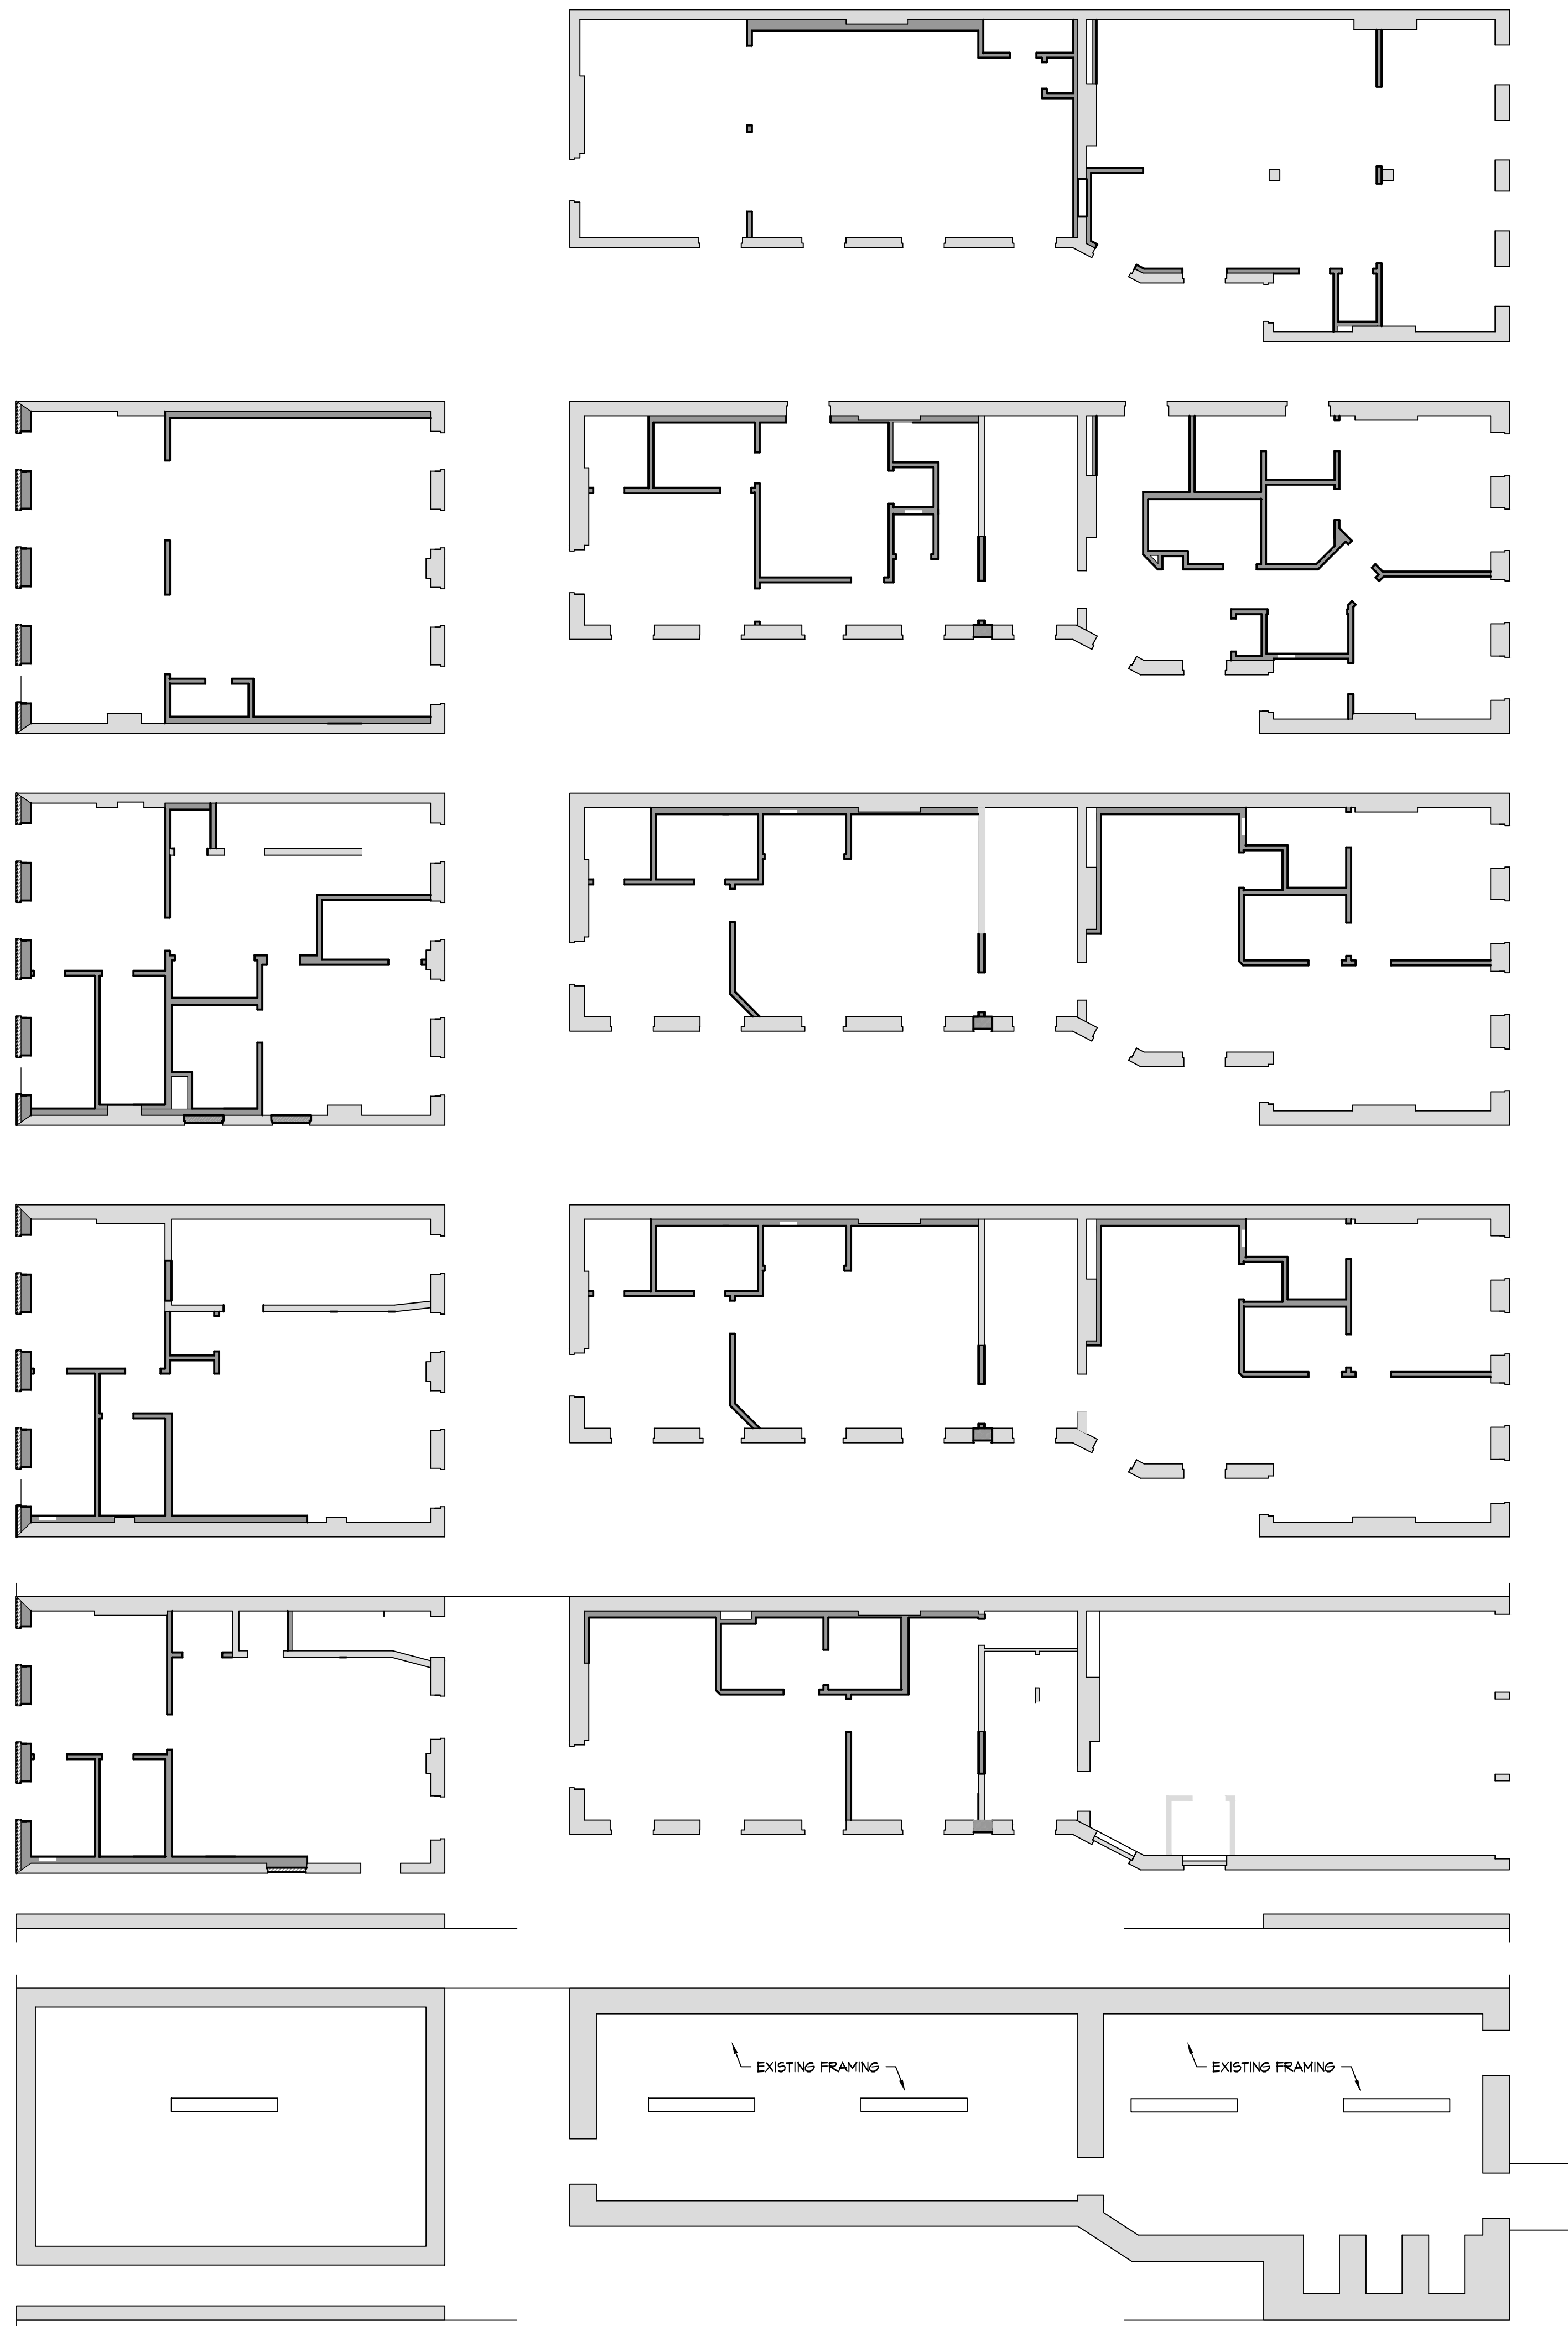
Print Record
10/10/17 SCHEMATIC
Project Number
2017-115
Date
OCTOBER 10, 2017
Sheet Title
REFLECTED CEILING PLANS
Sheet Number
<b>A1.7</b>

REFLECTED CEILING FIFTH FLOOR PLAN  
 SCALE: 1/8" = 1'-0"  
 0 4 8 16

REFLECTED CEILING FOURTH FLOOR PLAN  
 SCALE: 1/8" = 1'-0"  
 0 4 8 16

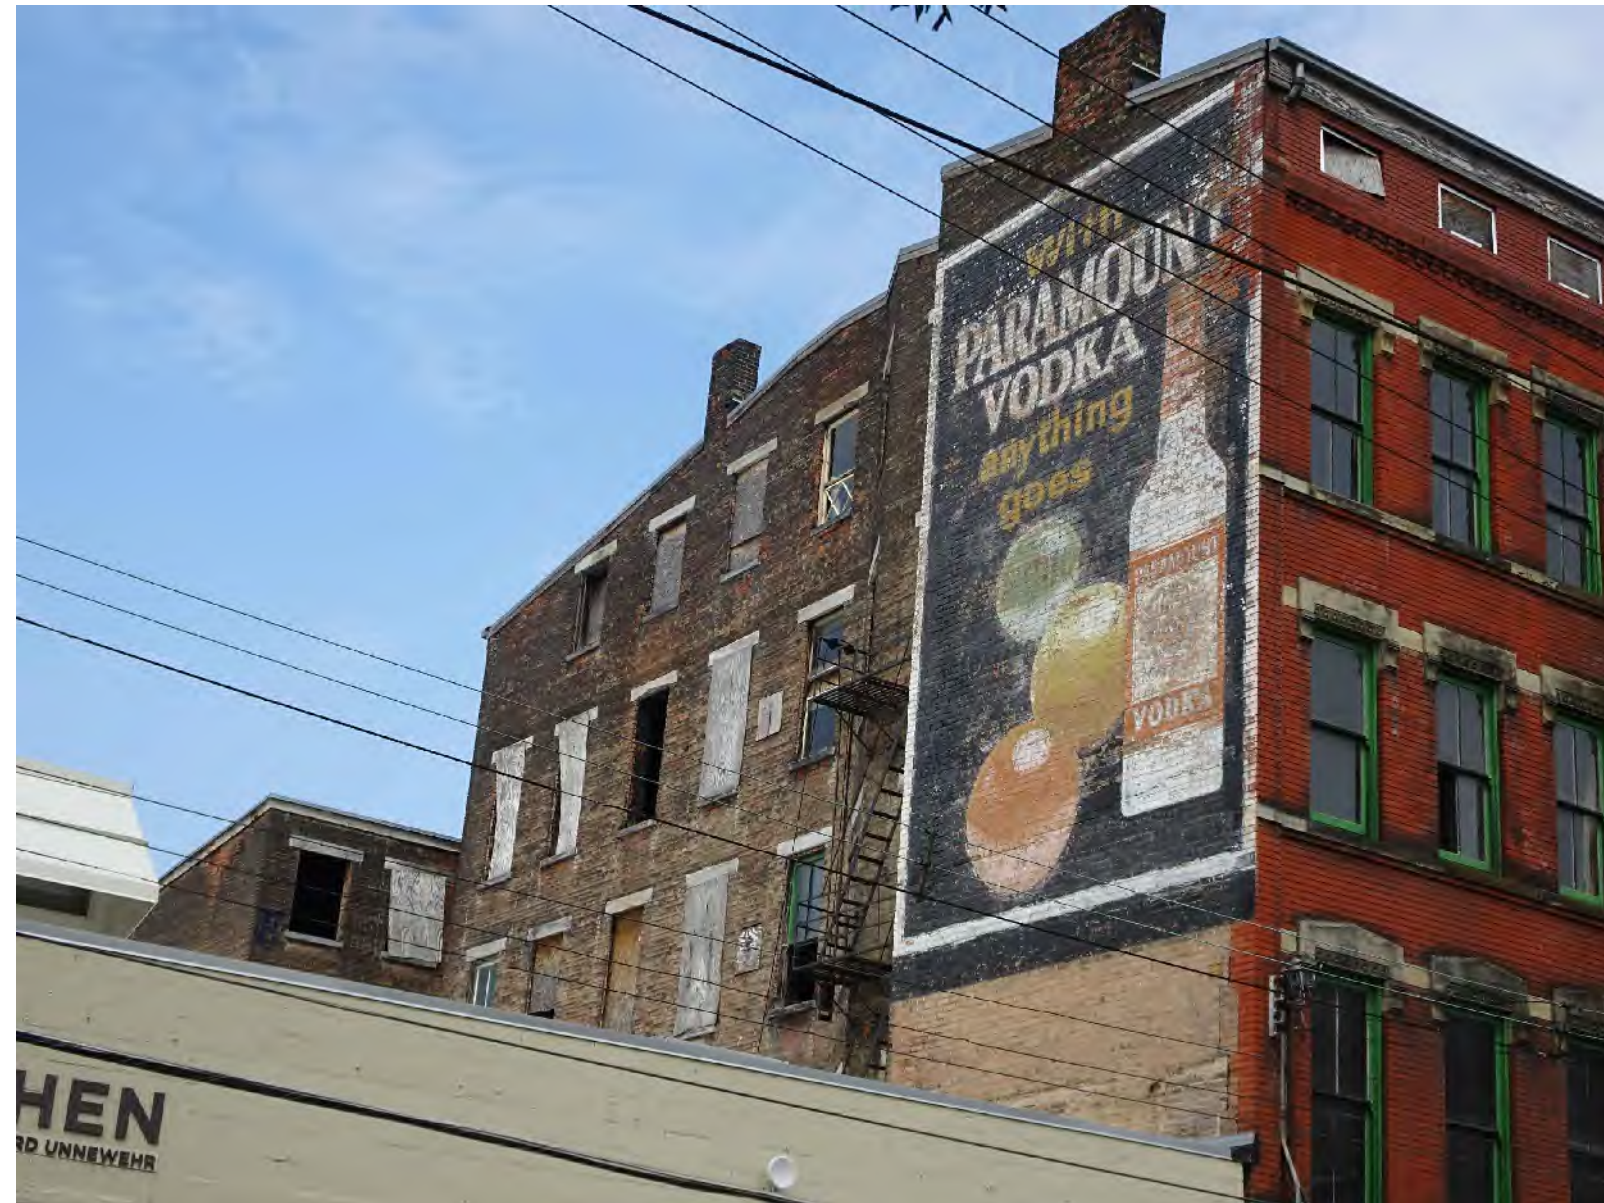
**A** SOUTH ELEVATION  
VIEW FROM ELM STREET
