## APPLICATION FOR HISTORIC CONSERVATION DISTRICT DESIGNATION HISTORIC CONSERVATION BOARD PUBLIC HEARING STAFF REPORT

APPLICATION #: N/A  
APPLICANT: Bond Hill Community Council thru Alexis and Wei Liu  
OWNER: Various. See attached excel sheet (Attachment 4)  
ADDRESS: **Properties on Bella Vista Street east of Reading Road**  
PARCELS: Various. See attached excel sheet (Attachment 4)  
ZONING: SF- 4 and RM 1.2  
OVERLAYS: None  
COMMUNITY: Bond Hill  
REPORT DATE: July 8, 2019  
HEARING DATE: Prehearing June 24, 2019- sign in sheet attached.  
July 22, 2019  
STAFF REVIEW: Beth Johnson, Urban Conservator

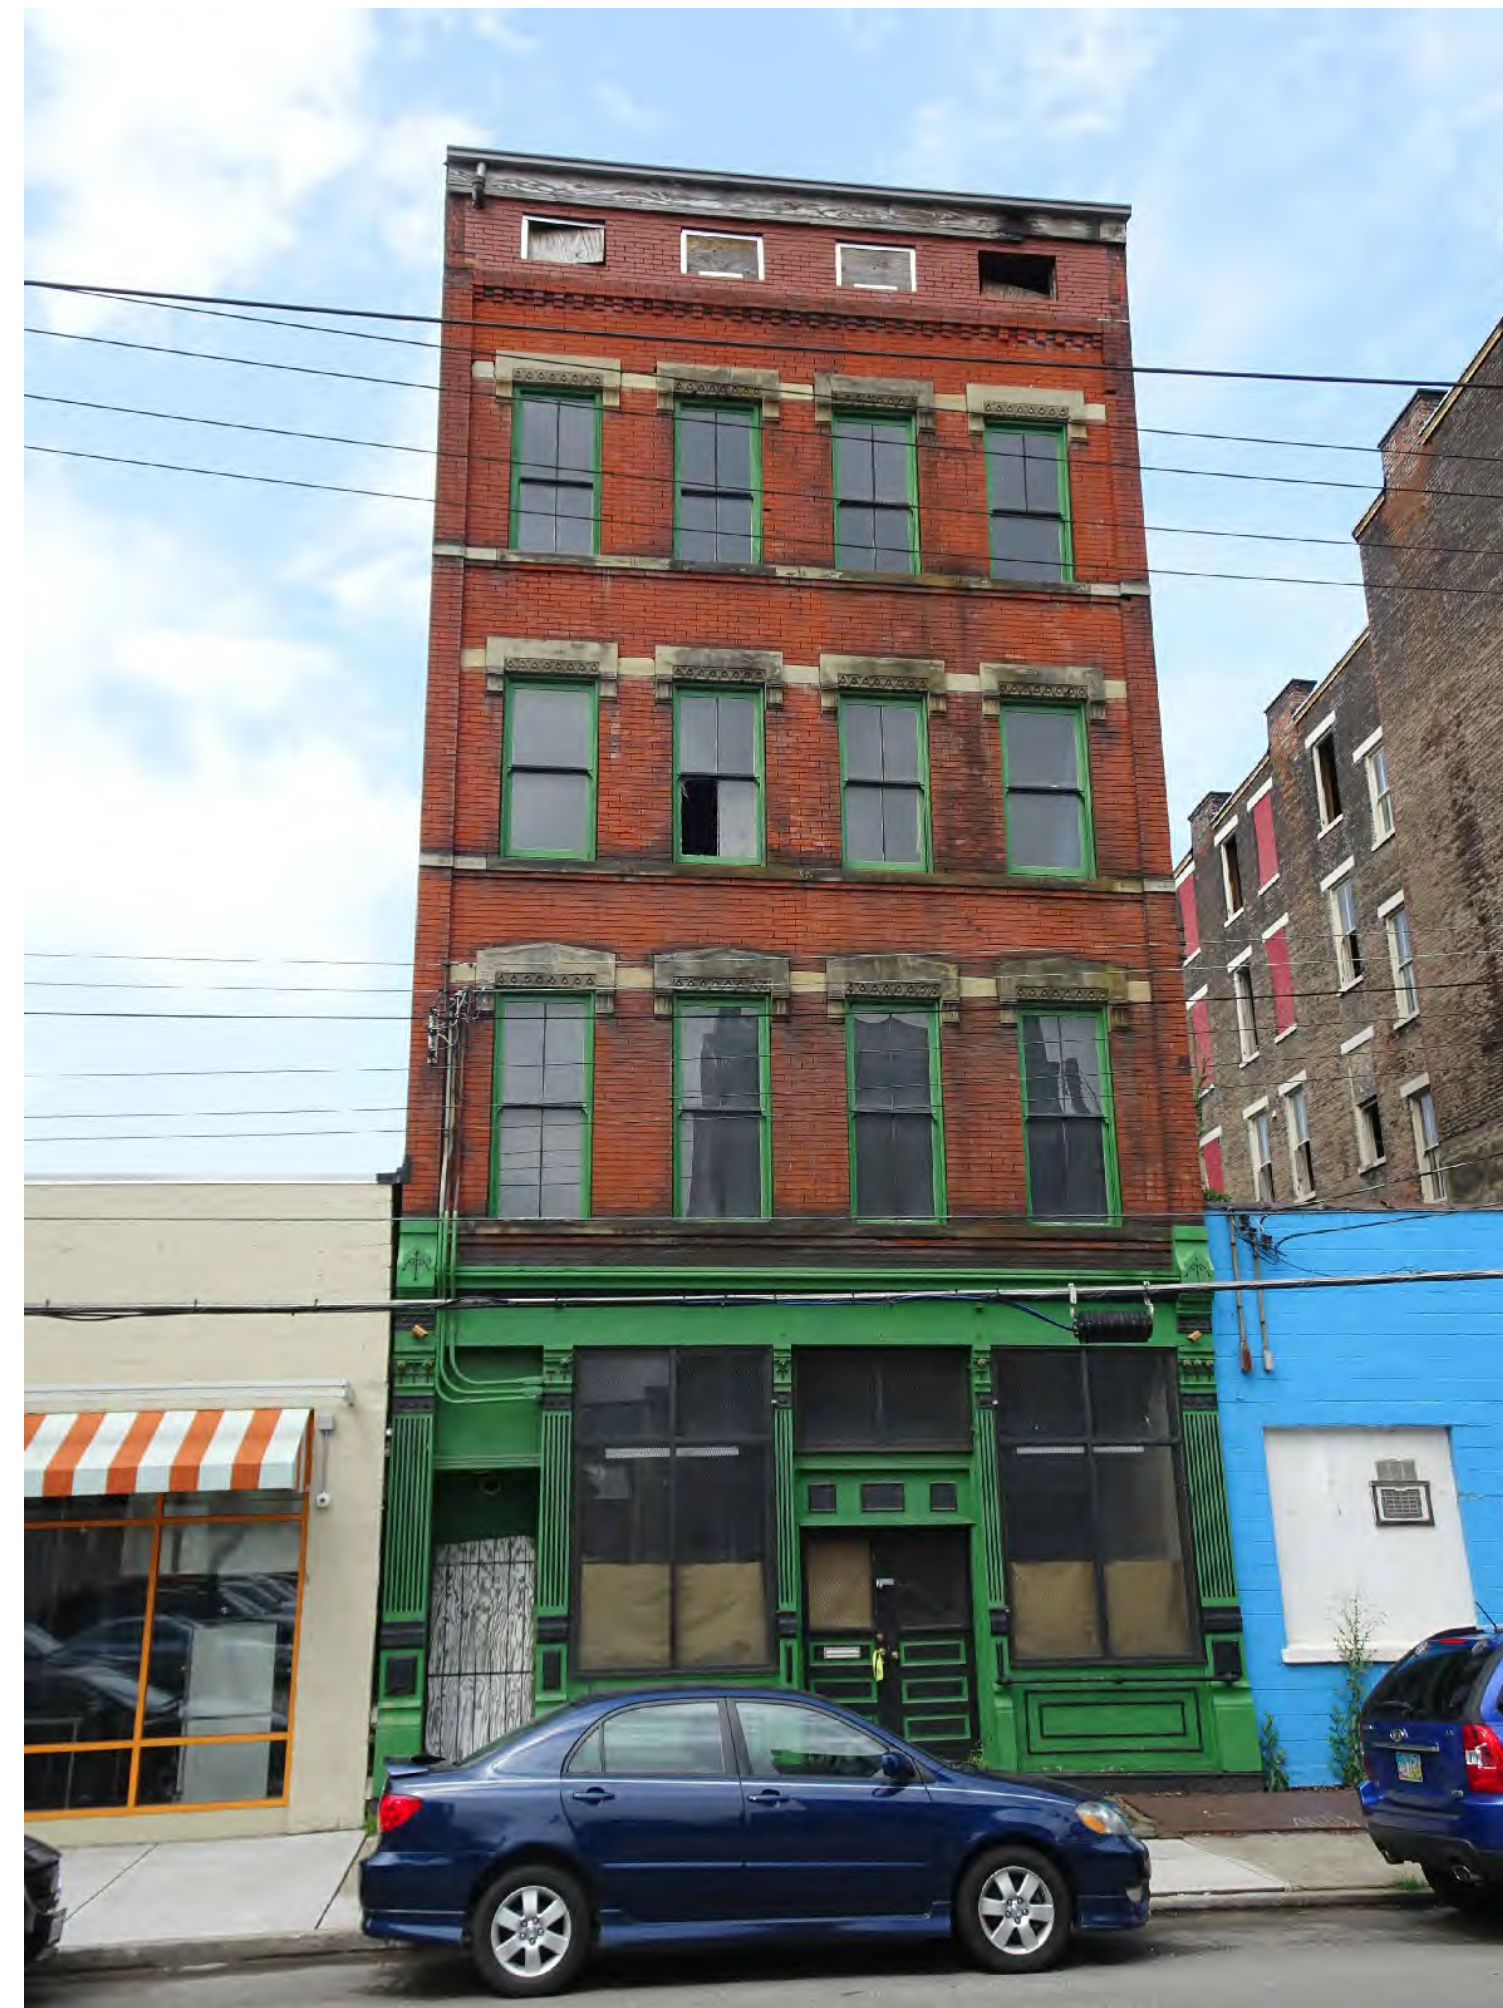
**B** EAST ELEVATION  
VIEW FROM ELM STREET

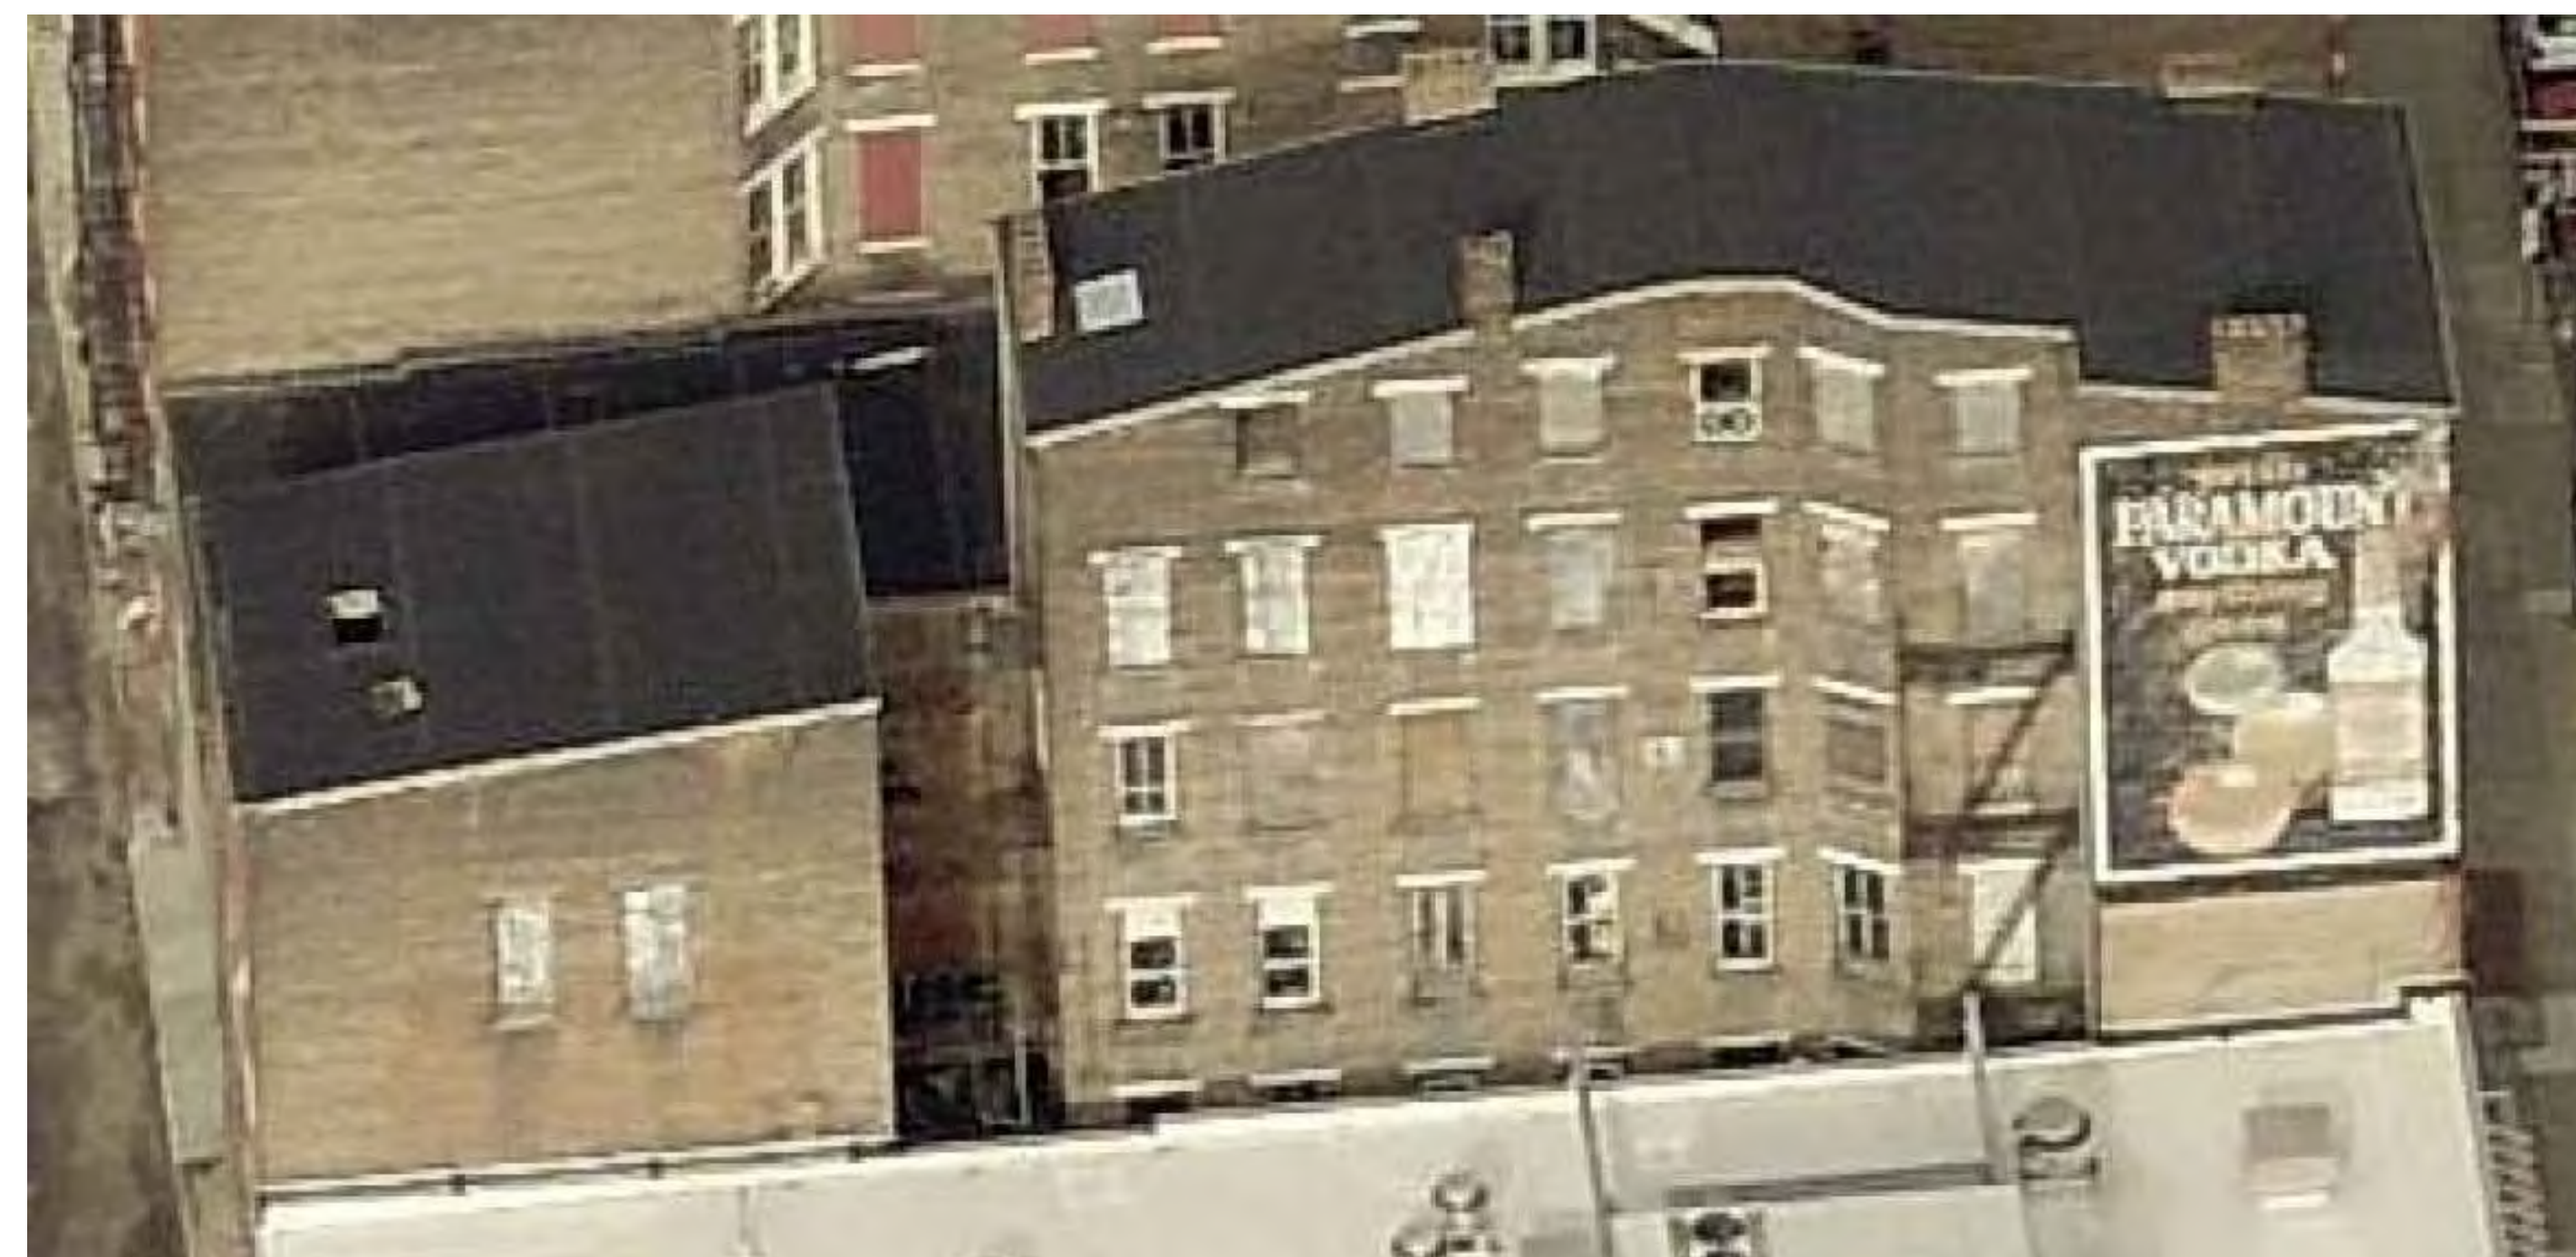
**E** SOUTH ELEVATION  
AERIAL VIEW FROM SOUTH

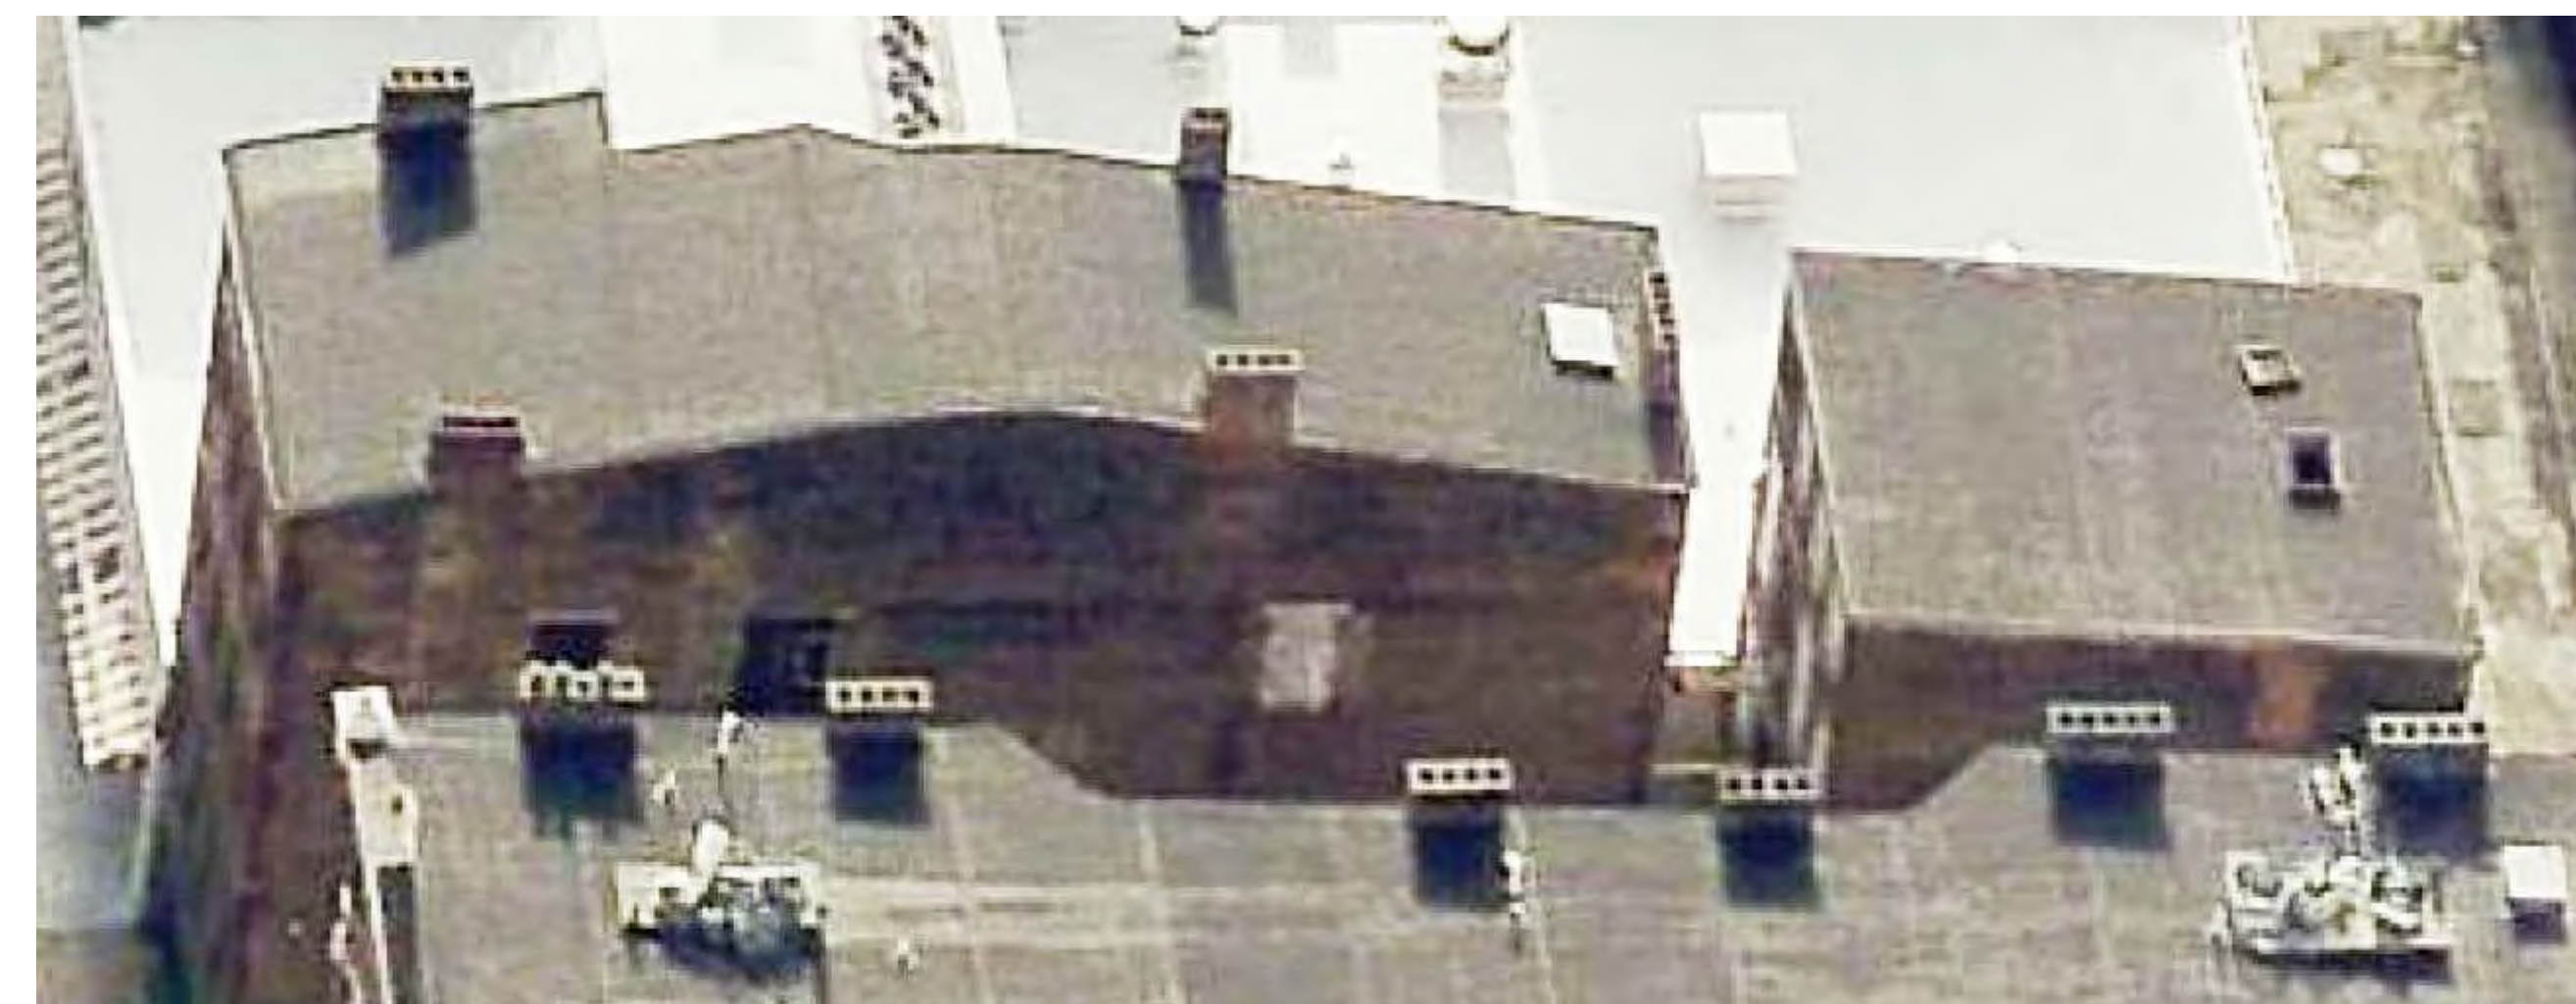
**F** NORTH ELEVATION  
AERIAL VIEW FROM NORTH

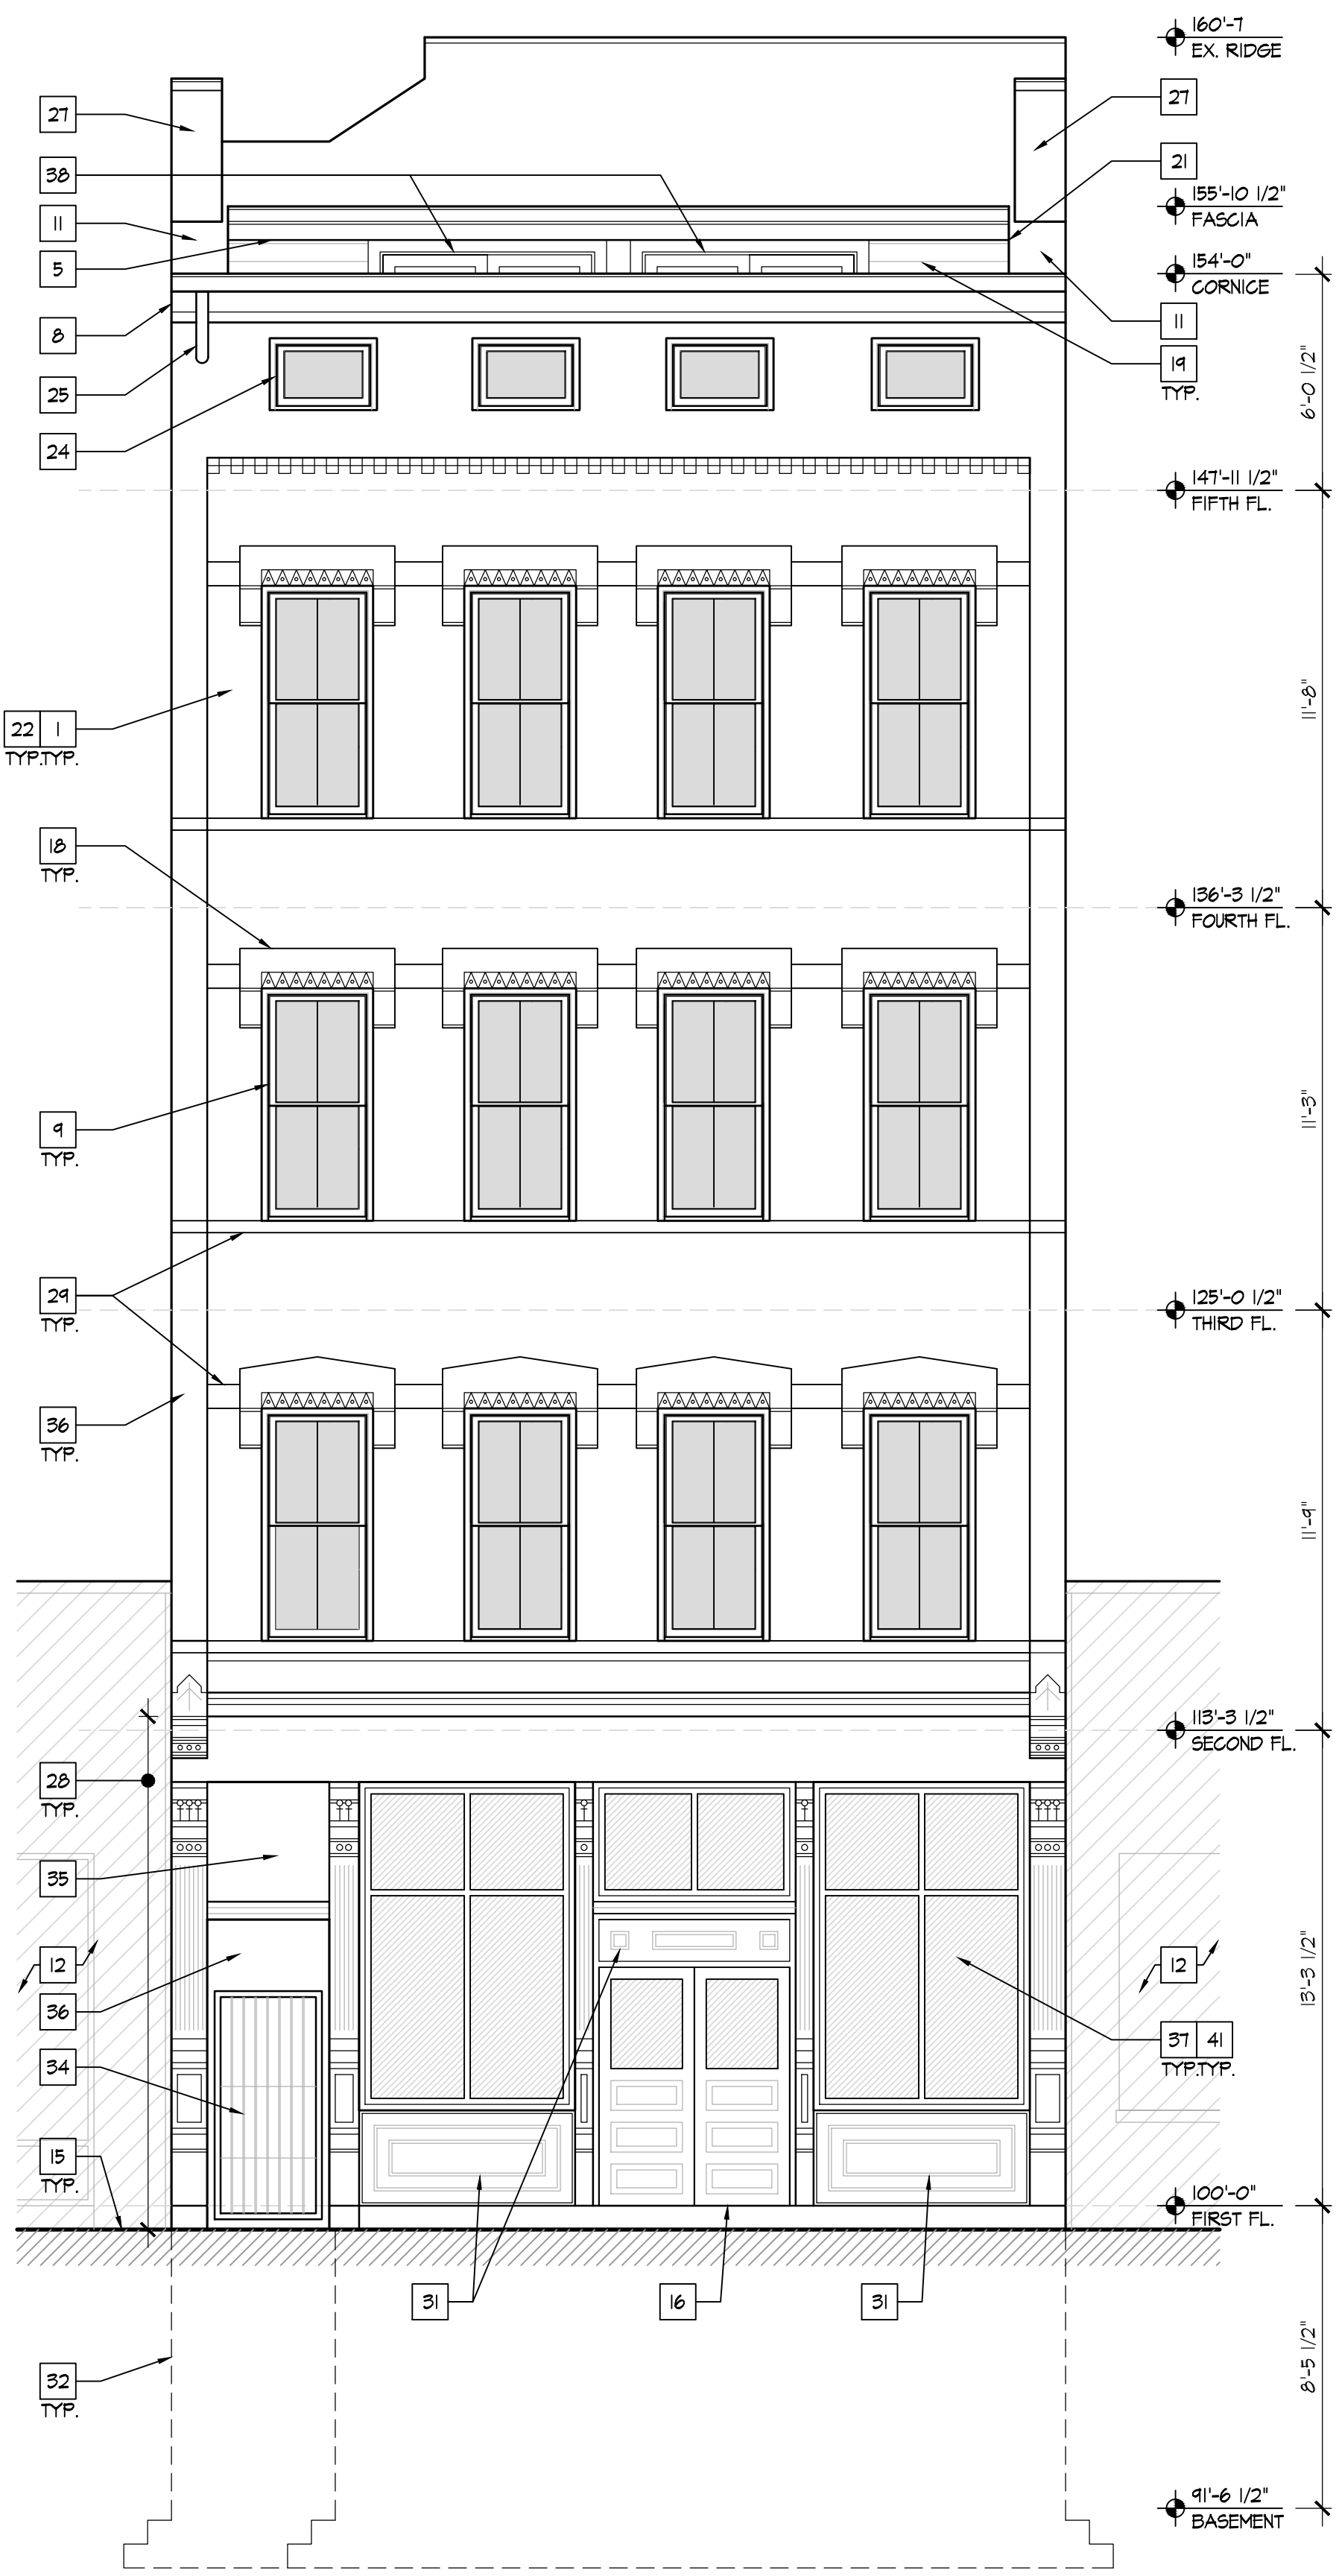
- CMU RECESSED 2" FROM FACE OF ADJACENT.
- EXISTING STEPS TO REMAIN
- NEW MEMBRANE ROOF SYSTEM TO MATCH EXISTING
- NEW ROOF DECK OVER NEW ROOF MEMBRANE
- OUTLINE OF ROOF TERRACE BEYOND

- NEW PAINTED METAL BALCONY.
- NEW FULL LITE DOOR WITH TRANSOM.

**A EAST ELEVATION [ELM STREET FACADE]**  
 SCALE: 1/4" = 1'-0"  
 0 2 4 8

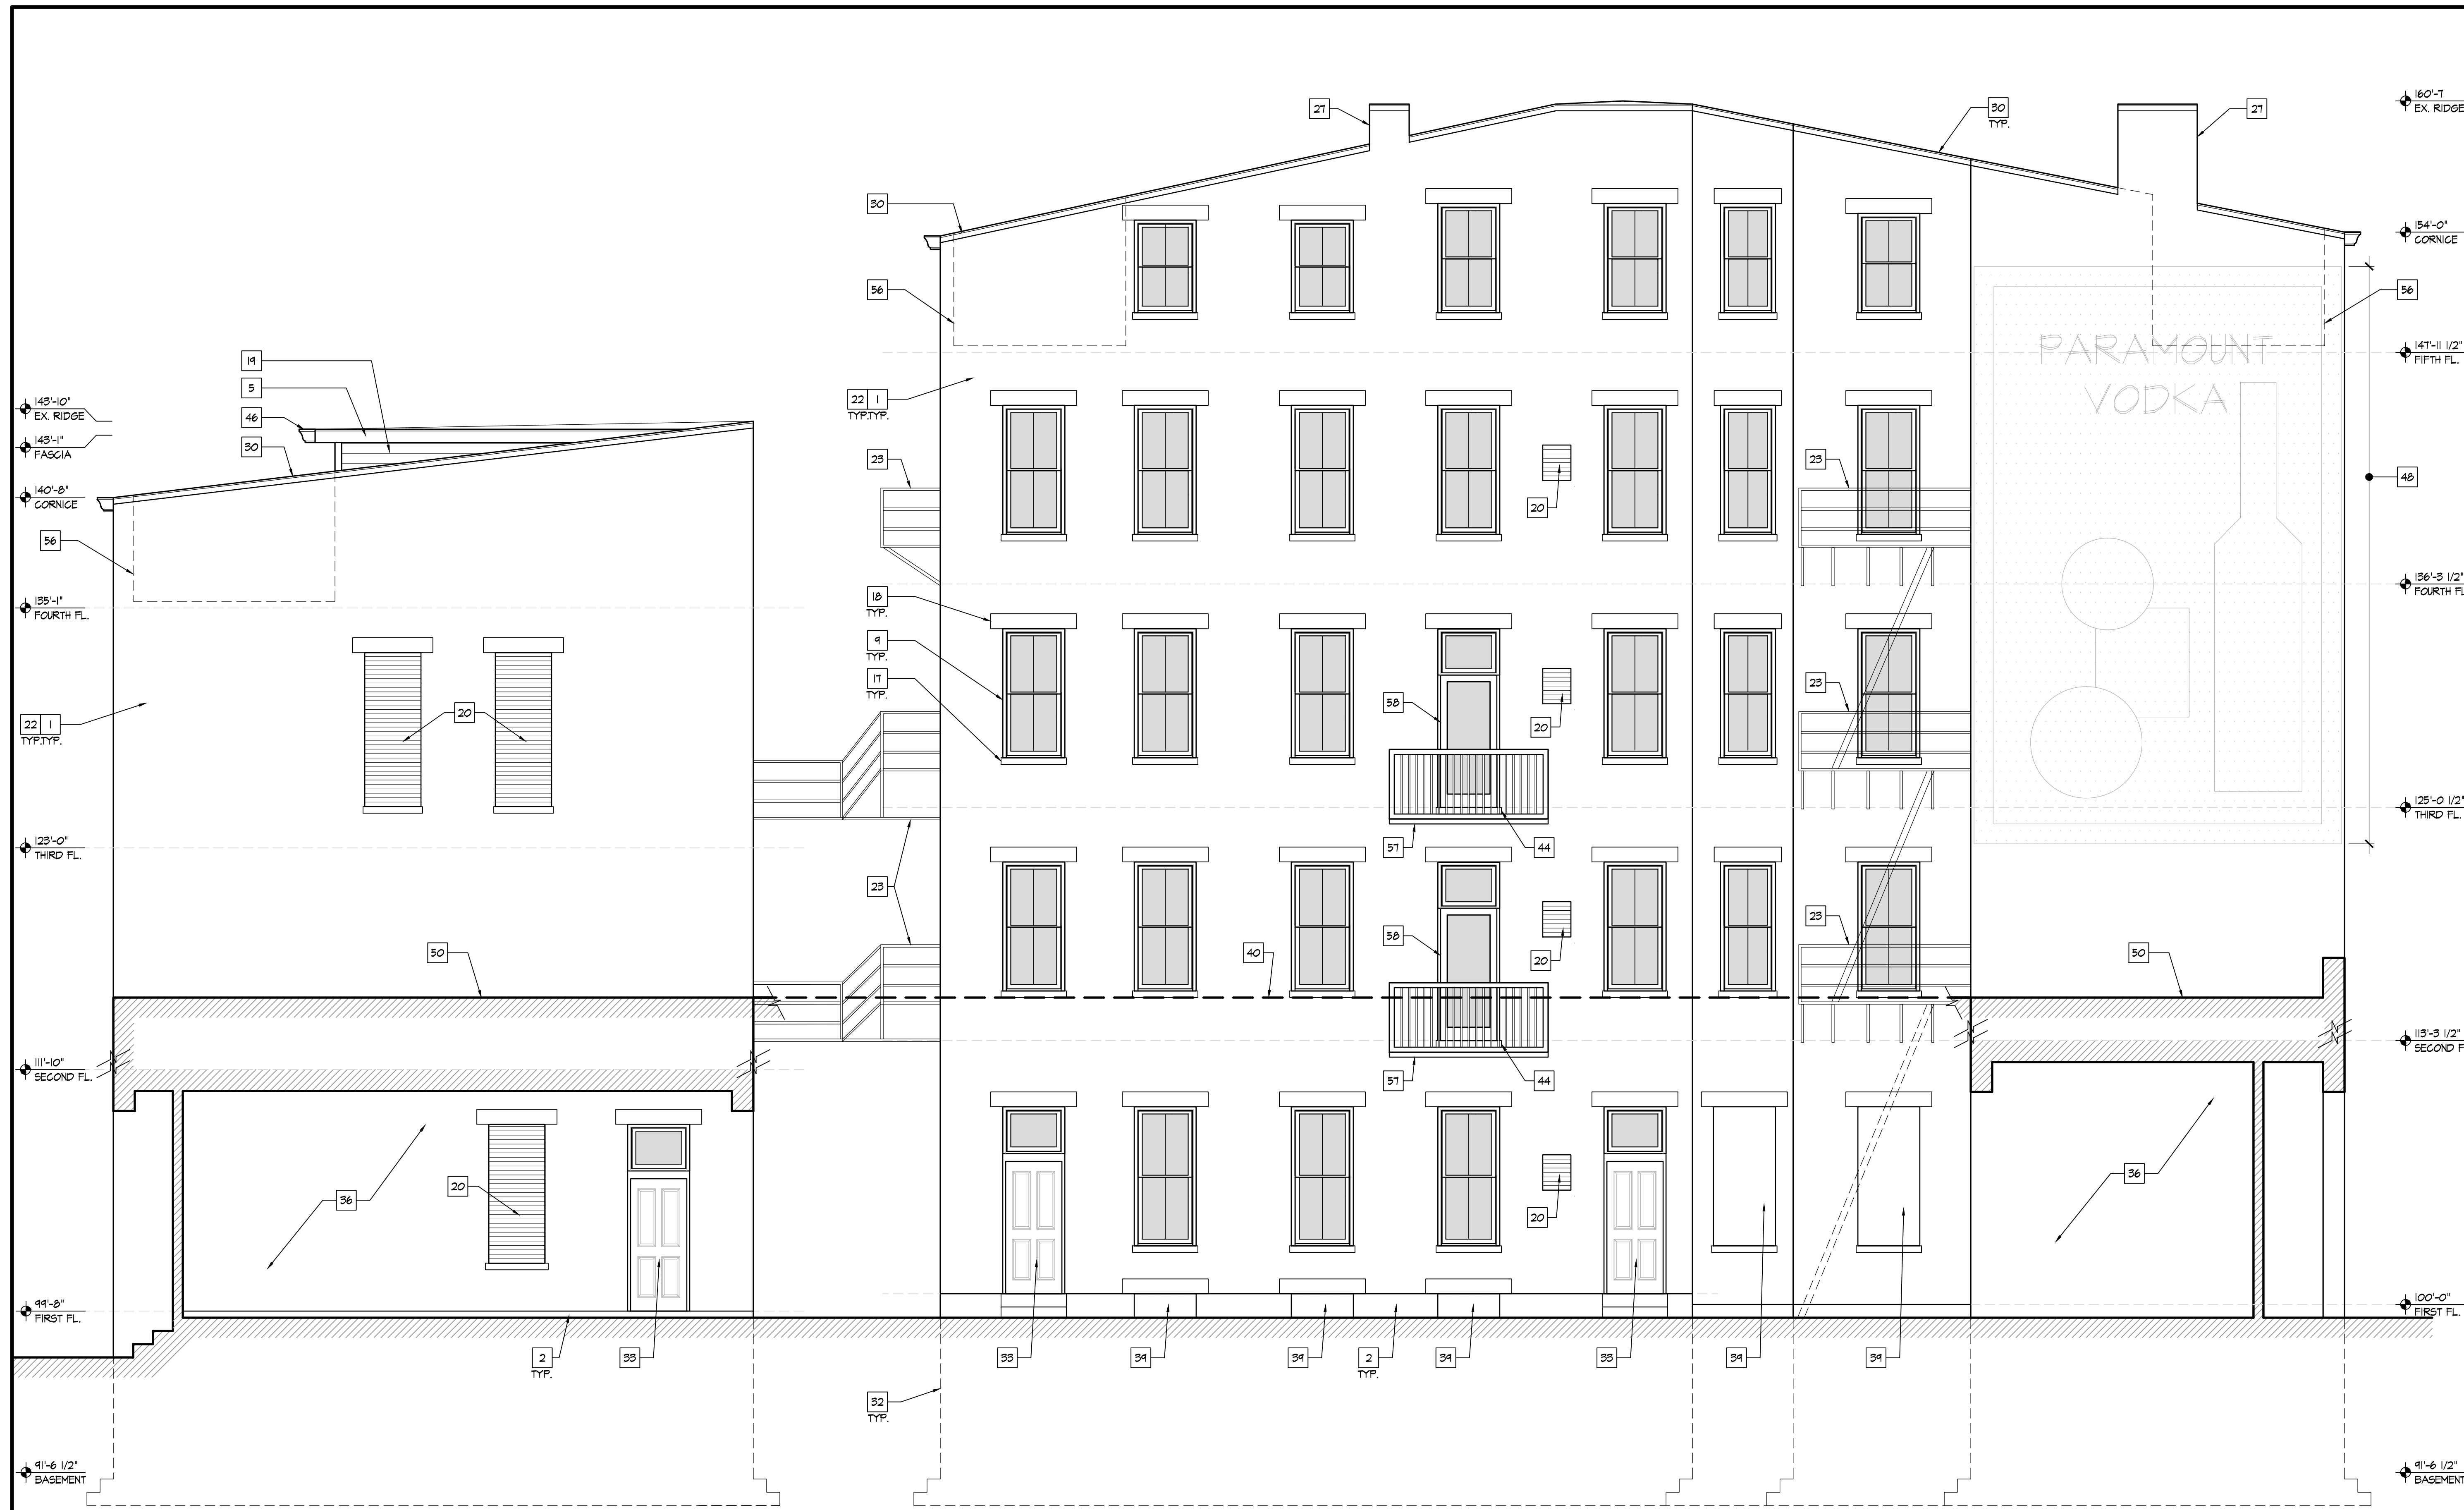
**A SOUTH ELEVATION**  
SCALE: 1/4" = 1'-0"  
0 2 4 8

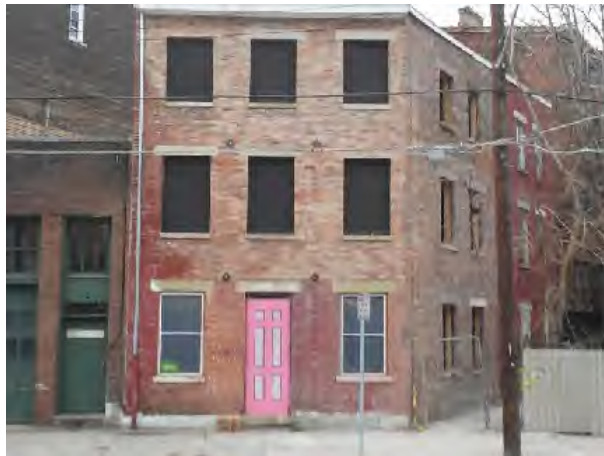
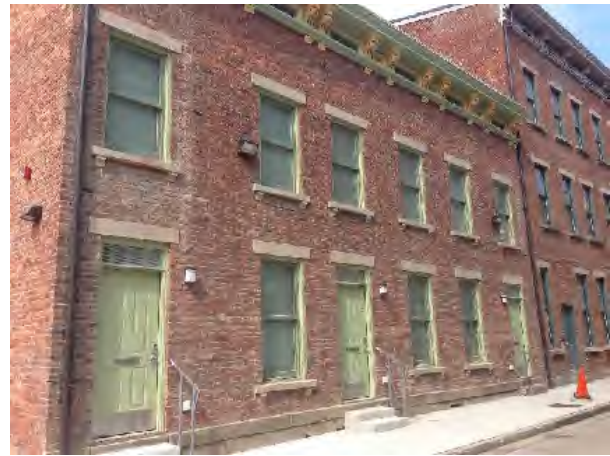
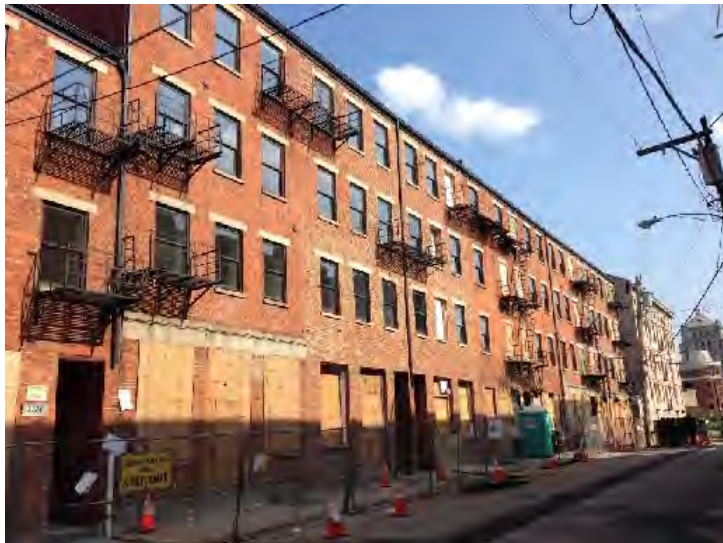
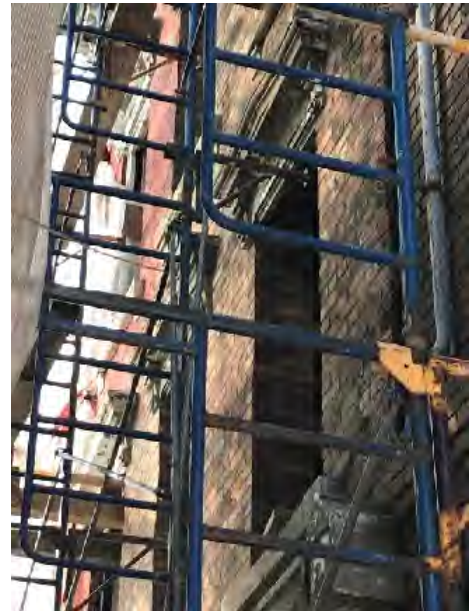
The most obvious issue facing the subject building is the deterioration of its west-facing masonry wall. The wall needs to be taken down and rebuilt. This is a perfectly feasible stabilization action to undertake. In fact, the complete rebuild of exterior masonry walls on historic buildings in Over-the-Rhine has become extremely commonplace and is regularly undertaken by property owners in the district.

Examples of Over-the-Rhine Buildings with Rebuilt Masonry Walls
