# H. & S. Pogue Service Building Historic Designation Report

310 Race Street  
Cincinnati, Ohio

Prepared for:  
City of Cincinnati  
Historic Conservation Office  
Department of City Planning and Engagement

**November 1, 2023**

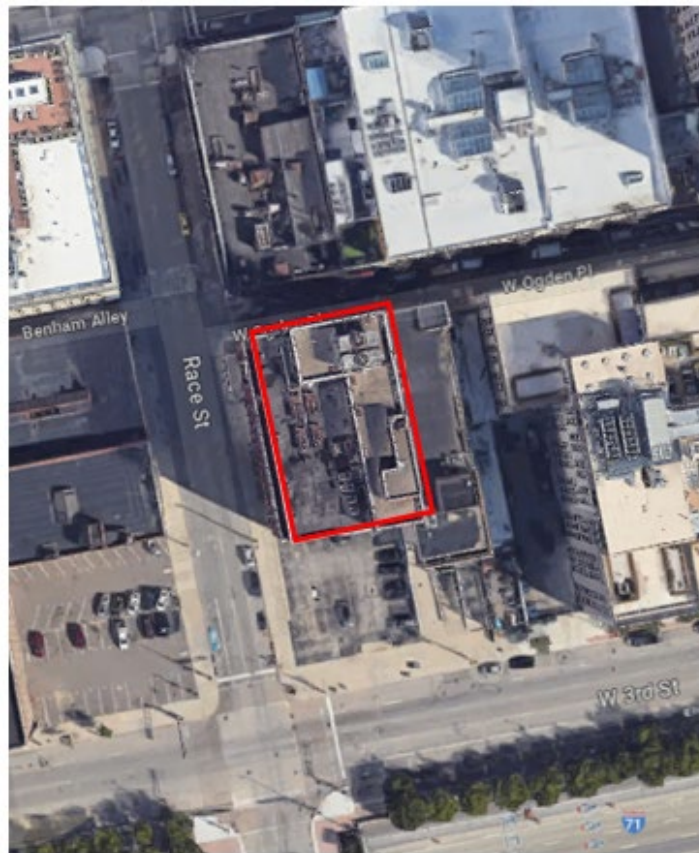
*Figure 1: The H. & S. Pogue Service Building, with boundary shown in red.*

The H. & S. Pogue Service Building is located at 310 Race Street in downtown Cincinnati, Ohio. It sits at the northwest corner of the block bounded by Race Street to the west, W. Ogden Place to the north, Vine Street to the east and W. 3rd Street to the south. It is located less than one-half mile north of the Ohio River and one-half block north of Interstate 71. The building lot slopes down from north to south and is bordered on the south by an open parking lot. Both the west elevation, facing Race Street and the north elevation, facing W. Ogden Place, are bordered by concrete sidewalks. Largely abutted by 27-29 W. Ogden Place, the east elevation faces the interior of the block. The surrounding neighborhood consists of densely concentrated, high rise commercial buildings, dating throughout the 20th century. Located immediately on the opposite (west) side of Race Street is the W. 4th Street National Register Historic District.

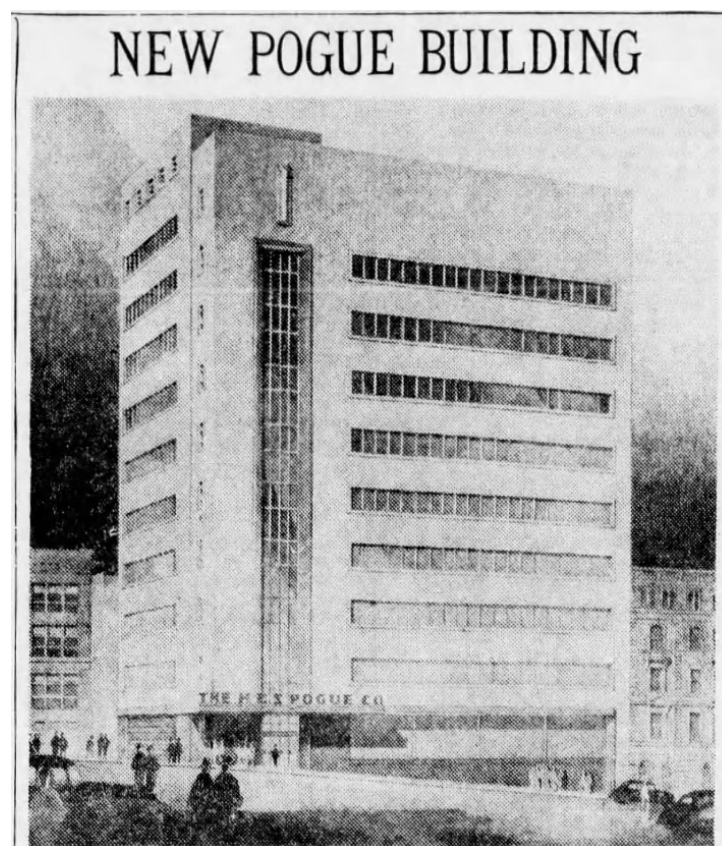
Figure 3: Rendering of the building from *The Cincinnati Enquirer* (February 3, 1946)

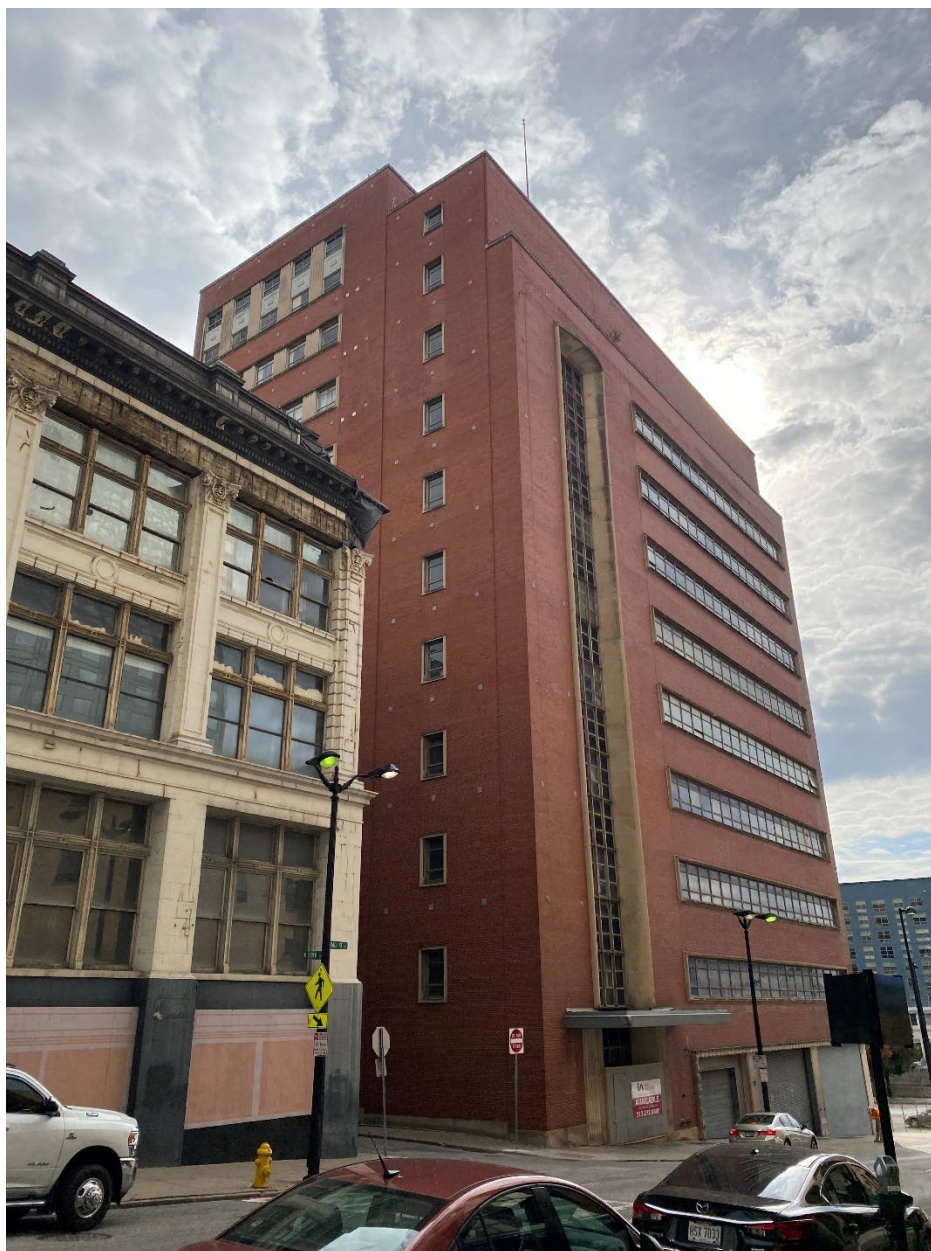
Photograph 1: West and north elevations looking southeast.

The primary, west, elevation faces Race Street (Photographs 1-3). It is clad in red brick, laid in a common bond, with a limestone water table and limestone caps along the 9th, 11th and 12th floors. The primary composition consists of a single column of windows along the north end of the façade with horizontal bands of windows along the remainder. On the 1st floor, the northernmost bay is the original main entrance to the building (Photographs 4 and 5). The original entrance doors were replaced at some with three, single-leaf roll up metal doors, which are slightly recessed from the façade. The 8-light steel transom above the entrance doors appears to be part of the original entrance design. The entrance is flanked by streamlined, fluted limestone pilasters, which are set at an angle, and topped by a cantilevered canopy that is clad in contemporary metal. Because of the change in grade of the street, there is a small concrete platform with a painted, pipe metal railing in front of the entrance. The remainder of the 1st floor contains three large loading bays that are separated by limestone piers and surrounded by a continuous limestone band with stylized, limestone, bas-relief plaques. All of the garage door openings have non-historic infill (Photograph 6). The northern opening contains an overhead metal garage door with an additional granite surround. The central opening has a full-sized corrugated metal overhead garage door. The southern opening is infilled with painted plywood panels.

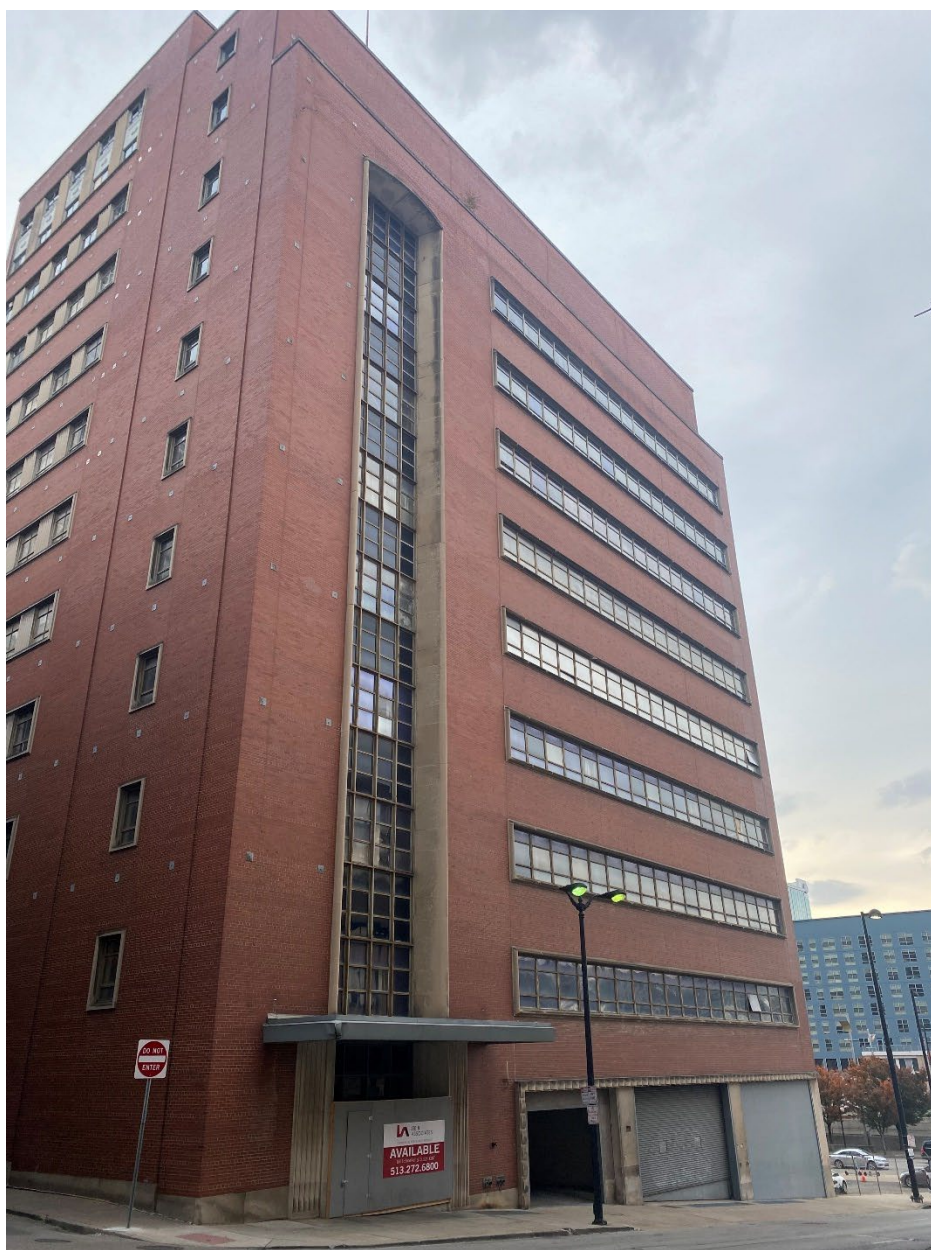
Photograph 2: Primary west elevation looking southeast.

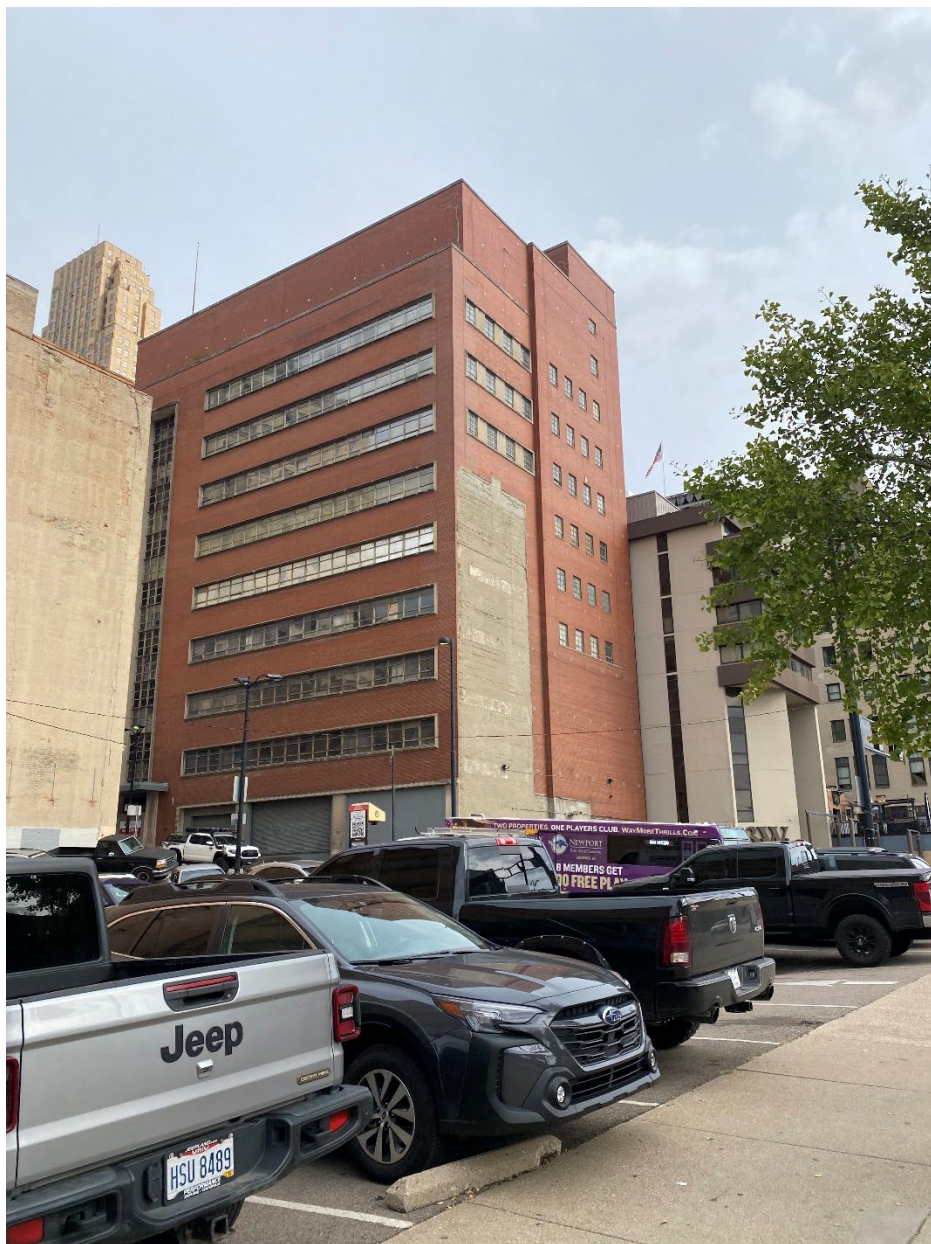
Photograph 3: West and south elevations looking northeast.

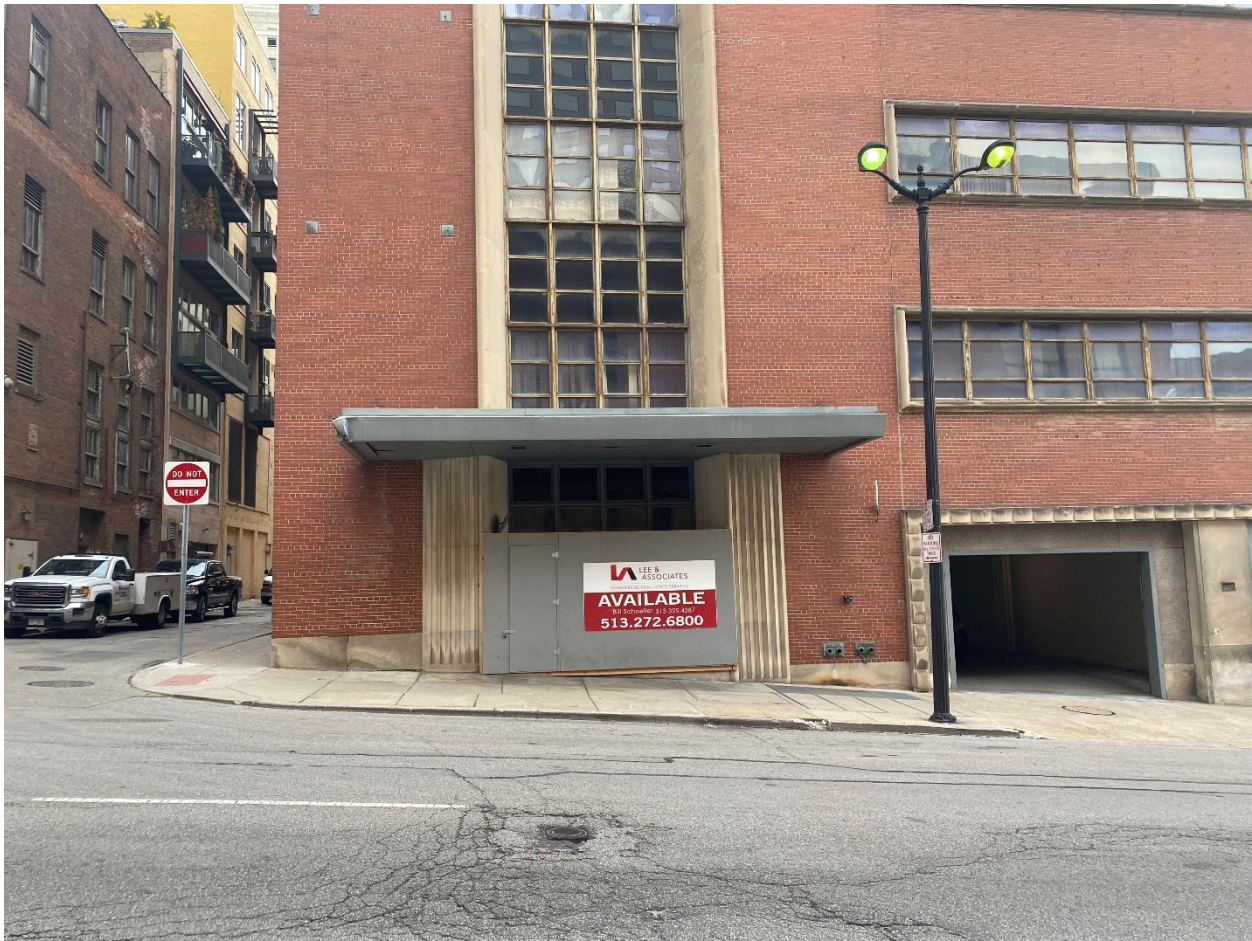
Photograph 4: West elevation looking east at entrance.

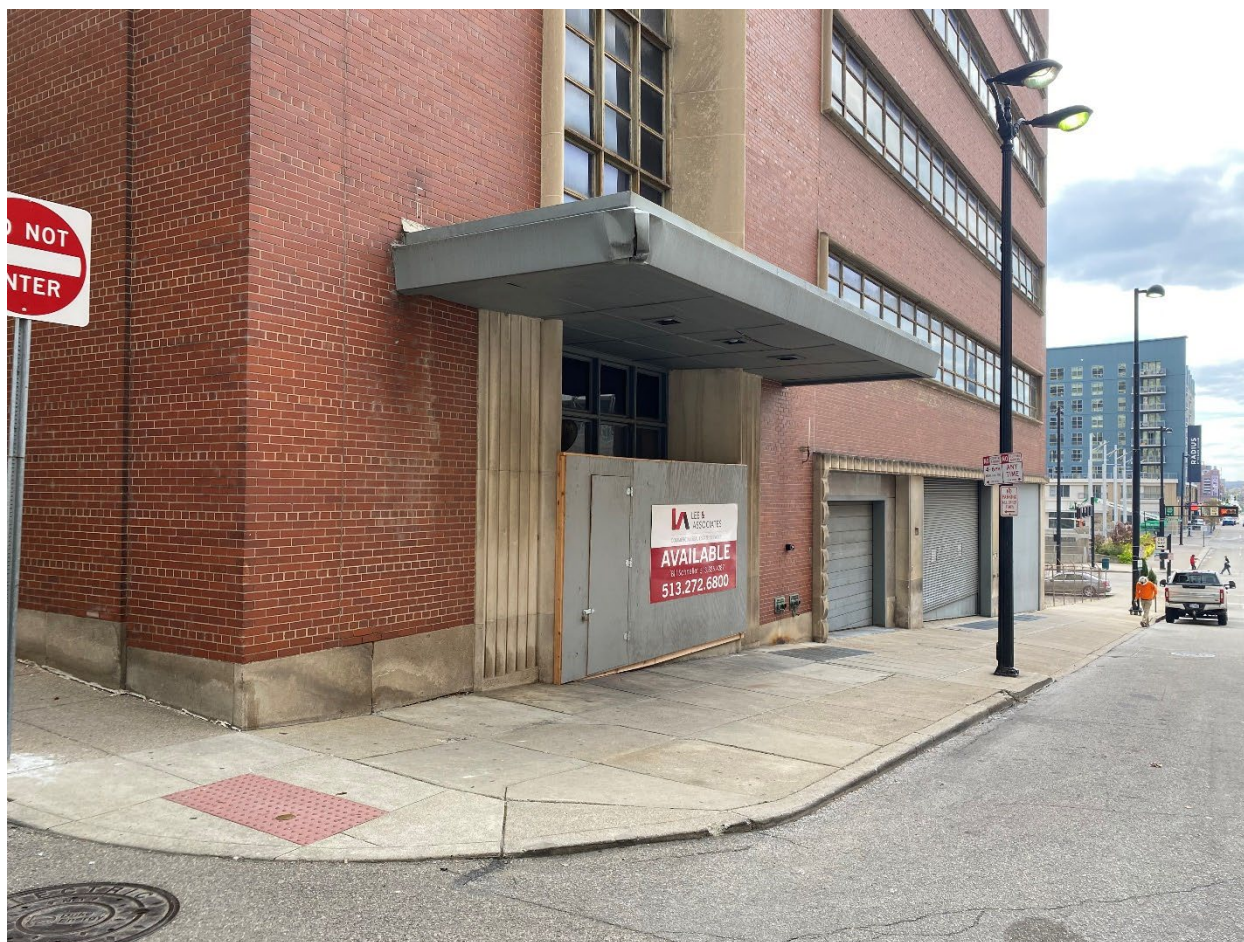
Photograph 5: West elevation looking southeast at entrance.

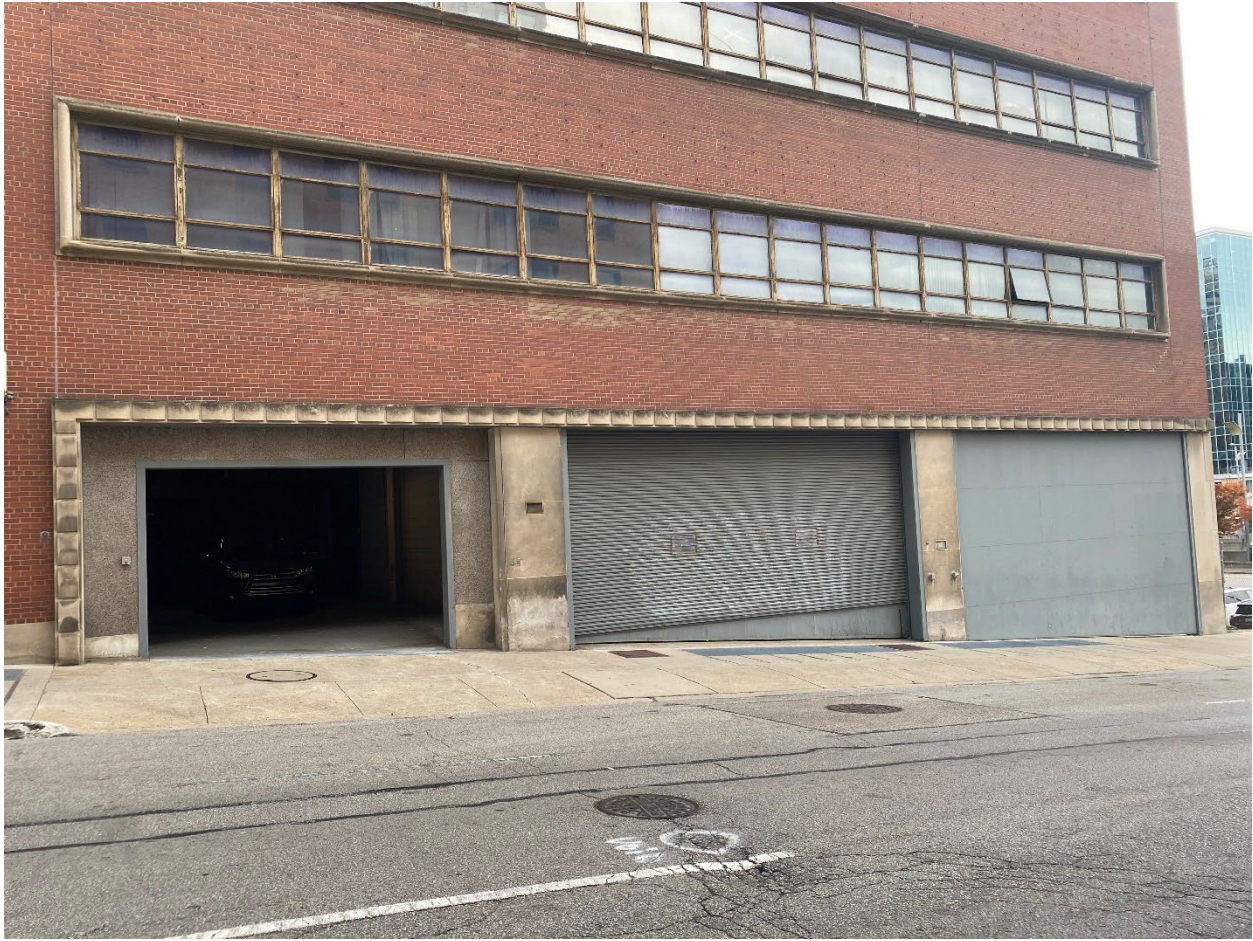
Photograph 6: West elevation looking east at loading bays.

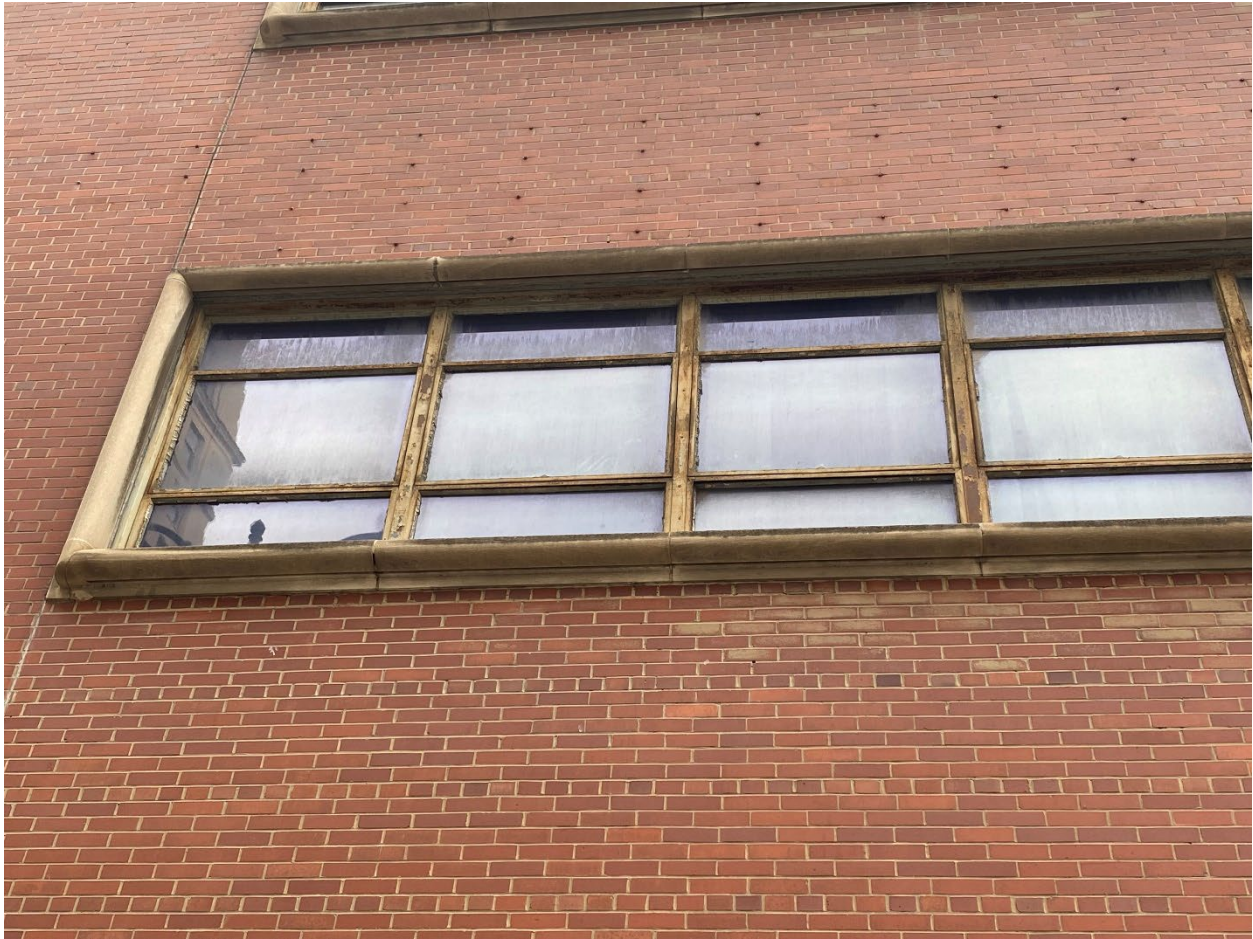
Photograph 7: West elevation looking east at second floor windows.

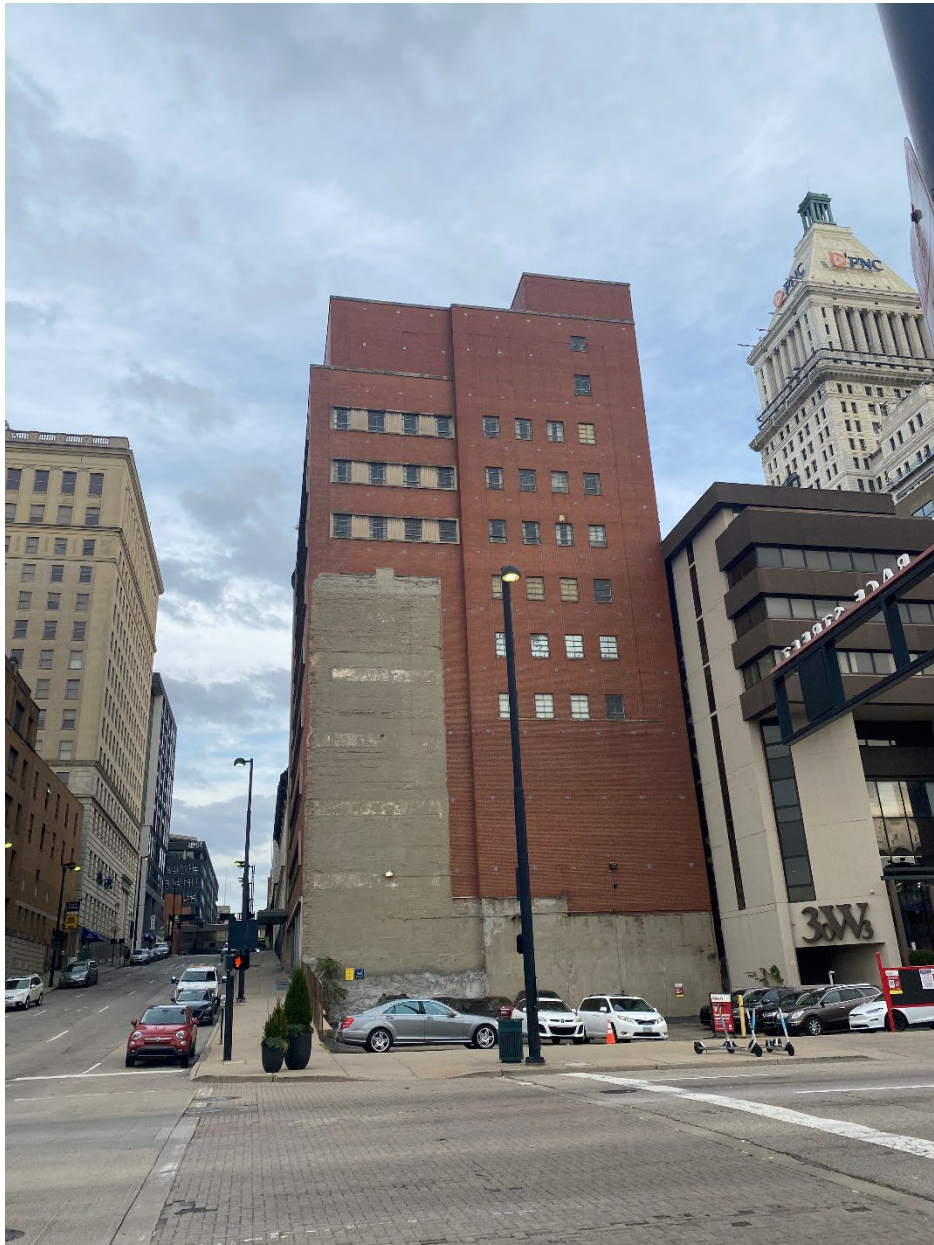
Photograph 8: South elevation looking north.

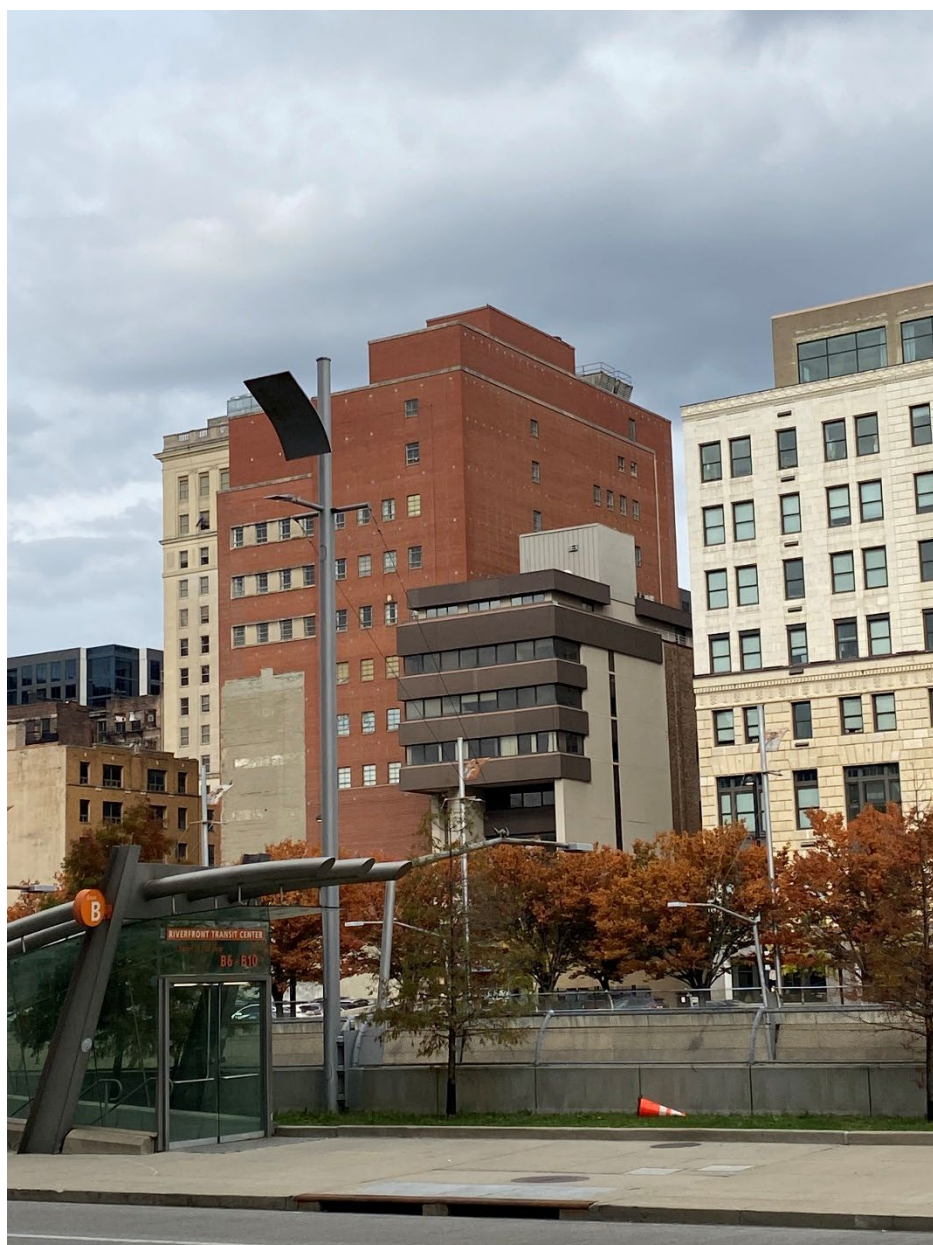
Photograph 9: South and east elevations looking northwest.

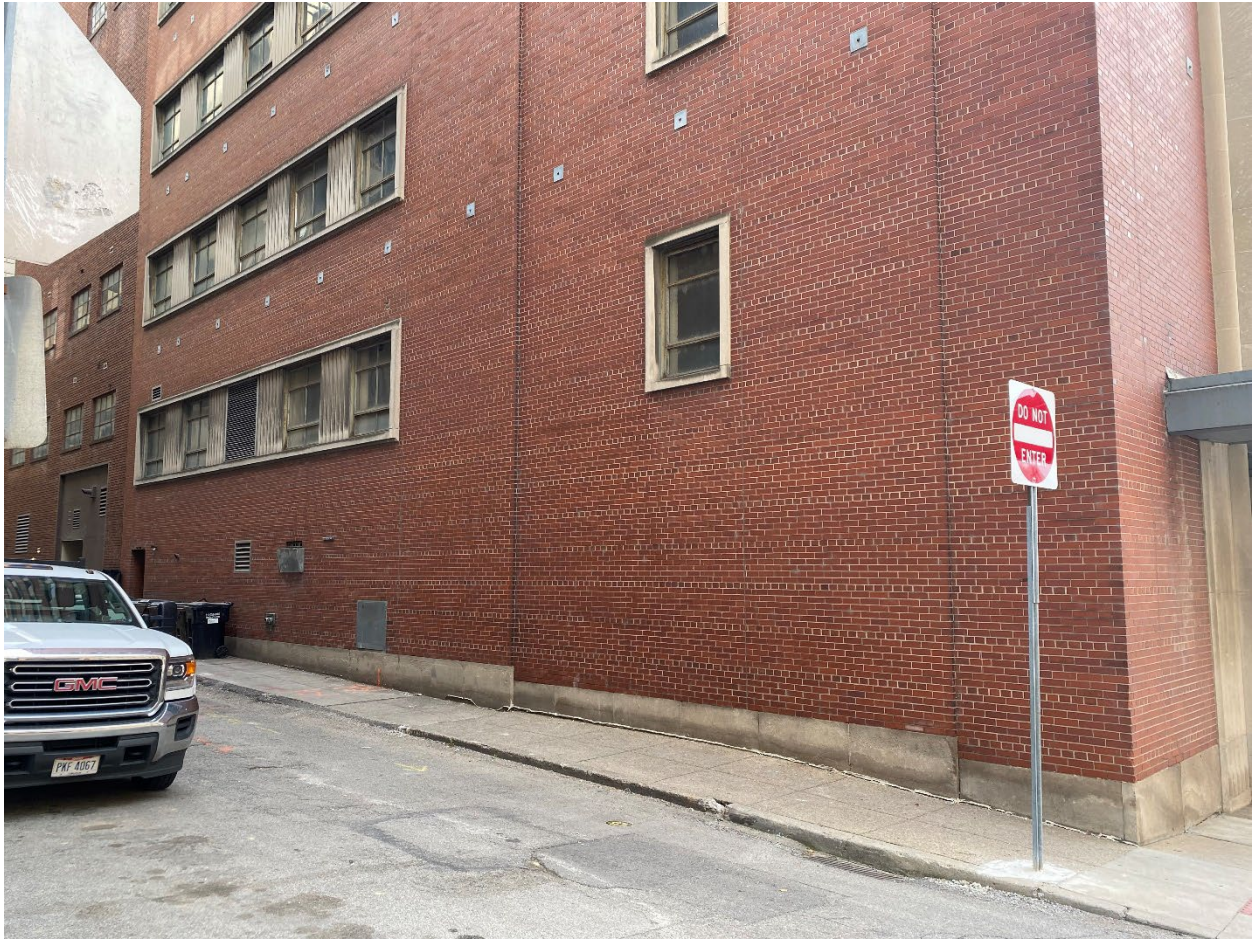
Photograph 10: North elevation looking southwest.

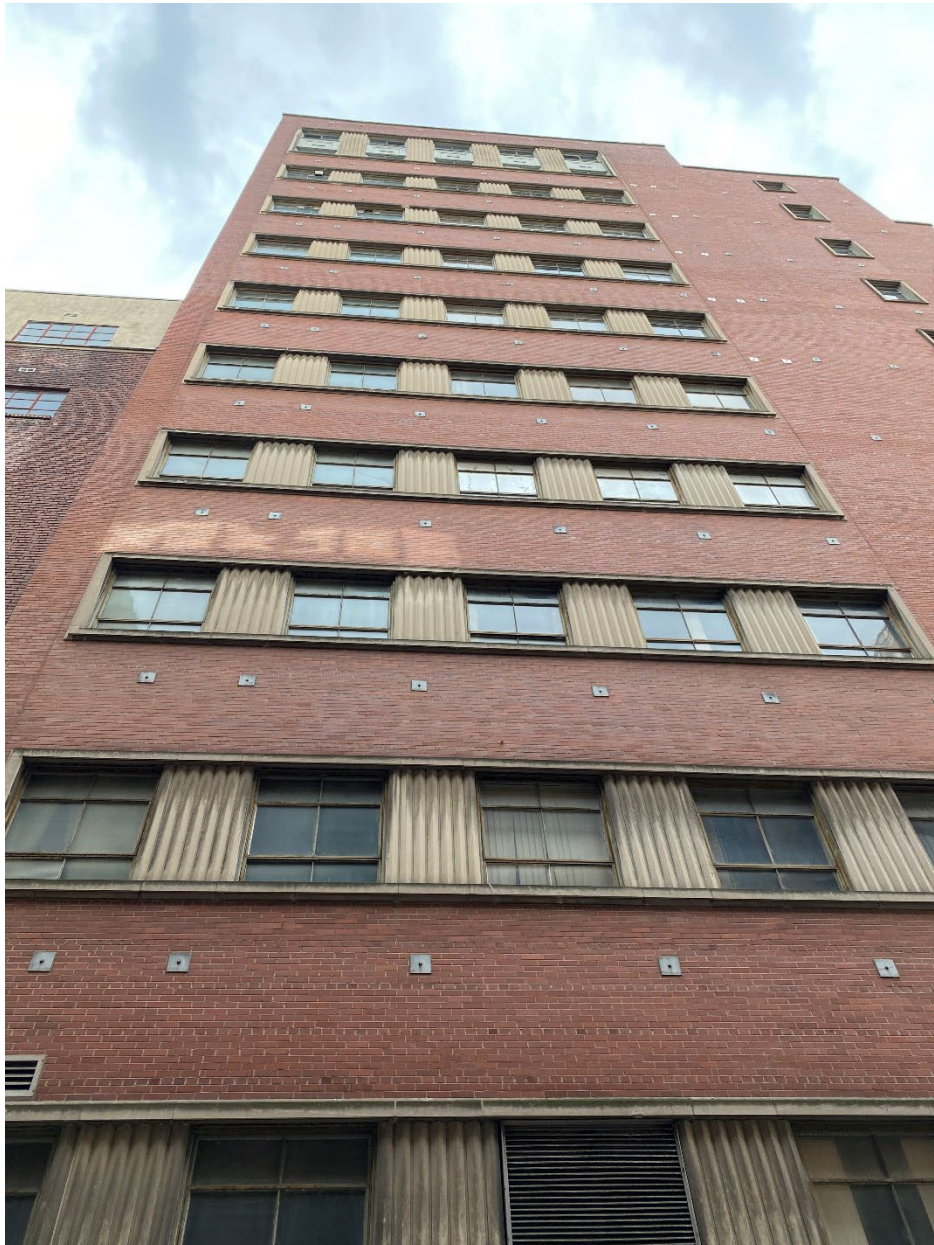
Photograph 11: North elevation looking west.
