2200 Block of Harrison Avenue – Crash Data and Recommendations

Education, Innovation, and Growth Committee

October 4, 2021

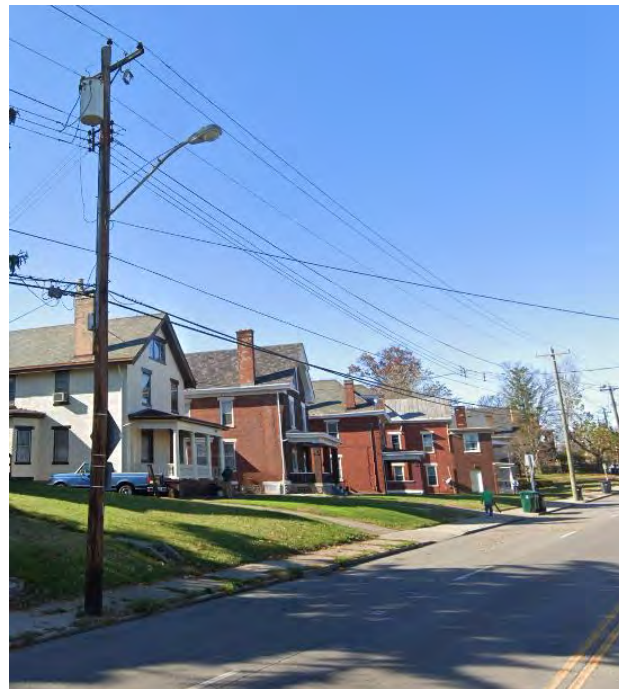
1. Improved streetlighting

- Duke Energy recently replaced two utility poles and added one new pole:
 - Streetlights missing on two replacements
 - DOTE has asked Duke to replace both lights
 - DOTE to ask Duke to add new light to new pole
 - Est. cost: \$2000
 - DOTE to use existing funds

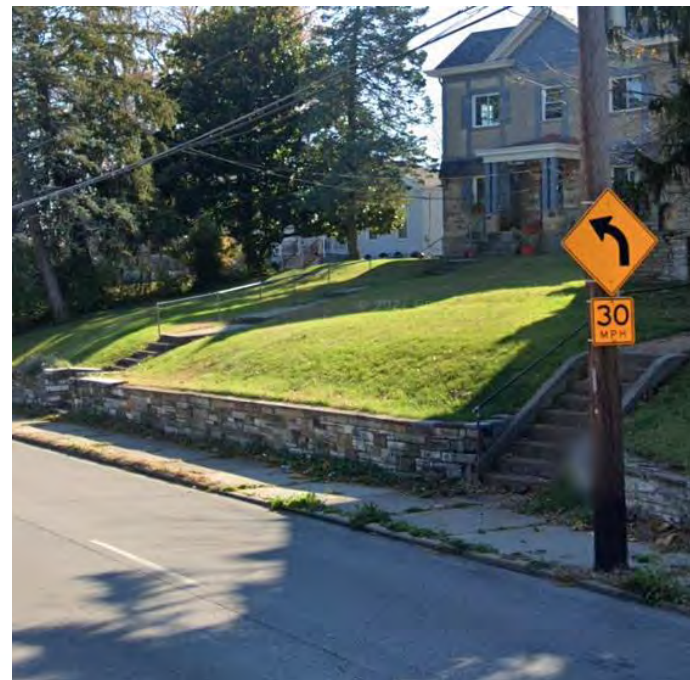
2. Upgraded/updated signage

- Some missing signage installed summer 2020
- Additional signage to be installed to help drivers navigate roadway
 - Est. cost: \$1,000
- Replace existing signage with new higher reflective signage:
 - Est. cost: \$1,000
 - DOTE to use existing funds

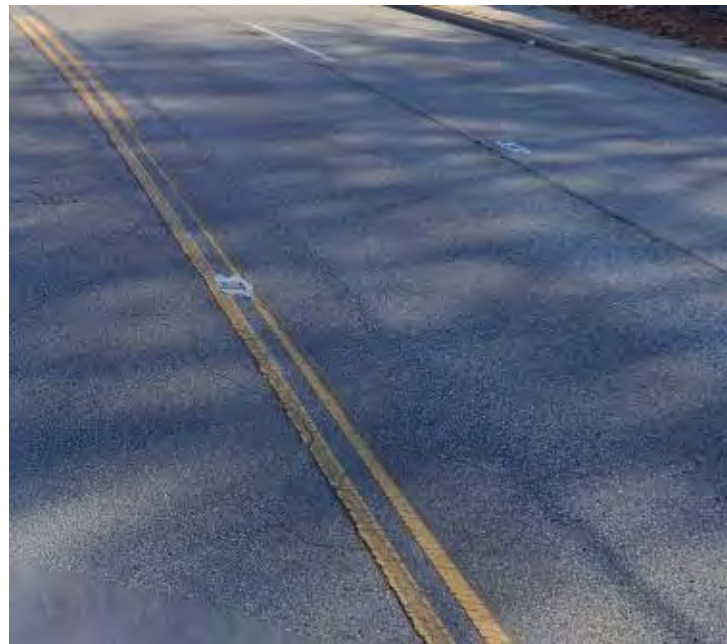
3. Pavement Markings

- Existing markings in average to good condition
- Restriping would improve visibility
 - Est. cost: \$15,000
- Raised Pavement Markings (RPMs)
 - Increase visibility at night/in wet weather
 - Replace reflectors in the existing RPMs
 - Est. cost: \$50,000
- Additional funding needed

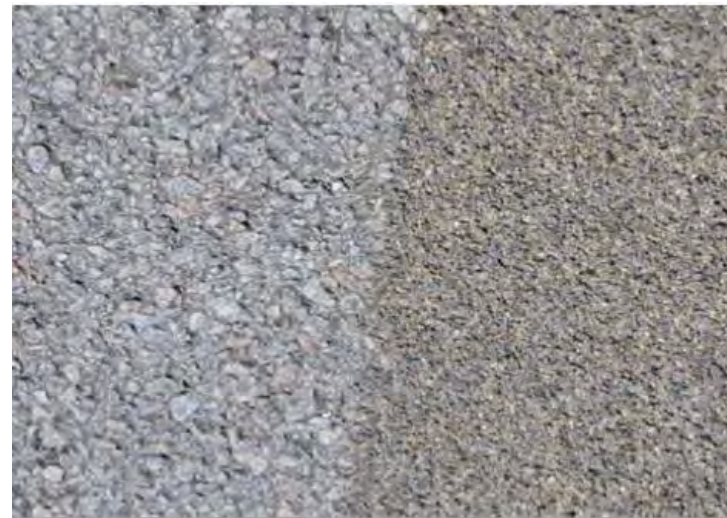
4. High Friction Surface Treatment

- Topcoat with rougher texture/better traction
- Most effective countermeasure for locations with lots of wet pavement crashes
 - Est. cost: \$300,000
 - Earliest installation: June 2022
- Additional funding needed
